STRUCTURAL BEHAVIOUR OF THE DAMAGED BUILDING DURING THE
FRIULI EARTHQUAKES BETWEEN MAY 6 AND SEPTEMBER 15, 1976

by Ewald Heimgartner, Structural Engineer ETHZ/SIA

BASLER & HOFMANN

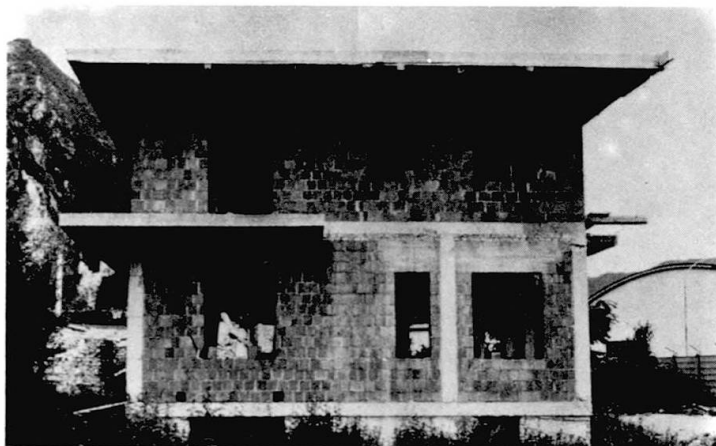
Figure 1: (after May 6th): Uncompleted building in Gemona with groundfloor open on three sides and living floor above. The supporting framework of the groundfloor consists of reinforced concrete columns, partitioned on one of the narrow sides by brick walls. The upper floor is exclusively brick. Due to the earthquake load, the building rotated around the partitioned transverse wall in the groundfloor. The fixing points of the columns were badly damaged in the cellar and groundfloor ceilings. The brick walls on the transverse side on the groundfloor were slightly cracked: the upper floor remained undamaged.

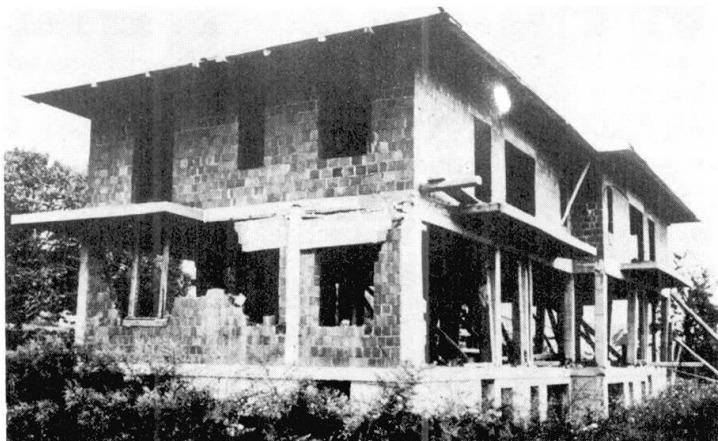
Figure 2: (after September 15th): Uncompleted building in Gemona after renewed earthquake stress. The reinforced concrete columns in the groundfloor were completely destroyed at their fixing points, connection being maintained by the reinforcement only. The massive wooden struts in the groundfloor saved the building from collapse during the second strong earthquake. The already damaged brick wall in the groundfloor was additionally strained due to the strenghtening effect of the wooden struts in the open groundfloor area. The wide brick window jamb was broken out and the reinforced concrete window supports shaken from their rests.

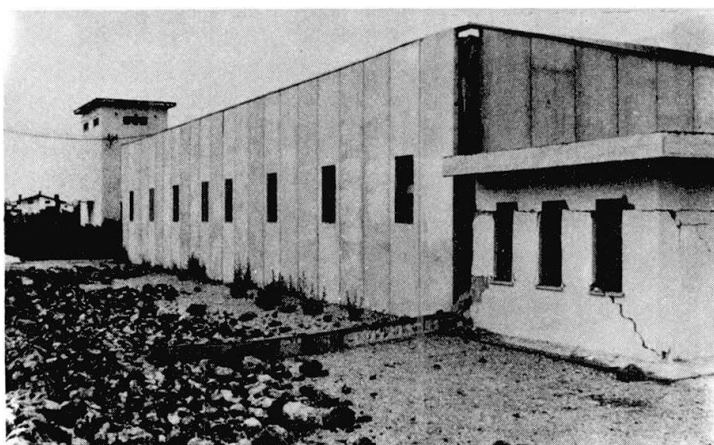
Figure 3: (after May 6th): Prefabricated shed with brick annex in Gemona. The supporting framework of the shed is undamaged. The concrete elements of the side wall, on the other hand, were slightly caved in by the impact of the rigid annex. The plastic material of the wall joints was torn by the large deformation. The roof of the annex was shorn off and pushed over at window level by the impulse load of the impact due to insufficiently wide joints.

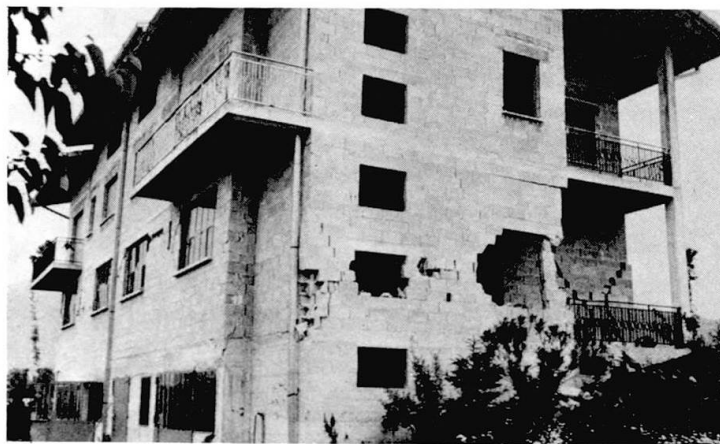
Figure 5: (after May 6th): Residential building with workshop near Artegna with a reinforced concrete cellar and two floors in concrete blocks. The side walls by the entrance incurred gaping X-shaped diagonal cracks due to the high shear stress. These cracks led to partial collapse of the masonry. The highly strained window jambs on the longitudinal façade were badly cracked.

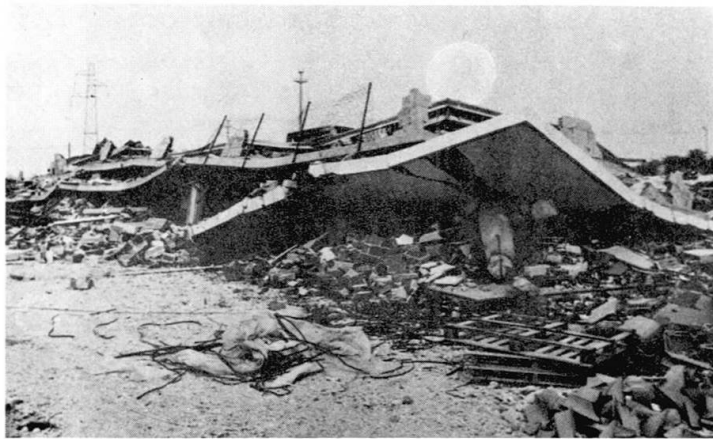
Figure 8: (after September 15th): Wreckage of the residential and business house near Artegna. The groundfloor of the building collapsed during the earthquake of September 11th. Through the impact, the undamaged living storeys also collapsed. The destroyed fixing points of the reinforced concrete columns in the groundfloor as well as the cracked brick walls of the staircase were not enough to carry the renewed strong earthquake stress. The experts had hoped, despite the doubts of the owner, to be able to repair the building.

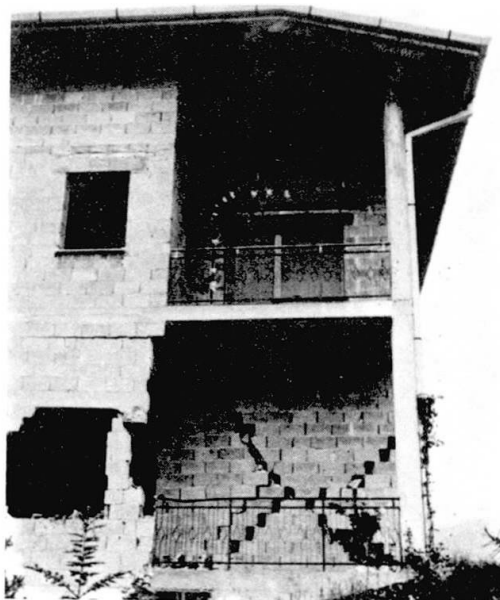
Walls and partitions consisting of brick and masonry are both rigid and brittle. Where the walls are insufficiently strong or where many openings exist, the masonry walls are no longer able to absorb horizontal forces. When overstrained, these walls crack mostly crosswise under 45° (Figure 13), the crack spreading, either along the mortar joints or in the bricks. Because of the brittle nature of masonry constructions, the cracks widen, joints gape open or the walls concerned even collapse. In a skeleton construction, the reinforced concrete framework can in certain cases continue to uphold the weight of the buildings. For purely masonry construction, on the other hand, at least a partial collapse of the building is unavoidable.

Figure 13: Dwelling house with workshop near Artegna. Basement in reinforced concrete and the upper stories in masonry without framing. Typical diagonal cross cracks in a wall of the ground floor.

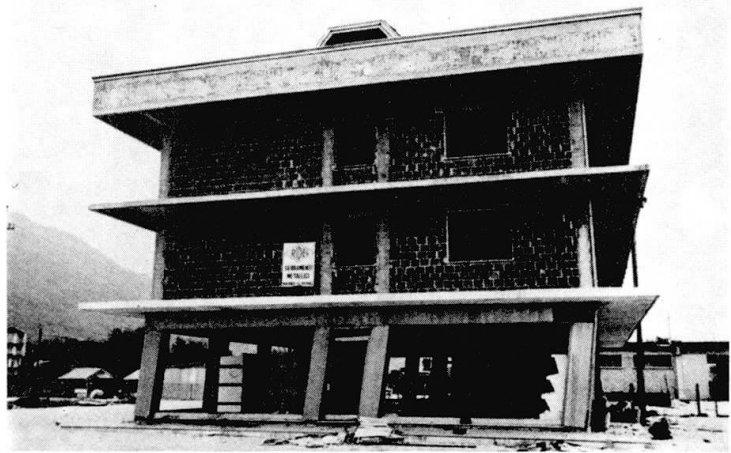
Figure 15:

Open or only slightly stiffened ground floors, mostly for commercial use, are particularly vulnerable. The locally severe destruction in the area of such weak spots caused the collapse of entire buildings or made their demolition necessary, even with otherwise only minor damage, because restoration would have been too difficult (Figure 15).

Three-storey dwelling house with shop in the ground floor near Artegna. Reinforced concrete frame with brick partitioning walls in the upper floors and mostly open ground floor. Plastic hinges at bottom and top of the ground floor reinforced concrete columns caused large deformations. No damage in the upper floors.

Greatly differing conditions of rigidity in a supporting structure result in local weak spots which are the first to be overstrained in an earthquake and plastically deformed. Hence the stronger parts of the building are no longer irreversibly deformed and energy absorption is limited to the weaker building parts. Consequently, an evenly distributed plastification of the entire structure is necessary to ensure that destruction remains within acceptable limits.

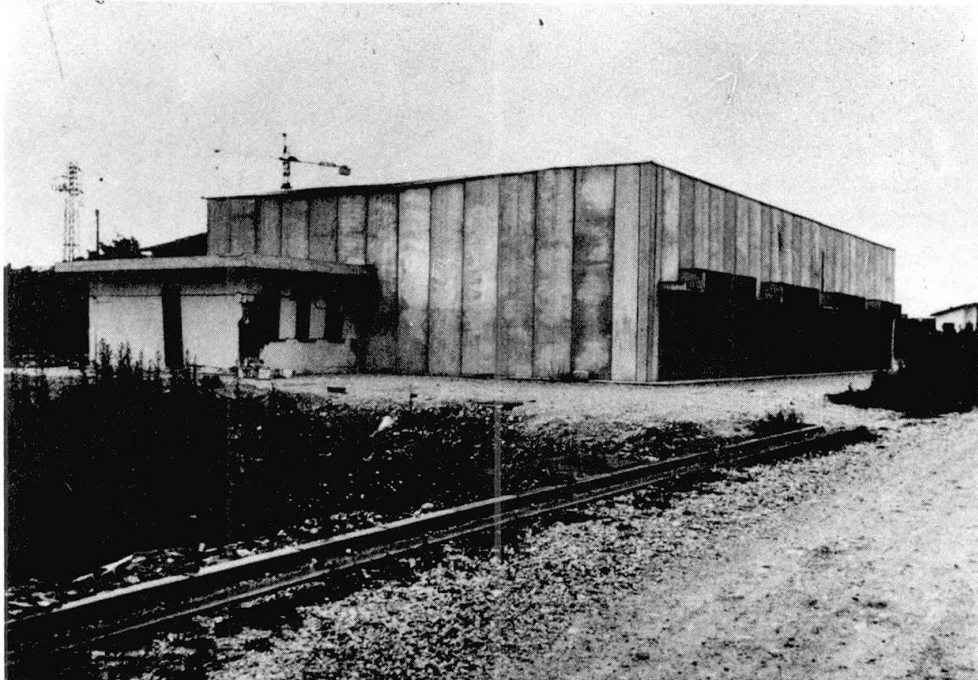
Severe damage could be located in structures composed of building sections with greatly differing rigidity due to diverse types of construction (for instance, reinforced concrete frame and pure brick) or which varied considerably in their design (Figure 16). This damage occurred because the individual deformation of each component was obstructed.

Figure 16: Prefabricated storage shed with brick annex in Gemona. Side wall panels slightly caved in by impact with rigid annex. Upper part of the annex shorn off and pushed over by the impact force due to insufficiently wide joints.

This problem can be overcome by arranging the joints as to divide the structure into sections, each with its own clearly distinct vibration behaviour. The joints should be made adequately wide since numerous uncertainties make an exact calculation impossible. It must be taken into consideration that, for example, the deformation usually provided for in a homogenous supporting structure can turn out to be considerably larger due to the formation of cracks or plastification. An adequate freedom of movement, therefore, allows for greater plastification and a larger capacity to carry earthquake stress.

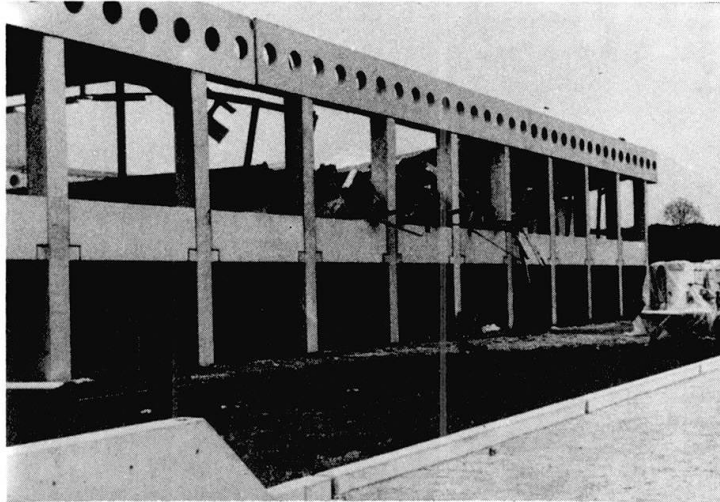
If prefabricated structures are designed only in accordance with the Standards laid down for earthquake forces or these forces are overlooked altogether, then the result is greatly underdimensioned connections of the structure elements. Load bearing connexions should be properly designed against the expected dynamic forces. Purely friction-type joints are no longer sufficient to transfer the forces that arise, even from only weak earthquake loads (Figure 19).

Figure 19: Heavily damaged prefabricated factory shed near Osoppo with roof girders fallen down. Friction joints insufficient to provide structural stability.
