Behaviour of large panel building during the Romania earthquake of March 4, 1977

BEHAVIOUR OF LARGE PANEL BUILDING DURING
THE ROMANIA EARTHQUAKE OF MARCH 4,1977

Miodrag Velkov *

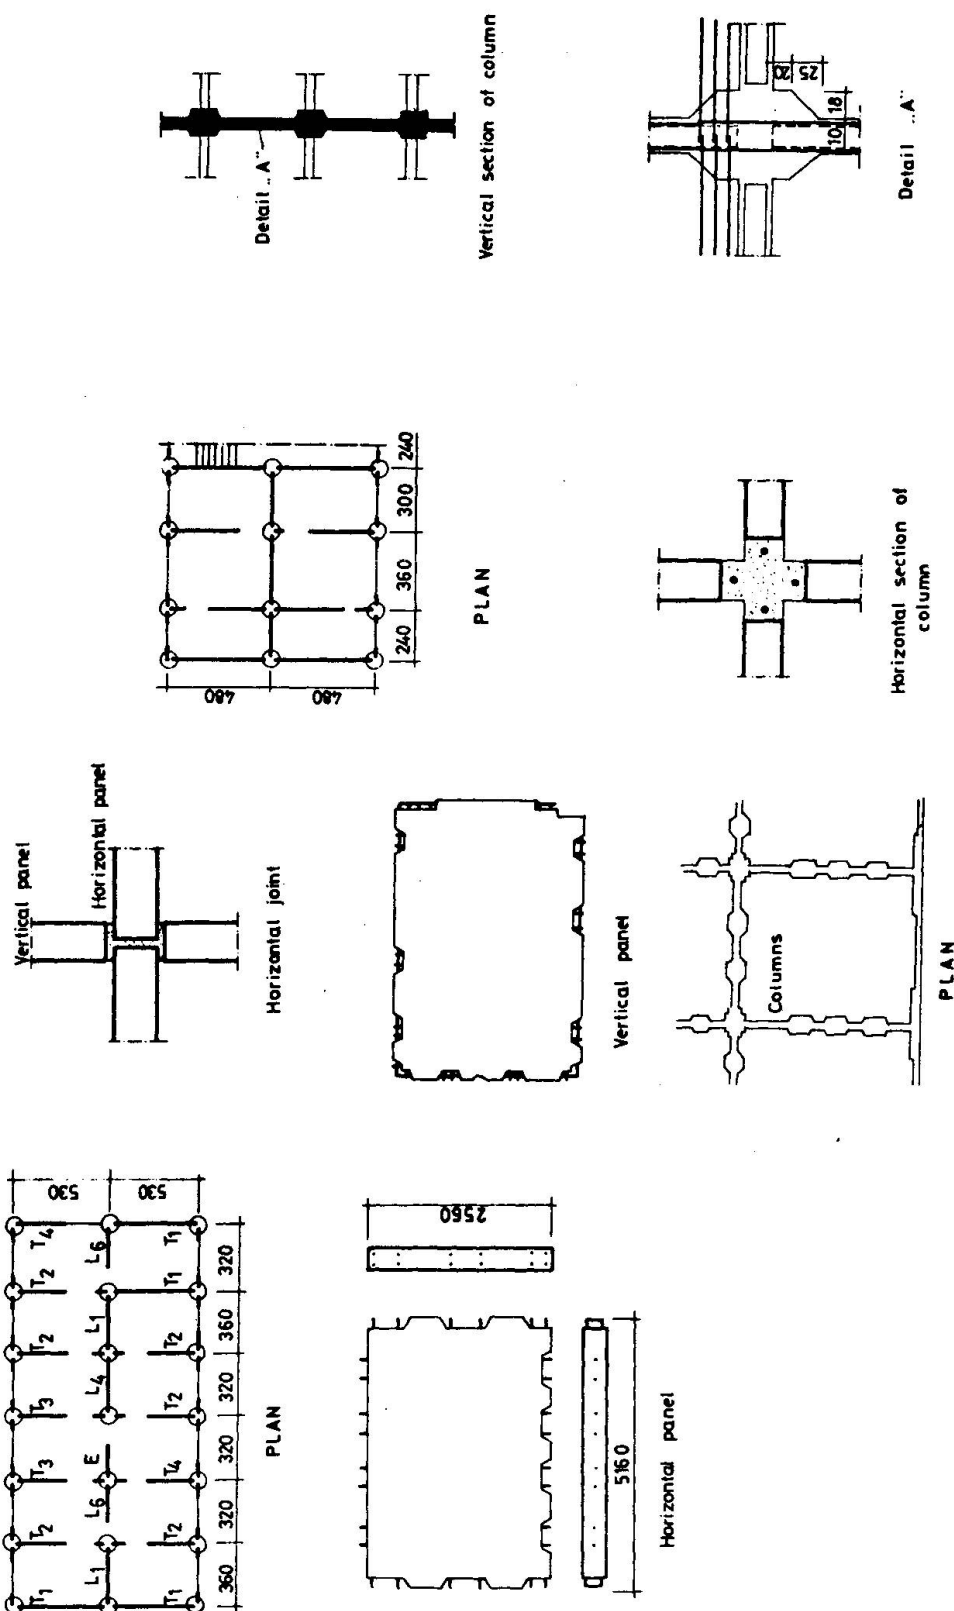
Fig. 6

4. In Ploesti which is closer to the epicentral region, construction of large panel structures is limited to 5 storeys. They always have monolith basement with monolith floor slab above it. The walls are in two-way system. Fig. 6. gives details of the most frequent type of system used. It should be noticed here the enlarged section of the monolythic column in order to increase its shear strength. This system was previously constructed without this enlargement for shears. The base shear coefficient is 15%.
