## QUANTITATIVE APPRAISAL OF DESTRUCTIVE EARTHQUAKES

by Dimitri Papastamatiou - Senior Engineer

Dames & Moore, 123 Mortlake High Street, London SW14 8SN, England.

This presentation is concerned with direct correlations of the field measurements with damage on engineering structures. The first part is a discussion of the set of simple structures that have the characteristics of field indicators. In the second part correlations are indicated between the field measurements and the inflicted damage. All the illustrations were obtained in the epicentral region of the May 6, 1976 Friuli earthquake.

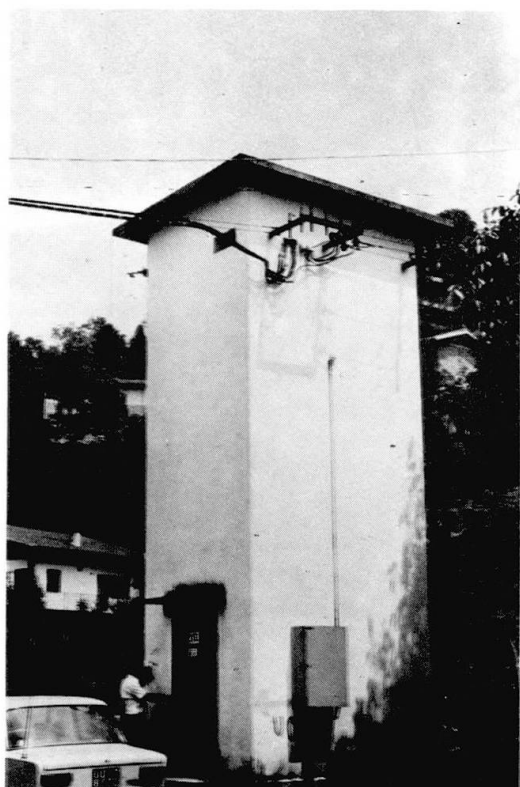
Fig 2. Distribution cabin at Bilerio.

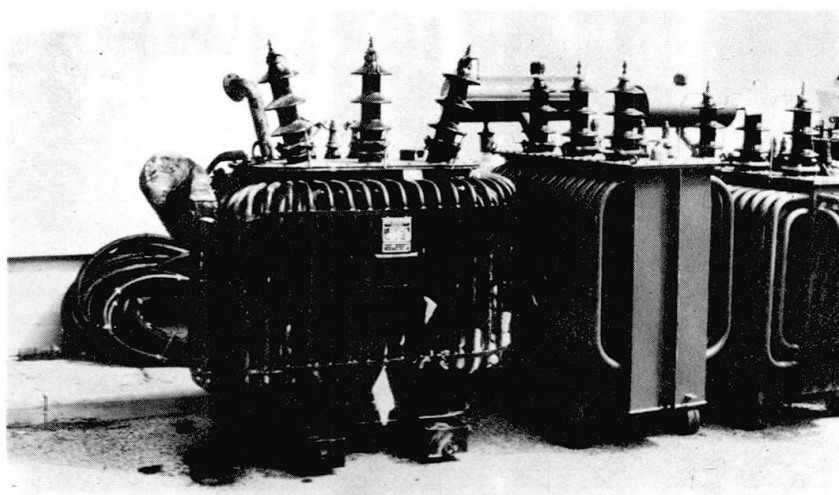
Fig 1. Damaged and new distribution transformers.

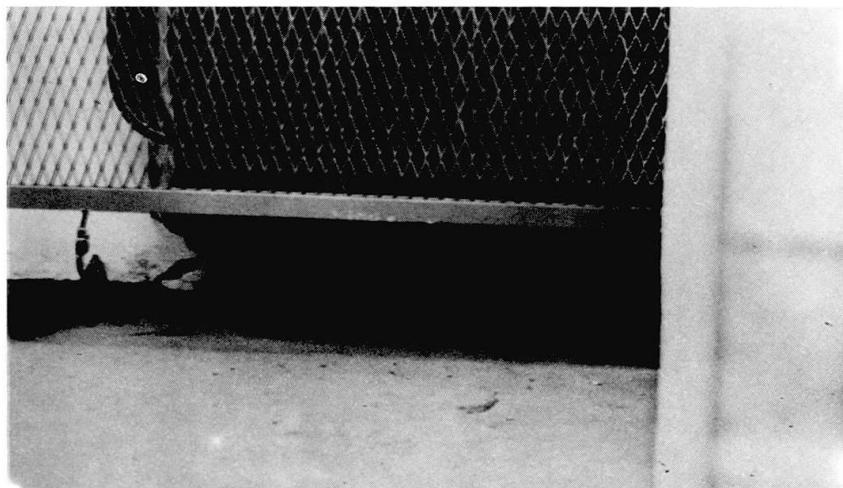
Fig 3. The transformer inside the cabin has moved during the earthquake; one of the back wheels fell into the oil drainage well.

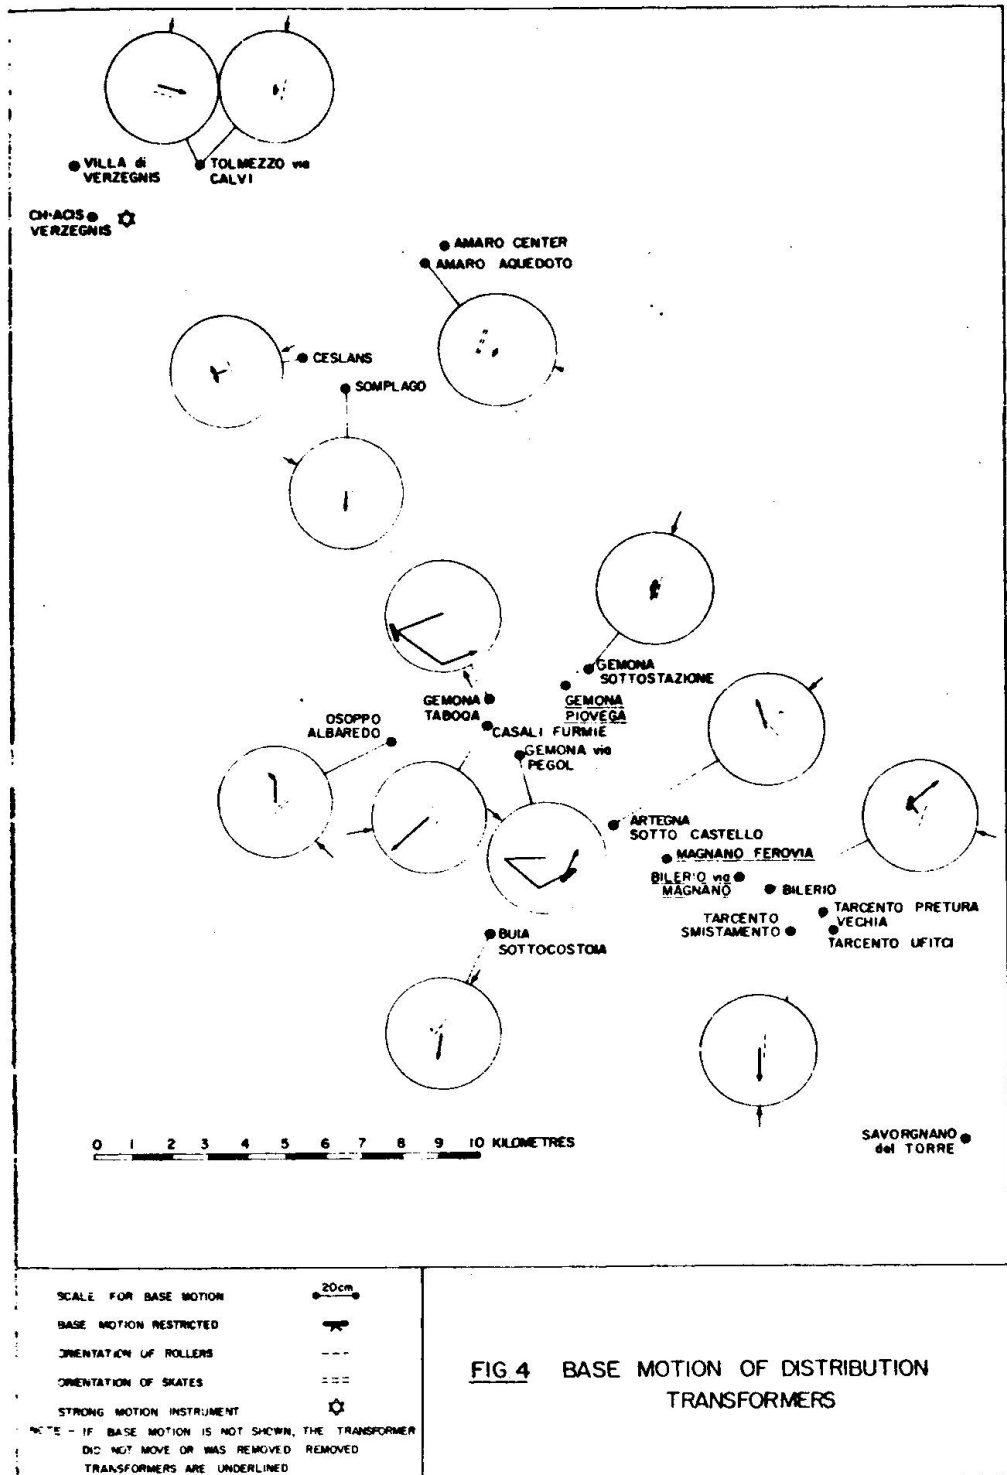
Field measurements in the epicentral area of the May 6, 1976 earthquake were restricted in a zone running NW-SE. The slip vectors of the transformers that were studied in this zone are shown on Fig. 4. The transformers at the NW end of the zone surround the nearest strong motion instrument that recorded the main shock at Diga de l' Ambiesta. The measurements have been described elsewhere (1,2). The transformers, in general, moved in a N-S direction. Exceptions were found on recent alluvium where motion was in both directions. Displacements were also larger on recent alluvium.

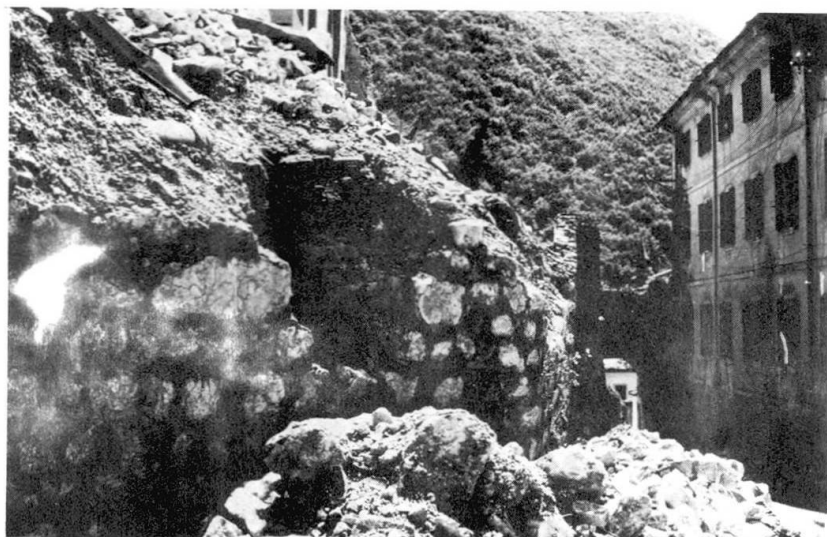
Fig. 7. Duomo Gemona; Failure of the retaining wall.

Figure 7 shows the failure of the retaining wall at Duomo, Gemona. Was this failure responsible for the collapse of the southern wall of the Duomo?

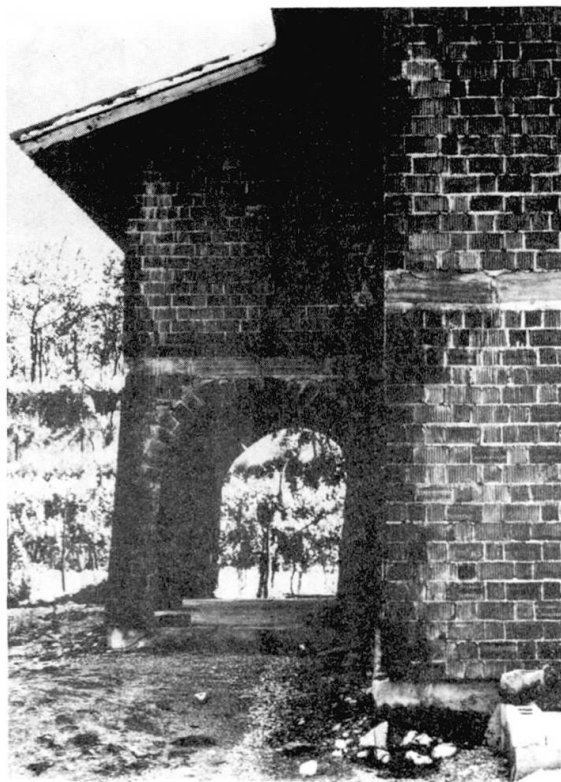
An unfinished brick building in Gemona moved on its concrete foundation like the transformers in the region (Fig. 9).

Fig. 9 Gemona; the building moved back and forth on the concrete base.

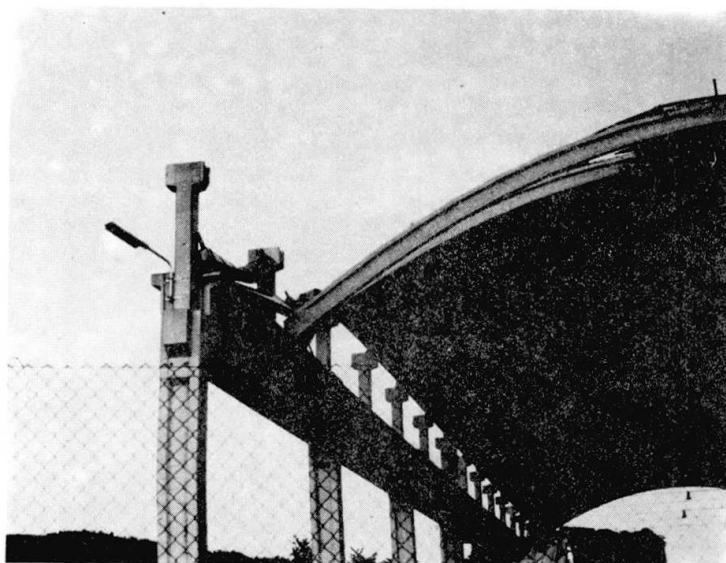
Figure 10 shows the mode of collapse of an industrial hangar. In this case the relatively small slip vector measured on the ground was amplified by the elastic deformation of the column.

Fig. 10 (above) Industrial hangar at Magnano; collapse mechanism.

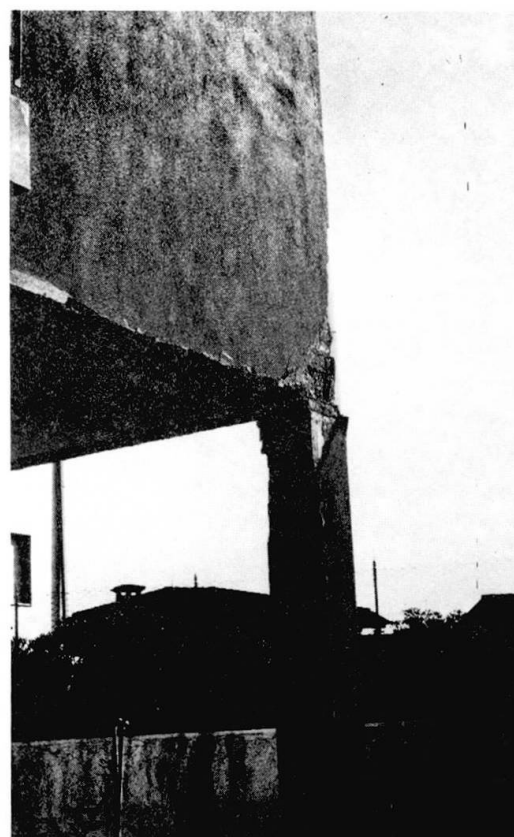
Dislocations along joints in prefabricated buildings may be critical in their earthquake performance as shown on Figure 11. The building is in Majano across the road from another building that collapsed. A variation of the joint strength in one direction could have set up the collapse mechanism.

Fig. 11 (right) Slip at the joint of a prefabricated building at Majano.

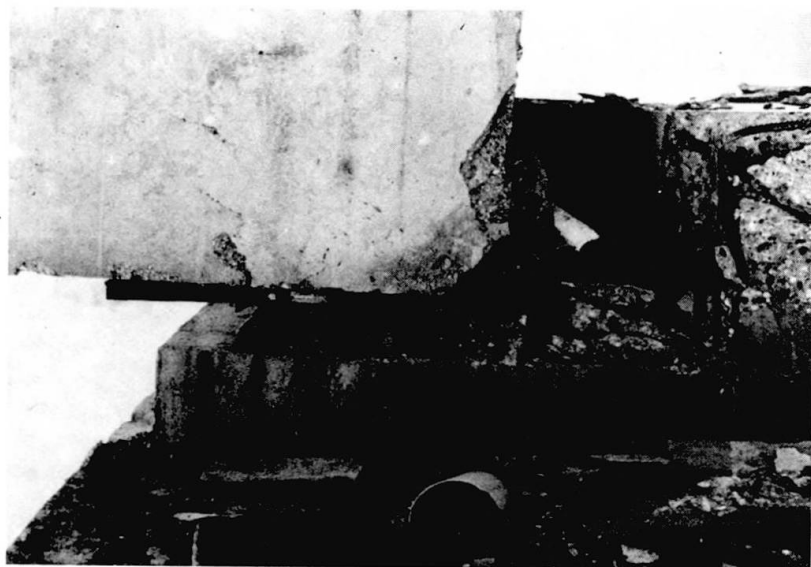
On the recent alluvium the transformers showed large displacements. The same large dislocations could be seen along the supports of the prestressed bridge across the Tagliamento River (Figure 12).

Fig. 12 Prestressed bridge over the Tagliamento River; slip of the supports.
