Short communications

Zeitschrift: **IABSE reports of the working commissions = Rapports des commissions de travail AIPC = IVBH Berichte der Arbeitskommissionen**

BEHAVIOUR OF AN ASEISMIC STRUCTURE
DURING CAUCETE EARTHQUAKE
OF NOVEMBER 23, 1977

DAMAGE TO BRIDGES DURING THE NORTH CAUCASUS EARTHQUAKES

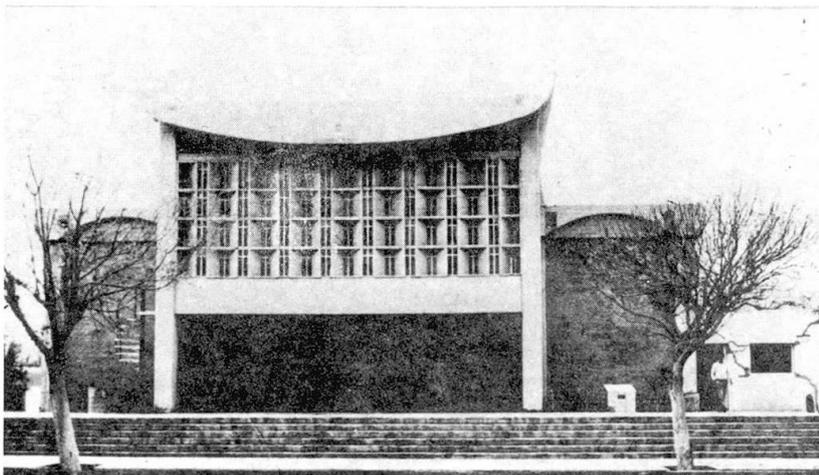
Fig. 1 - Front of the Church

Building examination after the earthquake reveals no damage in the reinforced concrete elements. The front brick walls show limited cracks, while there are no apparent cracks in lateral walls, but inner plaster spalled in wide areas. Some glass breakage in windows occurred (approx. 10 %), and light damages in masonry can be seen at both sides of apse, where roof shell touches the wall.

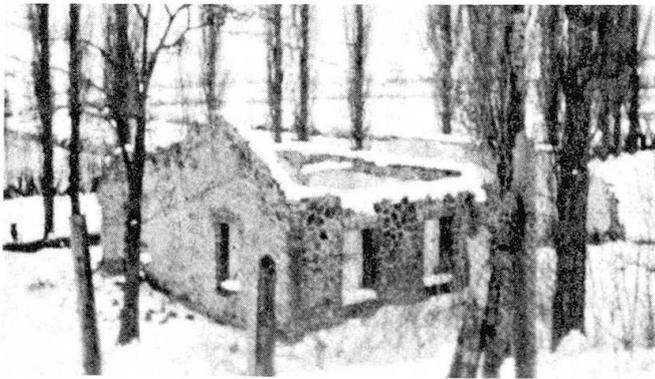
Fig. 1	Fig. 2
Fig. 3	Fig. 4
Fig. 5

The earthquake of 1970 with magnitude $M = 6.6$ and focal depth $H = 13$ Km spreaded over an area of about 600 Km^2 with intensity 8 (MSK scale). It was accompanied by rockfalls and landslides along river banks and steep mountain slopes. The volume of landslides in some places exceeded 1 million m^3 , the extent of the breaches reached several hundred meters [1, 2]. Some of the stone buildings in the settlements, located on the epicentral area, were collapsed (fig. 1). The quake of 1975 had intensity 7. It caused heavy damages to rubble buildings (fig. 2).

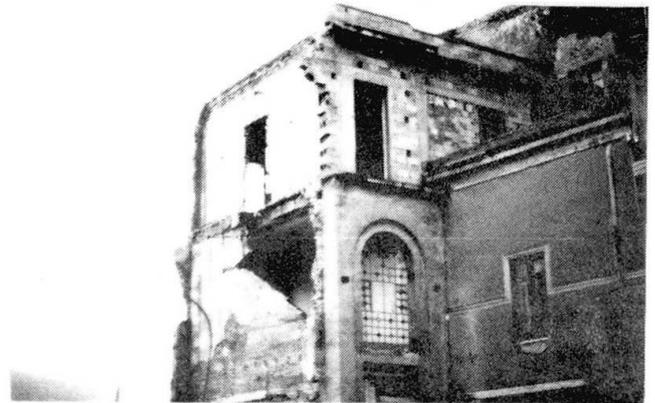
The worst damaged houses in Patti were those founded on sandstone, built of masonry and rarely cemented, in the old centre of the town.

On that site the sandstone formation assumes a hill configuration, which could produce an amplification on maximum ground acceleration (Maugeri, 1976), which can explain, together with the poor construction quality, the severe destruction of some houses.

In fig. 6 the damage suffered by one wing of Patti Cathedral is visible and in fig. 7, the damage at the corner of the main nave is evident.

Fig. 6: Patti Cathedral: the left wing.

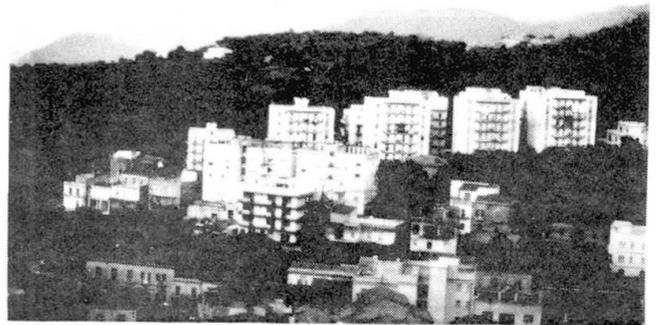
The new concrete buildings in Patti, shown in fig. 8, are built on fissured clay and were apparently damaged on the buffer walls only, mainly at the lower levels.

Fig. 8: Concrete buildings at Patti virtually undamaged.

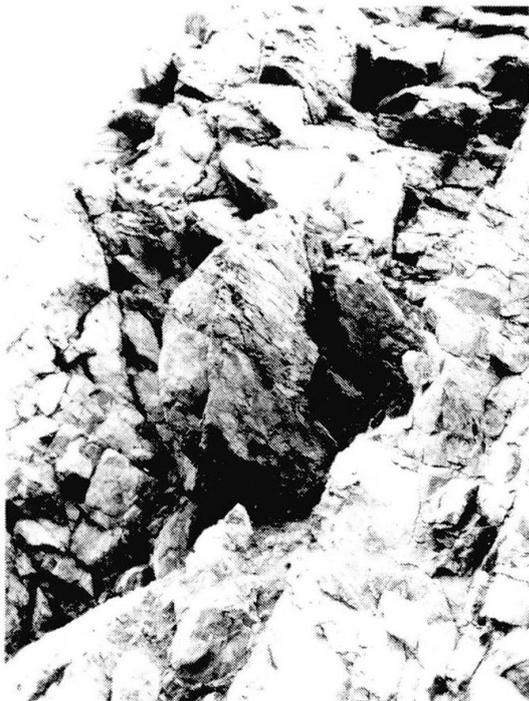
A landslide, consisting in a rock mass failure, was observed at Capo Calavà, whose location is on the left of the Patti gulf. The slope was high and formed of very jointed and altered rock, which has been consolidated in the past by spritz beton and anchorages.

Because of the earthquakes the rock failure was accelerated and a series of blocks, from 10 to 60 cm in diameter fell down into the road. As is clear from fig. 10 the entire cliff is at present in a dangerous limit equilibrium.

Fig. 10: Rock fall at Capo Calavà.
