BEHAVIOUR OF AN ASEISMIC STRUCTURE
DURING CAUCETE EARTHQUAKE
OF NOVEMBER 23, 1977

SILVESTRO BRUSCHI

TECHINT Engineering Company

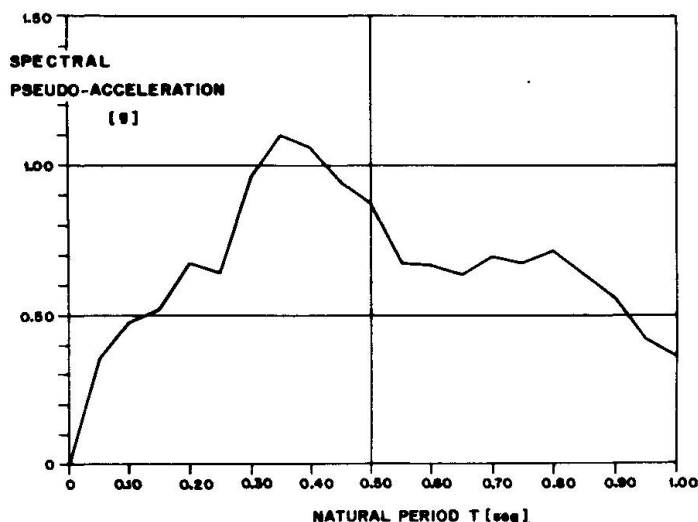
Fig. 3 - Pseudo-accelerations spectrum of Caucete 23.11.77 earthquake

To investigate this behaviour we used the spectrum shown on fig. 3, which was obtained from the spectrum calculated by IDIA, by multiplying its ordinates by the ratio between the records of two seismoscopes, one located in Caucete town, about 200 m distant from the structure, and the other beside the IDIA accelerograph in the city of San Juan,

These spectra are calculated for a damping ratio of 5% of critical damping. This figure is assumed to occur in reinforced concrete structures reaching yield, according to records from San Fernando earthquake of 1971.

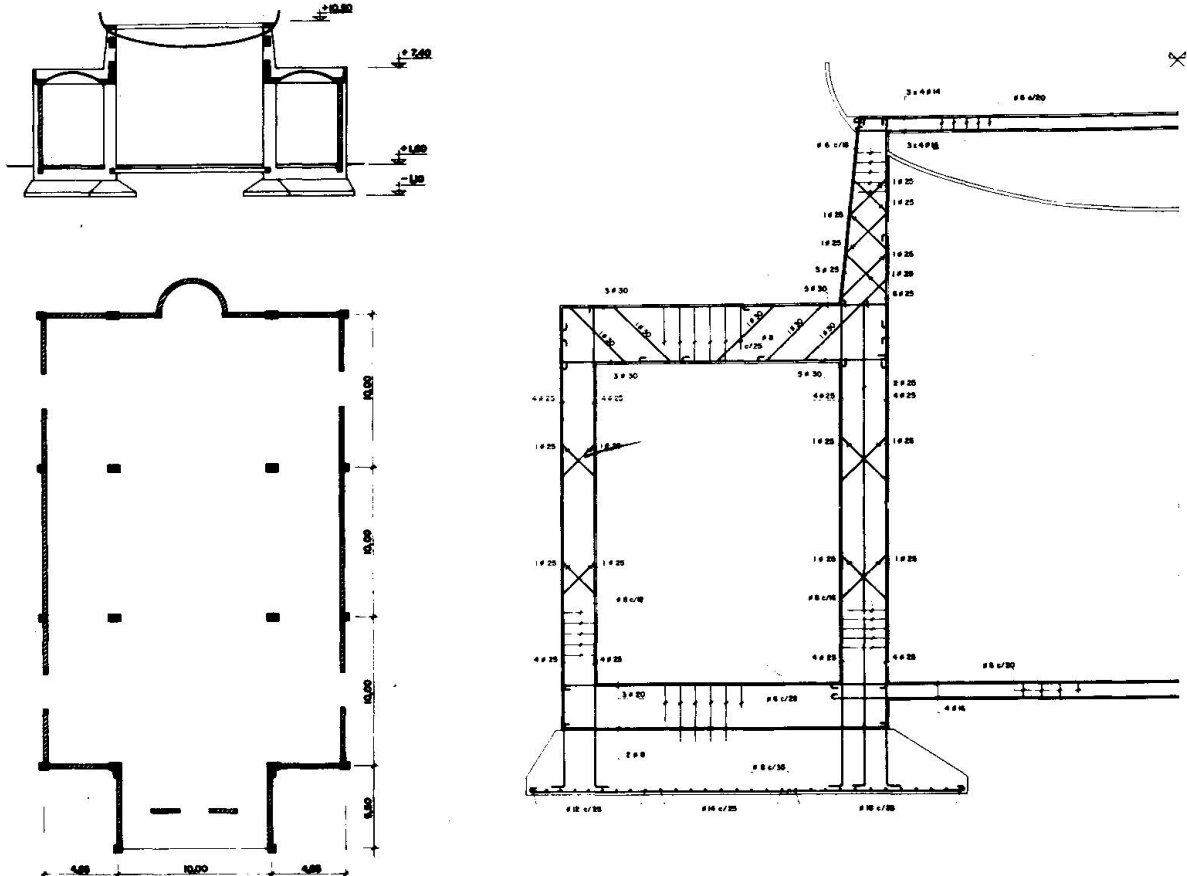
Fig. 5 - Reinforcing of transverse frame

In the original conception of the structure, earthquake-resistant elements in the transverse direction were formed by two simple frames in each line, joined together only by the roof whose stiffness in the plane of frames was negligible. These frames were designed in accordance with the Seismic Regulations in force as of 1958, using a seismic coefficient of 0.15; and an increase of 33 % for allowable stresses. Main columns, 50 cm by 80 cm in cross section, were reinforced with a total area of steel of 1.2 % of concrete area; shear reinforcing in provided by stirrups and bent bars in both directions.

Yield stress of steel is 2200 kg/cm²; concrete has a characteristic ultimate stress of 222 kg/cm², deduced from sclerometer measurements after the earthquake.

The two columns of each frame have a common footing, designed for a maximum pressure on soil of 1.1 kg/cm². The large stiffness of this foundation ensures a practically perfect fixed end for both columns. Due to the change of roof design these frames were joined by an element of certain stiffness, formed by the shell plus the top compression beams.

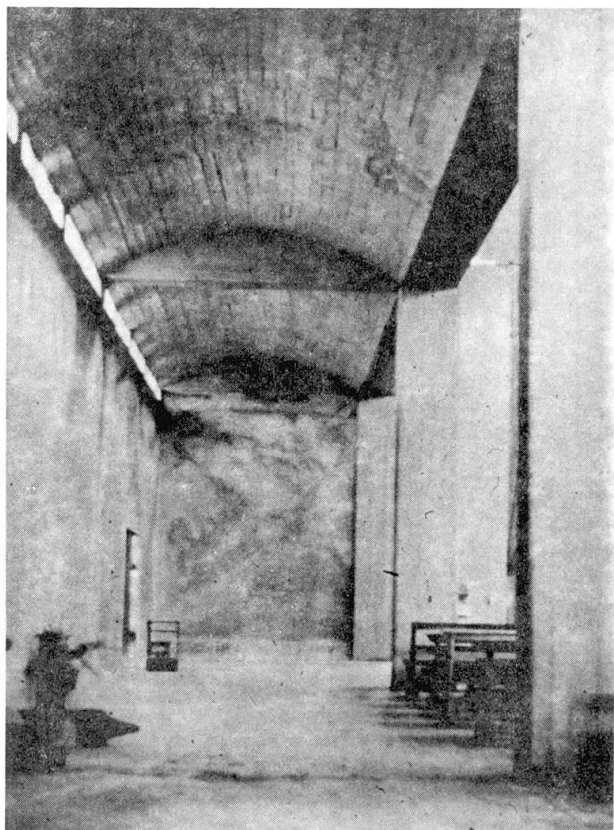
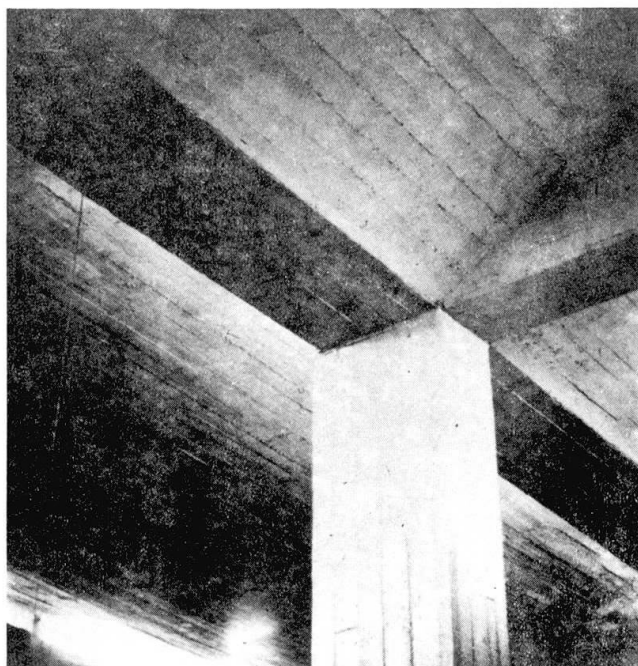
Fig. 7 - Detail of main frame joint

Fig. 6 - Lateral aisle
