Restoration and Widening of the Tasman Bridge

D.J. LEE

B.K.G. CROSSLEY

SUMMARY

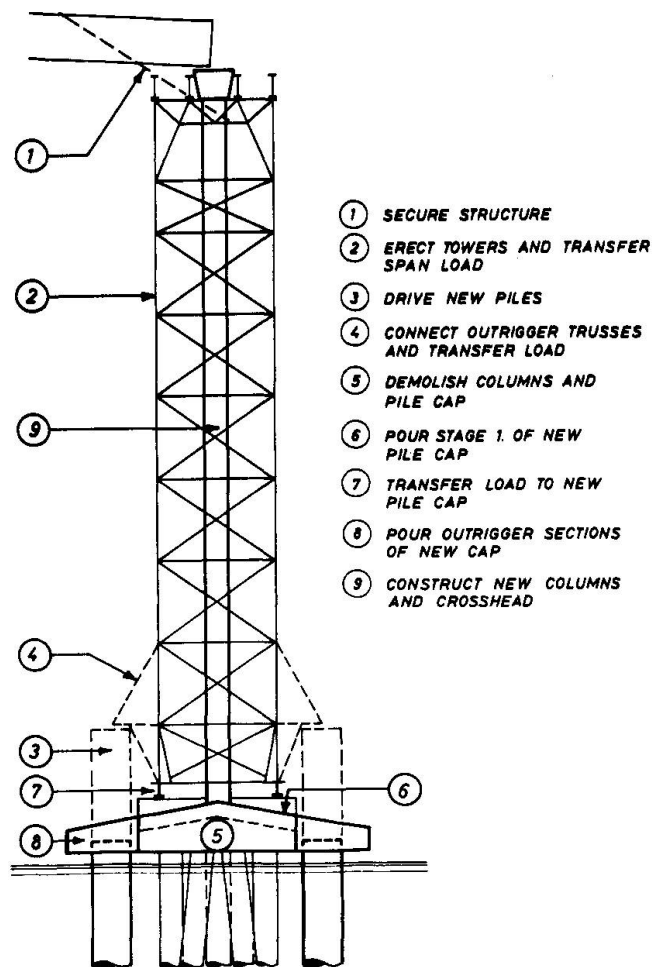
Fig. 8 Pier 17 construction sequence

The steel towers fulfilled many functions, including support of existing spans during column demolition, bracing for new concrete columns during construction, supports for the erection derricks and landing points for the new beams. The construction sequence involved in the use of the tower at Pier 17 is shown in Fig. 8.
