## **Collapse of the Viennese Reichsbrücke: Causes and Lessons**

### **Hans REIFFENSTUHL**

The paper describes in a simplified manner the essential peculiarities of the Viennese Reichsbrücke which led to increasing local splitting forces in the piers for decades. Supervening temperature stresses at the critical location in an unloaded state finally produced the collapse of the whole bridge.

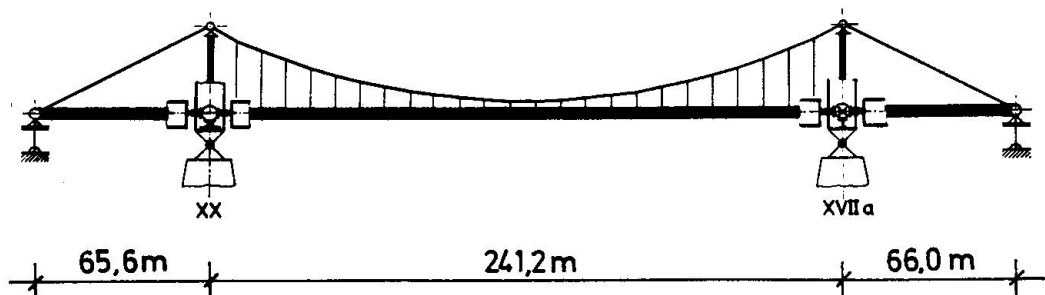
FIG. 2: STATICAL SYSTEM

This measure led to an unusual statical system with hinged connections of the stiffening girder at the piers, penetrating the pylons which acted as columns hinged at both ends. For the main loads this system was statically determinate. Failure of one essential member was sure to lead to the collapse of the whole structure.

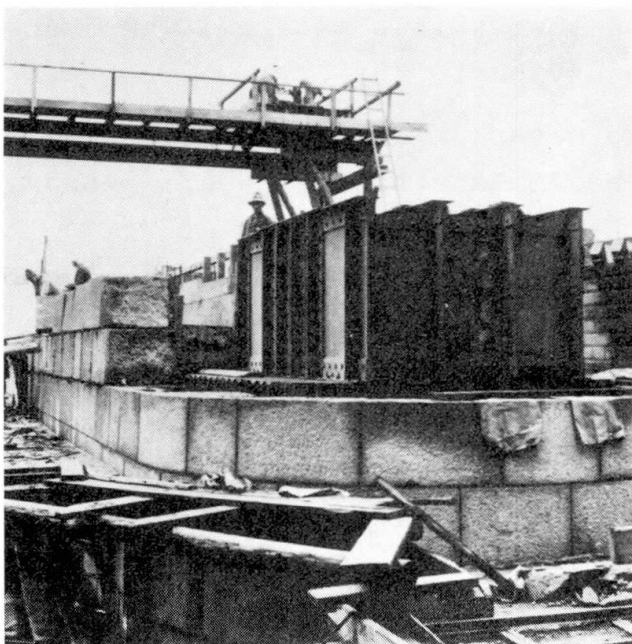
FIG. 3: PIER XVII  $\alpha$  DURING ERECTION (1935)

Under each pylon bearing a heavy grid of bolted steel girders of 1,60 m high was concreted into the head of the pier. For better distribution of the load the grid rested upon rolled I-beams layed closely to eachother (Fig.1 to 3). No other reinforcement of the piers was provided. The external dimensions of the pier shaft were just so large that the steel grid and the mat of rolled beams found enough
