Emergency rehabilitation of the Zárate-Brazo Largo Bridges, Argentina

Emergency Rehabilitation of the Zárate-Brazo Largo Bridges, Argentina

Abstract

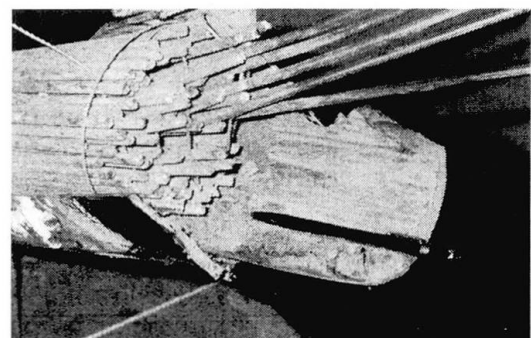
The evaluations revealed that a combination of corrosion and fatigue damage caused the failure of one cable, see Fig. 2, and large damages to a number of other cables. The corrosion was due to insufficient performance of the corrosion protection of the original cables. The cement grout, which was supposed to be the main active corrosion protection, was insufficient in the anchorage zone due to the presence of a non-protecting epoxy tar.

The fatigue damage has been severe due to larger traffic loads than accounted for in the original design, but not least due to large amplitude cable vibrations.

These amplitudes of the vibrations have been in the order of up to 1 m, which theoretically causes stress ranges well above the endurance limit of the wires. The corrosion has furthermore increased the fatigue stresses locally due to stress concentration.

Fig. 2 Ruptured cable

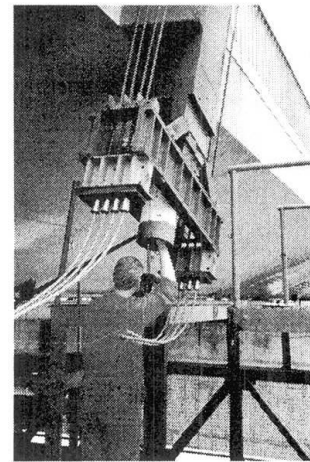
Fig. 3 Ultrasonic inspection of original cable. Temporary strengthening also shown.

The present condition of the cables were investigated through ultrasonic inspection as shown in Fig. 3. The investigations revealed that a number of cables were deteriorated with up to 62% damage of the original cable cross section. The material properties of the wires were established from tensile and fatigue tests carried out on specimens from the cables replaced first. The tests revealed that the tensile strength of the tested wires were below the original design values and that severe fatigue damage had taken place. The wires did no longer have an endurance limit.

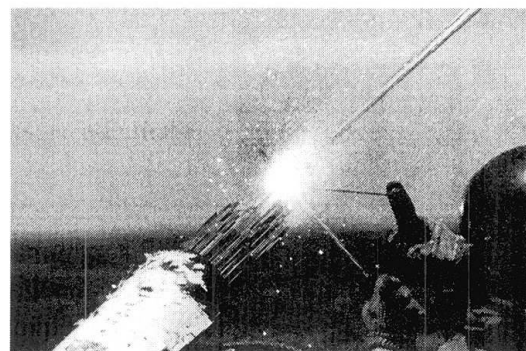
Fig. 4 Removal of existing cable by cutting of individual wires

A total of 13 cables were replaced during the emergency rehabilitation. The existing cables have been removed by cutting of the individual wires as seen in Fig. 4. It has been recommended to provide temporary wind ropes between the cables in order to limit the large amplitude cable vibrations. Furthermore, installation of guide deviators has been recommended in order to reduce the bending stresses in the anchorage zone.
