The Analysis, Design and Remedial Repairs for a Fire Damaged Two-Way Roof Truss Structure

THOMAS S. TARPY, Jr.
Structural Engineer

STANLEY D. LINDSEY
President
Stanley D. Lindsey & Associates, Ltd.
Nashville, USA

JACK R. HORNER
Structural Engineer

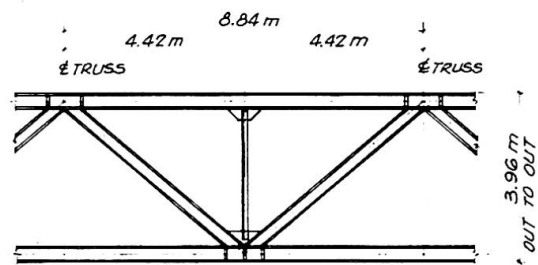
a) MAIN SUPPORT TRUSS

- a. The top chord of the main support truss had major flange buckling and lateral deformations.
- b. Virtually all bar joists and bridging were damaged beyond repair.
- c. The top chords of several adjacent trusses had warped stems.
- d. Several diagonals composed of double angles had buckled.
- e. Virtually all the miscellaneous support steel for the mechanical equipment was deformed.
