Artikel: Reconstruction of a railway station in Budapest

Reconstruction of a Railway Station in Budapest

TIBOR SIGRAI

UVATERV

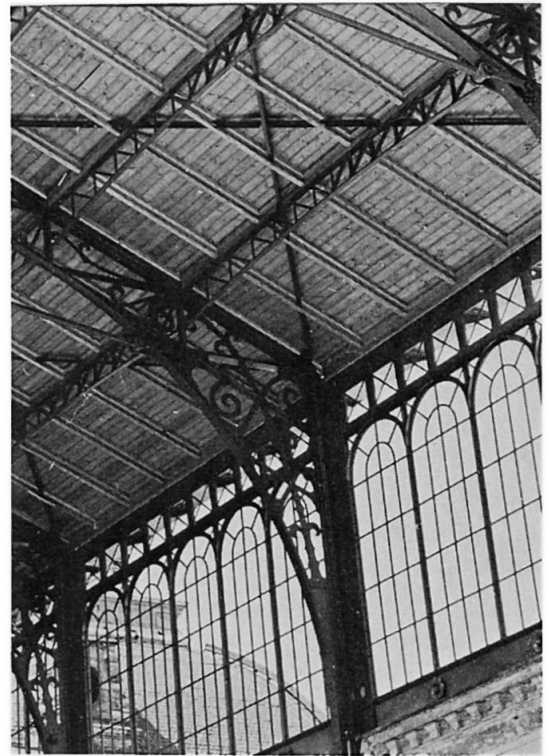
6. A renewed frame corner

The reconstruction took into consideration the point of view of the historical interest. It was based on saving of the less corroded structural parts, on the construction of a horizontal support system, on the load relief of the frame corners, and finally — taking into account that the problem was the mixed construction of the remaining and new parts — based on a conception that needs a very thorough manufacturing and assembly technology. The new track-hall, regarding its appearance, is almost the same as the old one, apart from minor details. The curtain wall, facing the Great Boulevard of Budapest, remained as it was and also remained the first two frames attached to it. These were cleaned by metal-spraying and were stiffened at the necessary places. The same principle applies to the decorative corners of the other frame structures. The latticed frame trusses between the frame corners are made anew by welding. The shape, the dimension and arrangement of the sections follows the original very closely.

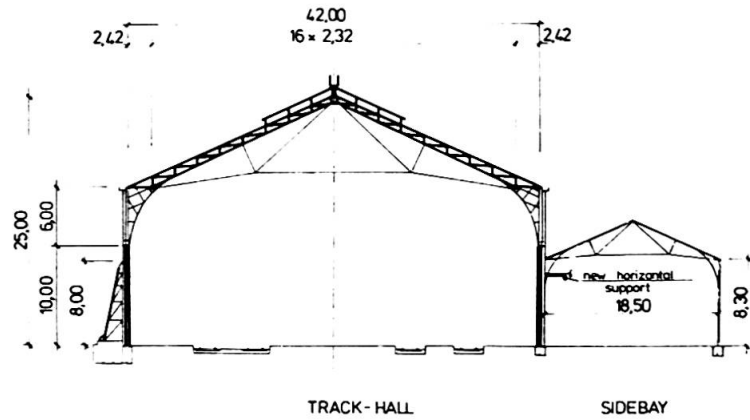
7. The remaining and the new parts of the frame structure

During the strengthening of the columns only those parts of the original columns were demolished which reached into the track-hall. The new and partly double-walled column section encases the remaining part of the original column, securing this way the composite action. Thus the remaining frame corners are located between new frame-beams and new columns. The full set of the tension bars of the trussings remained in the original state. But all of the latticed purlins had to be replaced. Also completely new are the construction of the roof glazing, the side glass-screens and the wind-braces, where the longitudinal wind-brace appears as a new structural element. The curtain wall on the exit side was totally destroyed and had to be completely rebuilt.

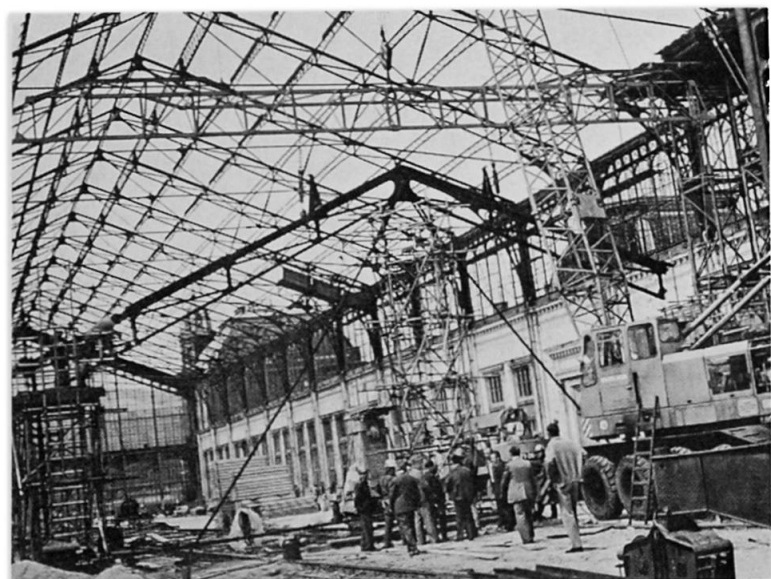
8. The demolition of a trussing

The demolition started at the exit side with the curtain wall, for this scaffolding was built on which the demolished structure was cut into transportable pieces. The demolition of the trussing was carried-out with the help of a rocker device that was fixed to the structure, and after the trusses were cut at the boundary line of the remaining frame corners they were lowered by an autocrane to the floor. The construction was started by strengthening of the remaining two trussings and this was done with a full scaffolding. The repaired corner elements were replaced on the reinforced columns, then the connecting longitudinal walls were lifted-in and the junctions were made.

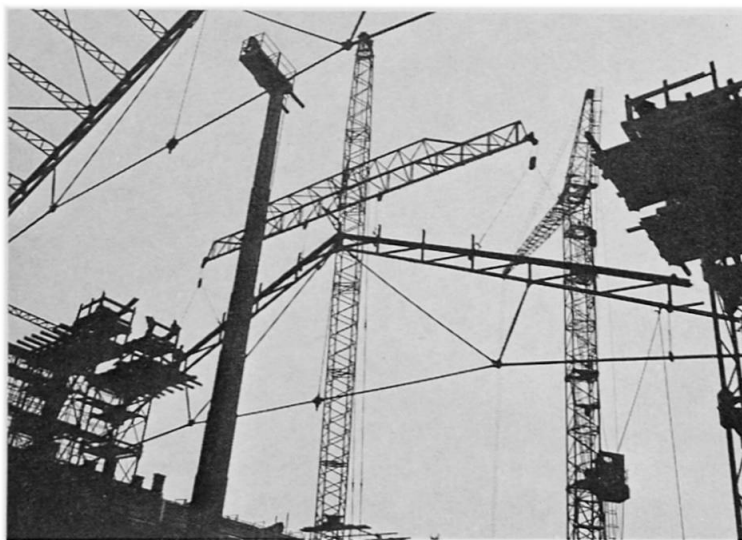
9. The lifting in of a new trussing

The new trussing part was assembled on the ground in the vertical position and the tension bars were adjusted in this position. With the help of the rocker device, the trussing

was lifted-in between the two corners. The tension bar was connected and the trussing was placed into its final position by further lifting to allow the connection of the trussing onto the corner parts with the plates. Afterwards the purlins and the windbraces were lifted-in. During the erection of the steel structure of the end wall for the exit side the 42 m long bridge, manufactured in three pieces was lifted in by three cranes simultaneously. The connections were made in the air, then the bridge was lowered onto its supports. The reconstruction of the roof boarding was made according to its original shape and over the boarding one layer of roof-plate water-proofing was placed finally on its top a zinc sheet covering was laid.

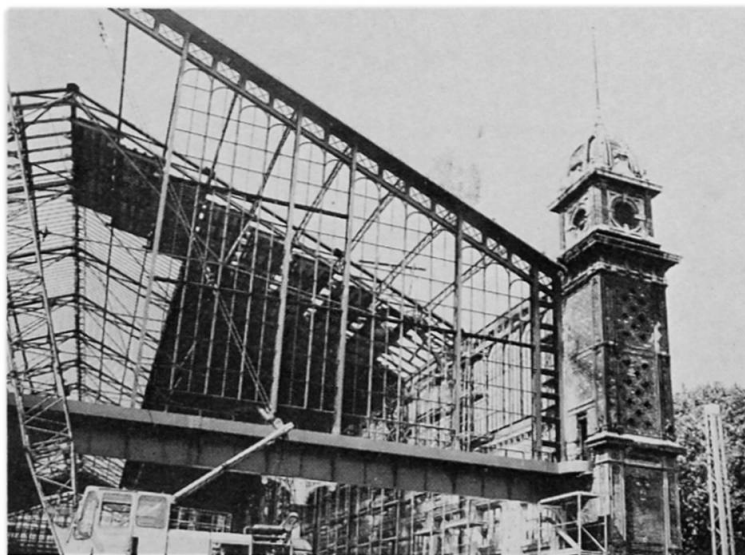
10. Erection of the new curtain wall

The new curtain wall was constructed as a closed frame-structure by building into a new vertical Vierendel-truss on each edge.
