**Artikel:** Damages due to snow loads

## Damages Due to Snow Loads

**Germund JOHANSSON**  
Tekn. lic., Lecturer  
Chalmers Univ. Technol.  
Göteborg, Sweden

**Bengt JOHANNESSON**  
Civ. Eng., Ph.D.  
Chalmers Univ. Technol.  
Göteborg, Sweden

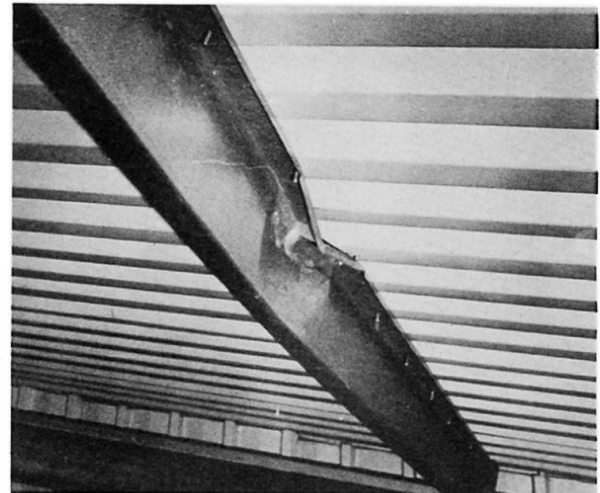
**Fig.3** Buckled Z-purlin.

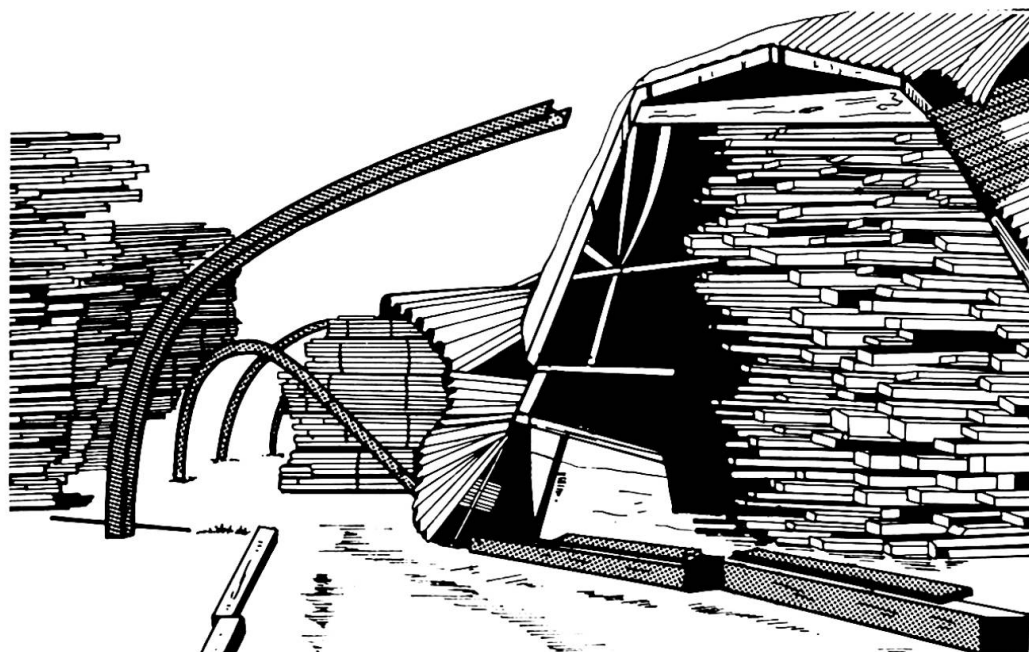
The whole structure collapsed due to overall column buckling (Fig.5). The roof snow depth was 0.55 m. The unit weight of snow varied between 2.6 and  $2.9 \text{ kN/m}^3$  which means that the roof was subjected to a snow load of approximately  $1.5 \text{ kN/m}^2$ .

The column load caused by dead load and snow load was estimated at 360 kN. Assuming Eulers *first* buckling case the column buckling load is 105 kN and the slenderness ratio about 400. On the other hand the buckling load 360 kN corresponds to the buckling length 1.08 times the column length. That is very close to Eulers *second* buckling case. This means that the stiffness of the connections between the columns and the roof girders have a certain influence on the buckling load. It probably also means that the columns were bracing each other due to smaller differences in loads etc.

Fig.5 Buckled columns.

This case is an example of a poor design. With diagonal bracings the collapse should probably have been avoided.
