Autor(en): **Seible, Frieder**

Zeitschrift: **IABSE congress report = Rapport du congrès AIPC = IVBH  
Kongressbericht**

Band (Jahr): **14 (1992)**

## **Seismic Damage and Retrofit to California's Urban Concrete Bridge Structures**

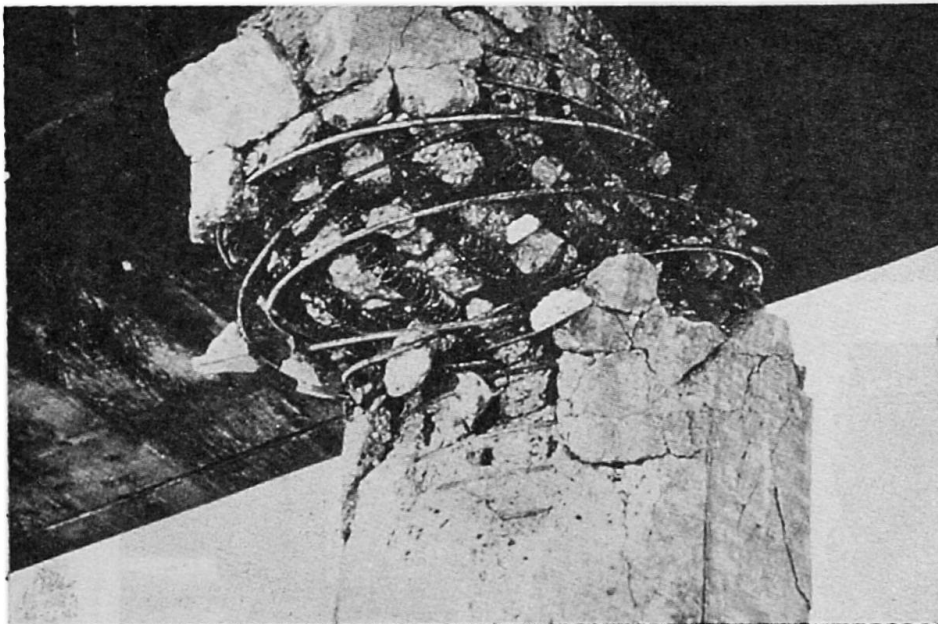
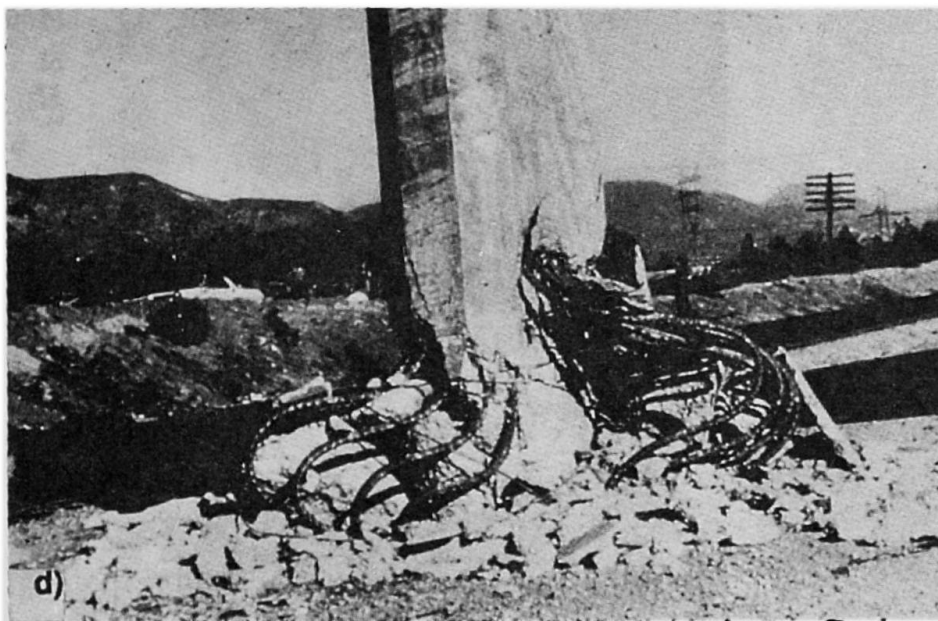
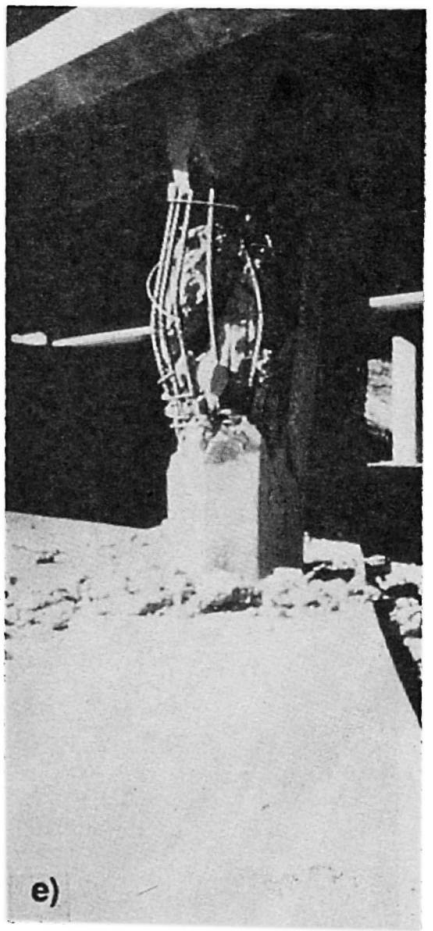
**Fig 1. Bridge Damage During the 1971 San Fernando Earthquake**

The 1971 San Fernando earthquake caused significant bridge damage, particularly to newly constructed interstate bridges. Key problems identified ranged from excessive seismic displacements and subsequent unseating of complete bridge spans at movement joints, see Figs. 1a and b, inadequate confinement of flexural plastic hinge regions in columns, see Figs. 1c and d, and Figs. 2a and b, anchorage problems with large diameter  $\varnothing$  57 mm (#18) column reinforcement into the footing, see Fig. 2d, brittle shear failure of short columns with insufficient shear reinforcement, see Fig. 1e, and joint failures of knee joints due to the lack of joint shear reinforcement, see Fig. 2c. It is of interest to note that subsequent earthquakes such as Whittier (1987) and Loma Prieta (1989) did not uncover completely new problem areas which were not already identified in San Fernando (1971) but rather reemphasized some of the above mentioned problems.

While design guidelines for new bridge structures were immediately changed to reflect higher seismic force levels, confinement of column concrete particularly in potential plastic hinge regions and increased force and displacement requirements for movement joints, seismic retrofitting of existing bridge structures focussed initially on movement joint restrainers to prevent unseating and span collapse.

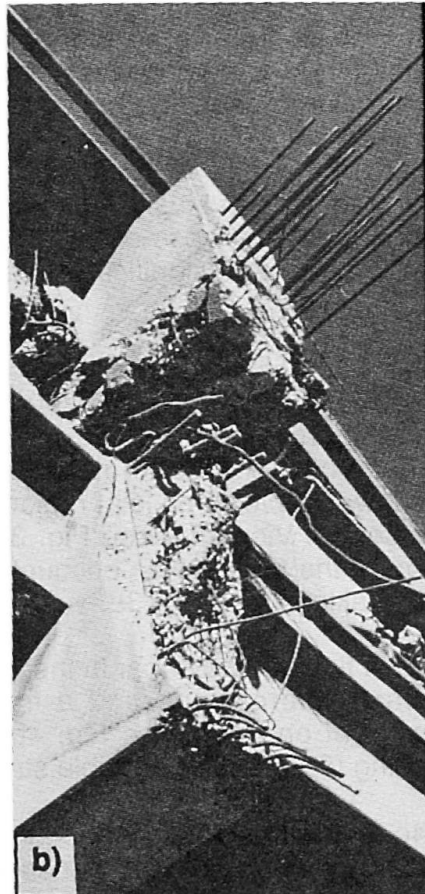
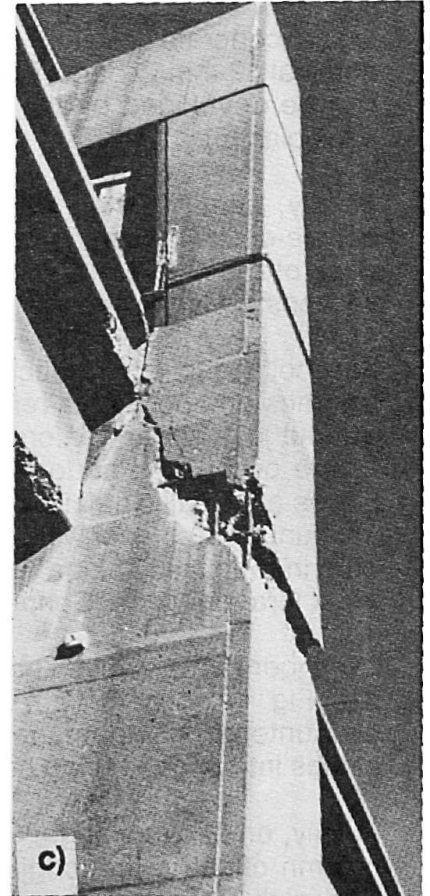
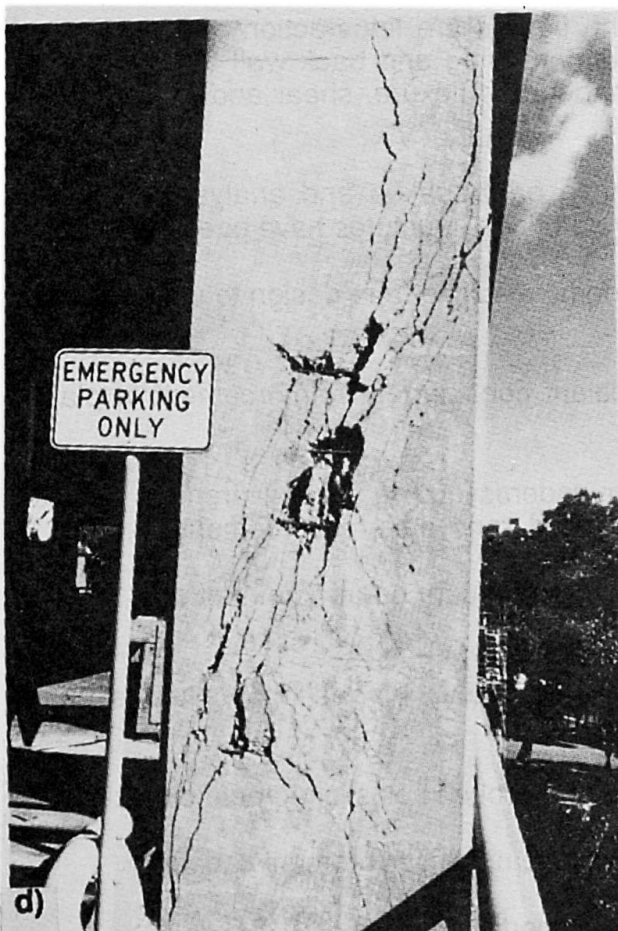
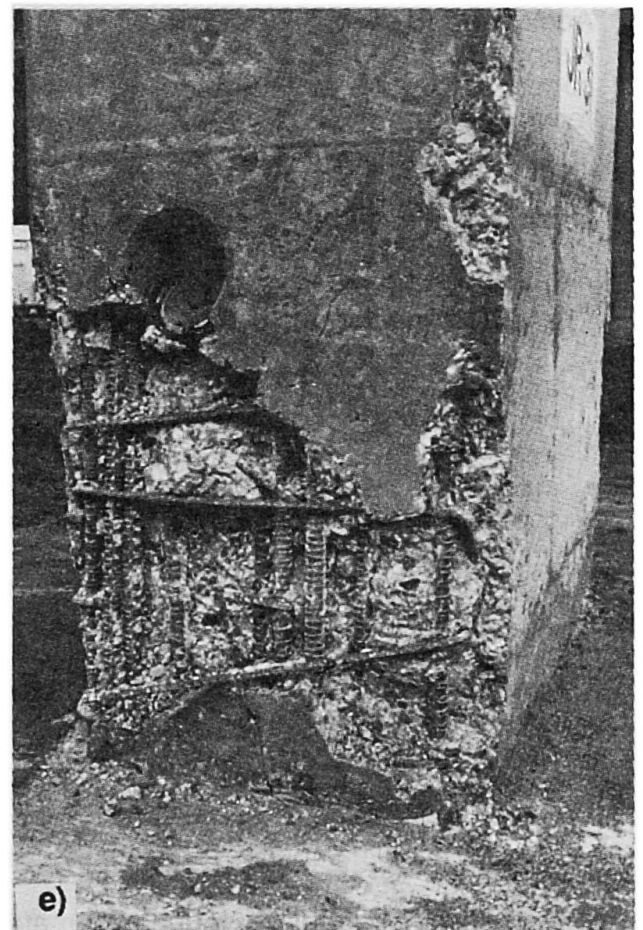
**Fig 3. Bridge Damage, Loma Prieta 1989 (M7.1)**

Finally, Loma Prieta (1989) revisited all previously encountered problems with emphasis on double-deck viaduct structures through the collapse of a 1 km (0.7 mile) long section of the upper deck of the Cypress Viaduct in Oakland, and significant damage to other double-deck viaduct sections in San Francisco.

The collapsed upper deck of the Cypress Viaduct in Oakland is shown in Fig. 3a, featuring columns and pedestals reinforced with 12 mm  $\varnothing$  ties @ 300 mm (#4 @ 12 in.) and joint regions without joint shear reinforcement. Figure 3b depicts a lower cap/column connection with pullout failure of top and bottom cap reinforcement due to inadequate anchorage length and Fig. 3c shows a typical joint failure of the lower cap/column joint region. Typical column shear failure was encountered on Highway 101 – Central Viaduct – see Fig. 3d, and lap-splice failure of column bars in the plastic hinge at the top of the footing was encountered in single-column bents on the West Grand Avenue Connector in Oakland, see Fig. 3e.

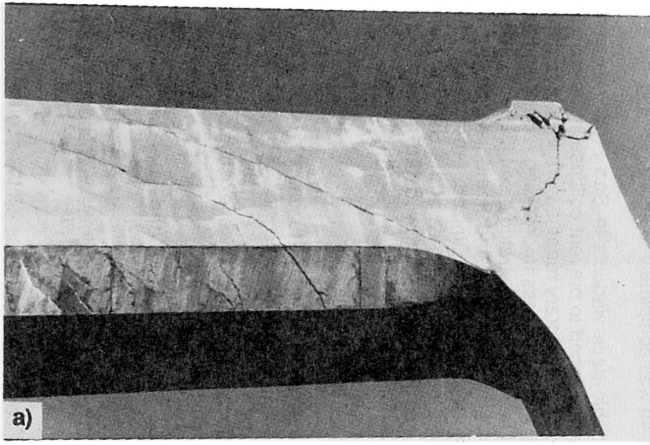
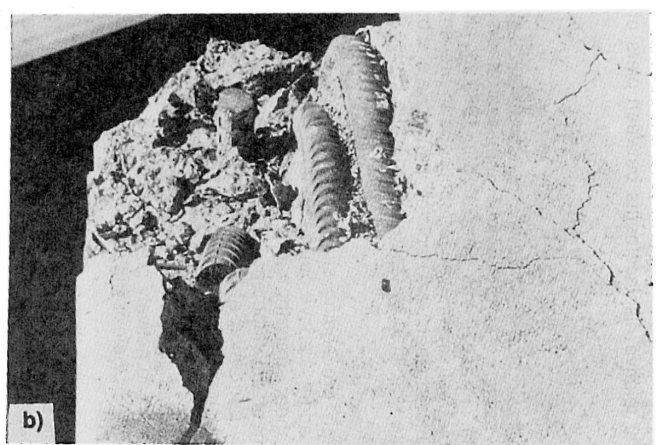
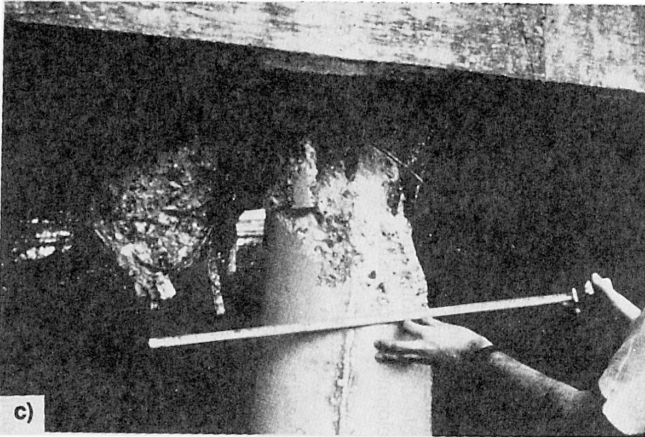
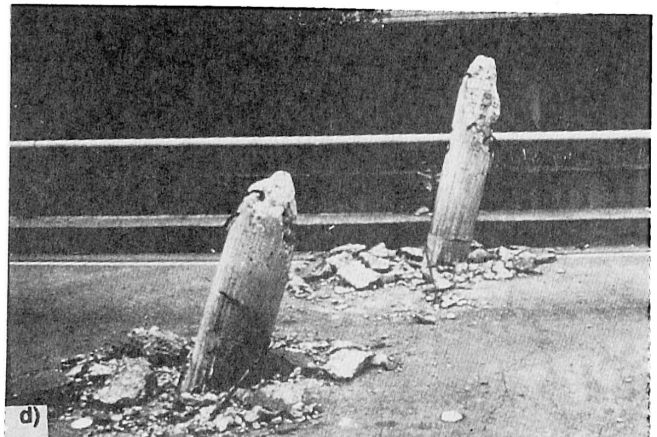
**Fig 4. Knee Joint and Plastic Hinge Failure, Loma Prieta 1989**

Outrigger bents showed problems in flexure and shear in the cap and shear failure of knee joints, see Fig. 4a, due to lack of shear reinforcement, and a fractured 57 mm  $\varnothing$  (#18) bar was encountered in a damaged knee joint on I-980, see Fig. 4b, which can be attributed to large strains introduced during bar bending (6.25%) and possible strain aging effects.

Finally, on struve slough, Figs. 4c and d, the plastic hinge at the column top sheared off and the column offset in the longitudinal bridge direction and punched through the reinforced concrete deck slab.

A flared pier wall which experienced shear distress during the Loma Prieta earthquake was repaired and retrofitted with a full height steel jacket, see Fig. 5c, for increased shear capacity. The previously discussed joint shear failure in an outrigger knee joint of I-980, see Fig. 4b was repaired by full replacement of the joint concrete, see Fig. 6d, and added joint shear reinforcement, while the outrigger bent shown in Fig. 4a was completely replaced, see Fig. 5e.
