## **The Clifton Suspension Bridge – Preservation for Utilisation**

### **M. Stuart CULLIMORE**

Deputy Chairman  
Clifton Suspension Bridge Trust  
Bristol, UK

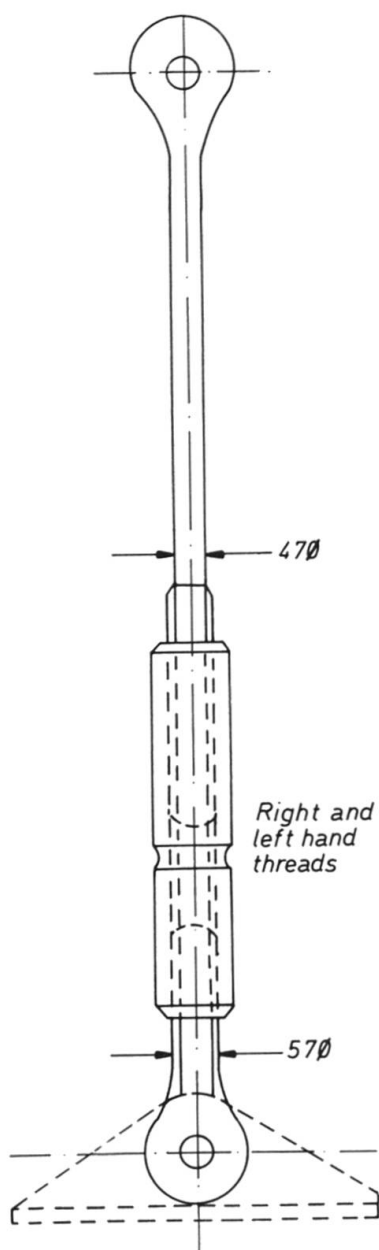
**Fig. 2** Suspension rod

The greatest measured stress range in the rod with an 8 tonne vehicle on the deck was less than  $8 \text{ N/mm}^2$  comprising axial and bending stresses. Even allowing for the stress concentration effects due to the rough surface of the rod and changes in section the risk of fatigue failure of the suspender rods could be discounted since the maximum expected stress range is so far below the endurance limit.

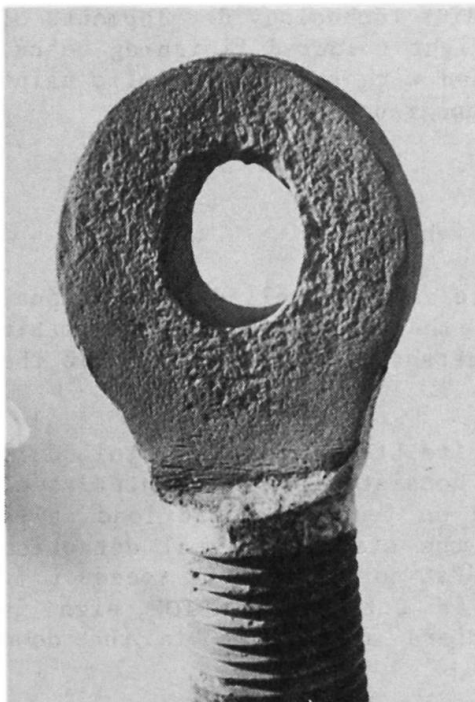
Fig. 5 Wear in suspension rod eye

The passage of a load across the span causes relative longitudinal movement between the chain and the stiffening girder. The resulting rotation of the ends of the suspender rods about the pins connecting them to the structure and the consequent wear is greatest at mid-span where the rods are shortest and decreases towards the ends of the span. Bolts in the shorter rods have been replaced at various times since 1887 but by 1970 wear of bolts, eye ends and shackles had become unacceptable in 66 rods around mid-span (Fig. 5).

Rods were removed for repair two or three at a time by transferring the load in each to a 12mm dia. length of pre-stressing strand which was attached to a yoke and tensioned with a pre-stressing jack. The rod eyes were filled with weld metal, bored, grit-blasted and bushed with a steel backed sintered bronze layer impregnated with a PTFE/lead mixture.
