Structural updating of steel television and radio broadcast towers in the USA

Autor(en): Ratay, Robert T.

Zeitschrift: IABSE structures = Constructions AIPC = IVBH Bauwerke

Heft C-34: Telecommunication towers

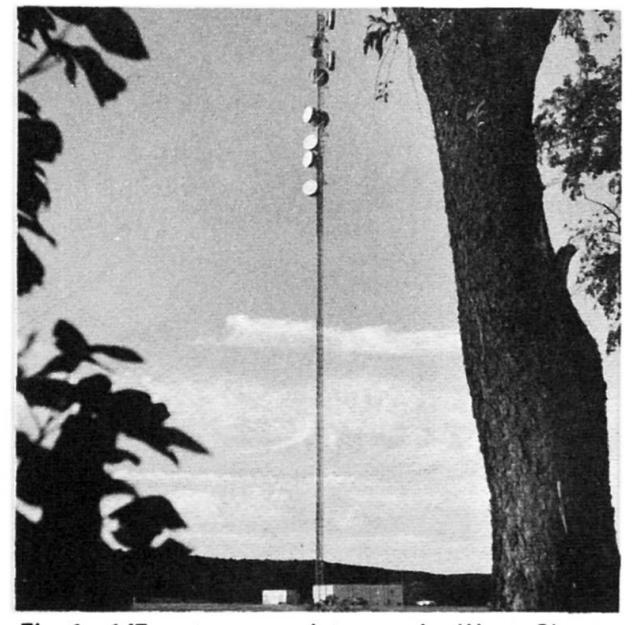
Fig. 1 147-meter guyed tower in West Chester, Pennsylvania. (Courtesy of ITT/United States Transmission Systems, Inc.)

A good example of a thorough investigation is the 147meter guyed microwave tower in West Chester, Pennsylvania. As part of a program of structural review of their towers, ITT/United States Transmission Systems, Inc., commissioned a comprehensive structural analysis, supplemented by field inspection, of this tower. It is a slender triangular trusswork, has five levels of guy cables with torque stabilizers at the top three guy levels. It supports twelve large-diameter microwave dishes and several small antennae (Fig. 1). The work was performed under the author's direction. The calculations, computer print-outs, graphical presentation of results, discussions, conclusions and recommendations were presented in a five-volume report.

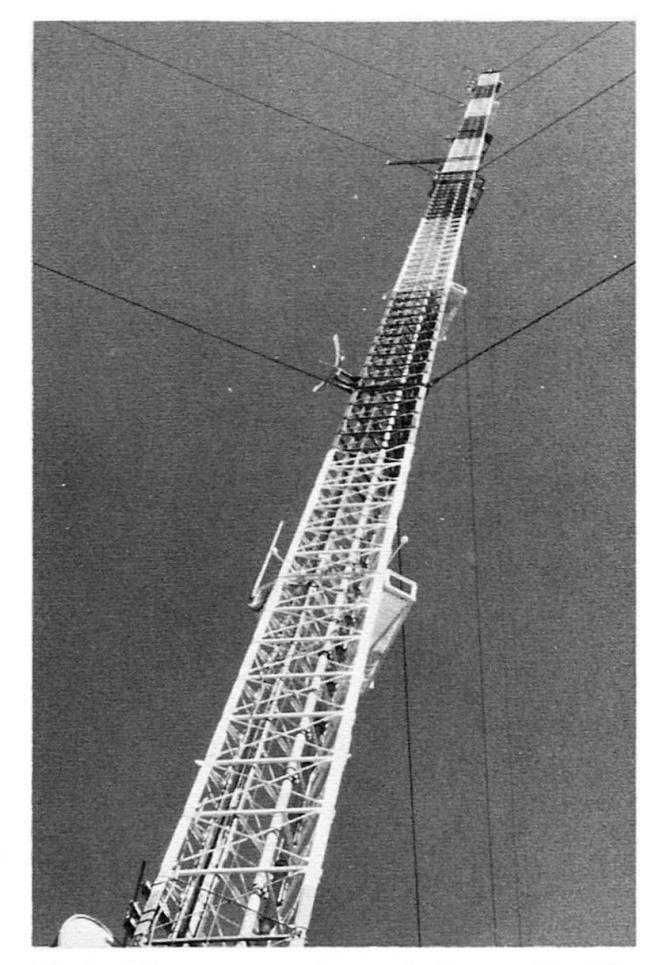
The changing requirements between 1953 and 1983 of the ANSI, UBC and EIA codes, as well as the local building code, were evaluated by the author for the 290meter guyed tower of KMBC-TV in Kansas City owned by The Hearst Corporation, as part of an in-depth structural review (Fig. 2). The study traced the major events in the history of the tower: original construction, later changes of equipment, subsequent structural modifications and recent changes of ownership. It was found that at each event during those thirty years the codes required considerably different wind pressures: increasingly greater by the ANSI, EIA and local code and slightly decreasing by the UBC. This points up the situation that a tower standing for 30 or 40 years may become structurally inadequate and need to be reinforced because of changes in codes.

Fig. 2 290-meter guyed tower in Kansas City, Missouri. (Courtesy of The Hearst Corporation)
