# Rehabilitation of the Gardiner Expressway, Toronto, Canada

Autor(en): Li, Edward K. / Woodman, Carl W.

Zeitschrift: IABSE reports = Rapports AIPC = IVBH Berichte

Band (Jahr): 73/1/73/2 (1995)

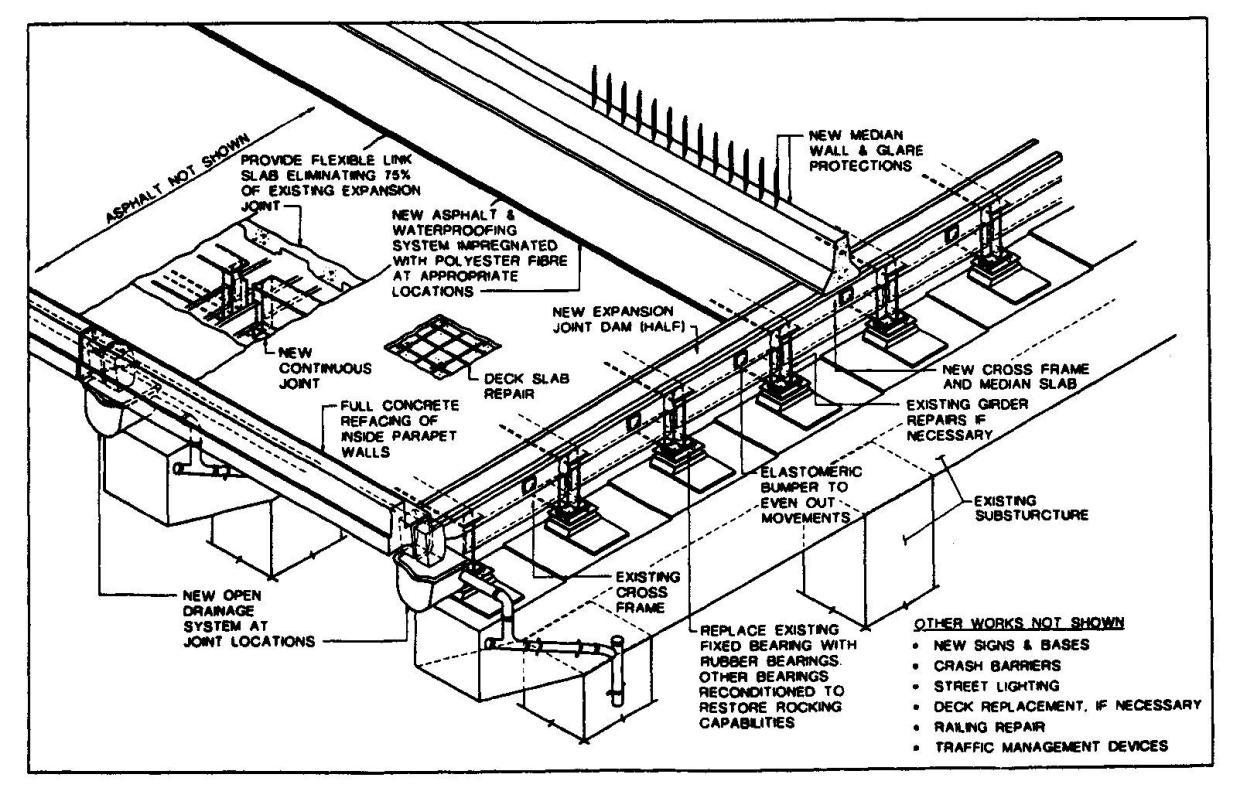
Figure 2 - General Deck Rehabilitation Scheme

3.5 Some of the above design details can be found in [4]. A general view of the repair scheme is shown in Figure 2.

To accomplish this, it was decided to 3.2 minimize the number of existing joints . The longitudinal joint between the twin bridges was replaced with a concrete slab and additional cross-frames, essentially tying the 2 bridges together. Three out of existing expansion joints were four eliminated by making the deck continuous for a number of spans. The tying of originally simply supported spans required complete revamping of the bridge articulation system, by providing new bearings and expansion joints. Thermal were movements of tied deck the accommodated by flexing of the supporting bents, while ensuring that the existing fixed bearings would be strong enough to withstand such movements. The tying method chosen was called the "flexible link", which consisted of a thin and highly reinforced concrete slab. This link allowed the connecting spans to continue to behave as simply supported spans, with the end rotations due to traffic loading being accommodated by the flexing action of the A more detail description of the link. link slab can be found in [4]. Such rearrangement of structural layout in rehabilitation projects was the first designed and built in Canada. A11 remaining expansion joints were replaced joints incorporating readily with replaceable seals with steel armouring.

"3.3 An innovative "flood-free" drainage system was devised. The system utilized a fibre-glass hopper mounted on either the girders or the supporting bents. The hopper collected silt and allowed sediment-free water to enter the main drainage network. The inlet was designed to discharge water as quickly as possible and to accommodate a "vacall" type hose for the periodic removal of silt. At those times when the hopper was filled with silt, water could still drain off the deck by overflowing at the hopper.

- 3.4 The rehabilitation also involved
  - 1. Repairing damaged deck and parapet areas, by patching and refacing;
  - 2. Incorporating a new bituminous waterproofing layer and asphalt surface;
  - 3. Reconditioning bearings to re-activate their movement capabilities.
