Defects and Repairs at an Interchange Bridge in Tripoli, Libya

D.V. MALLICK

M.M. TAWIL

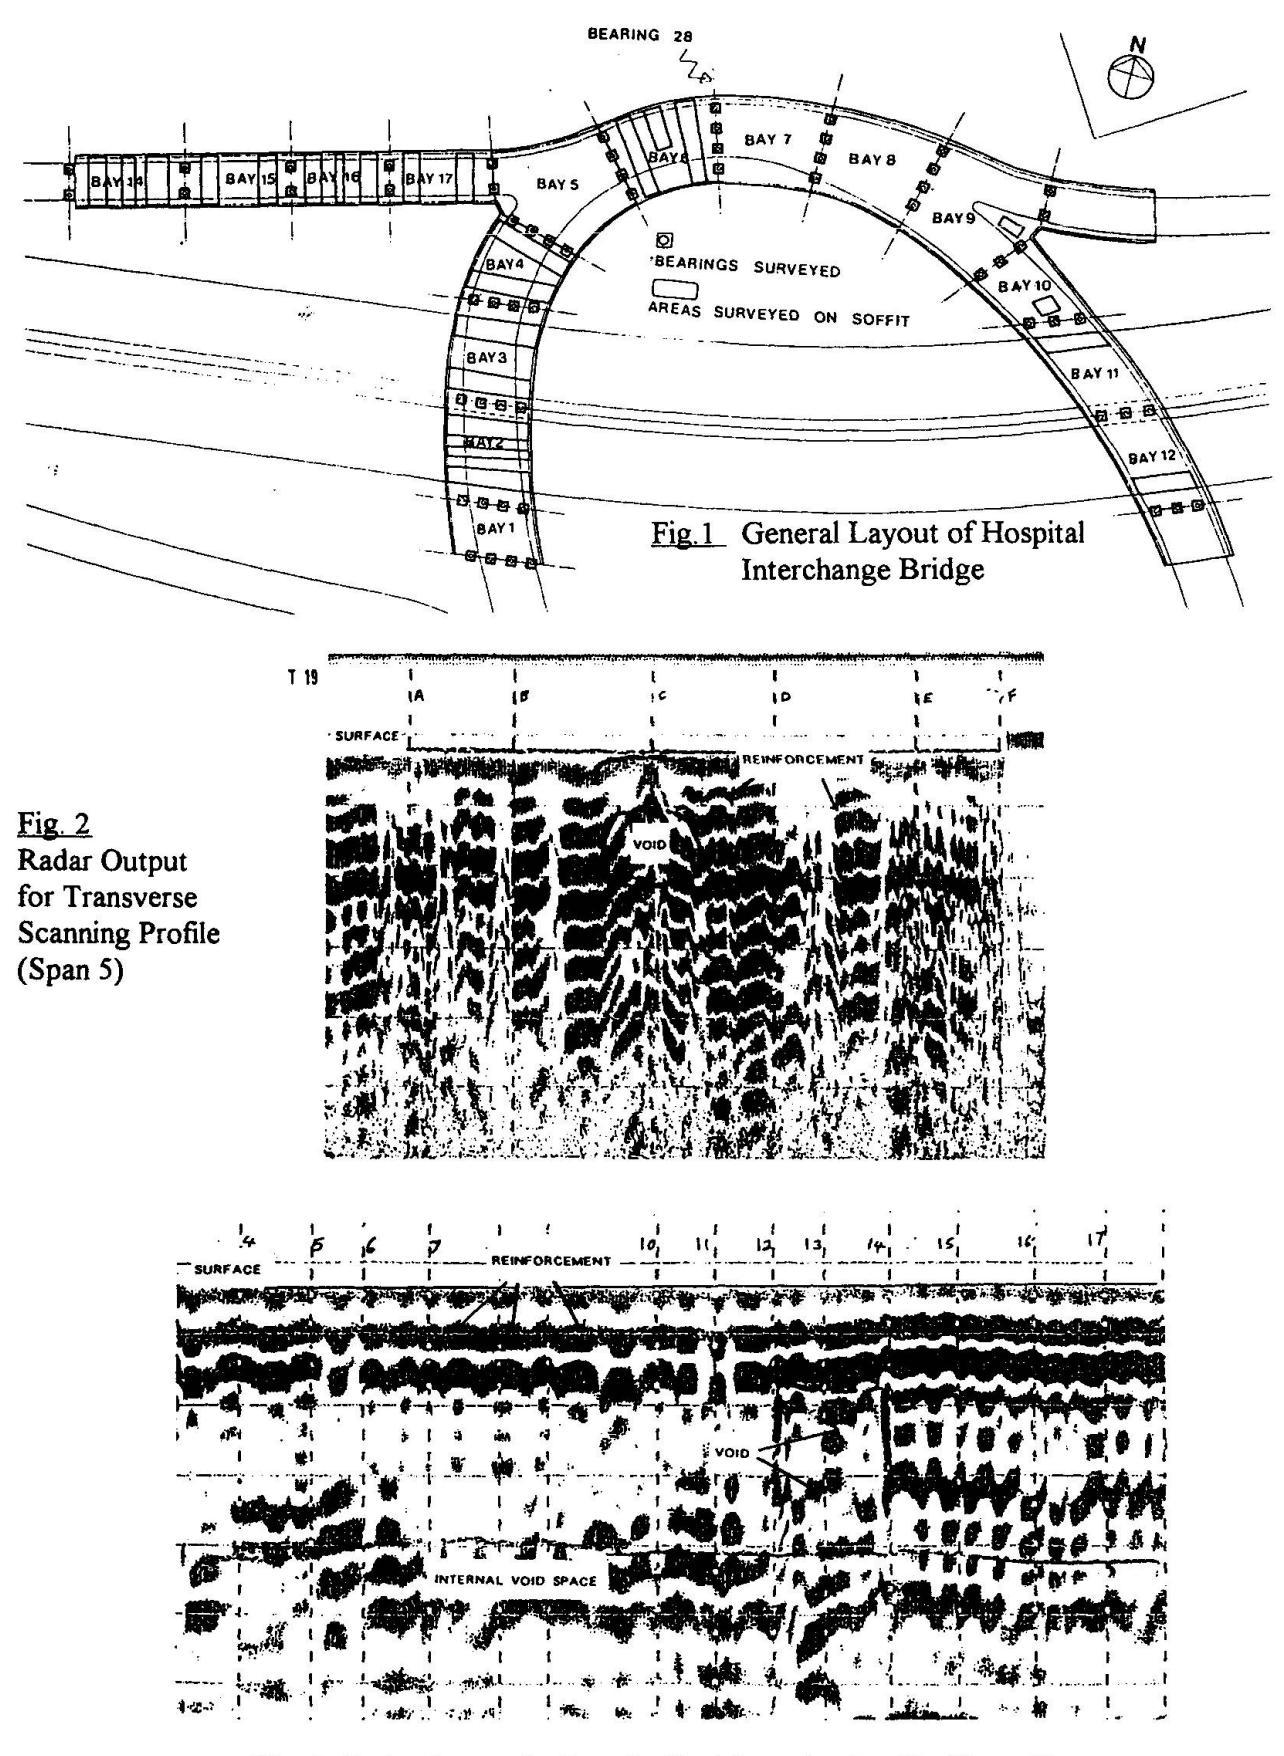
Fig. 3 Radar Output for Longitudinal Scanning Profile (Span 5).

Figure 3 shows data collected with the 900 MHZ transducer along a longitudinal profile of deck 5. It can be seen that the hyperparabolic return from the reinforcement are interrupted: this is caused by the presence of a void reducing the energy coupled to steel thus sharply alternating the returning signal and creating a blank area in the data. The deeper void attenuating located between the reinforcement and the internal void former is not as readily identifiable within the data, but a disturbance or irregularity in the signals can be noted both as a cancellation or attenuation of signals from the reinforcement and also as a phase shift in the response from the metal skin of the internal void former.
