Correcting Design Deficiencies in a New Five-Story Building

A five-story office building was investigated to assess its structural integrity immediately following construction, prior to occupancy. Each floor level consisted typically of two-way post-tensioned concrete slabs, except the fourth level which was built in reinforced concrete. Significant structural deficiencies were identified. Some elements had little or no reserve against failure at normal service loads. A proposed load test was judged to be inappropriate, as it would have likely resulted in failure of structural elements. Repair and strengthening measures involving various methods and materials were engineered.

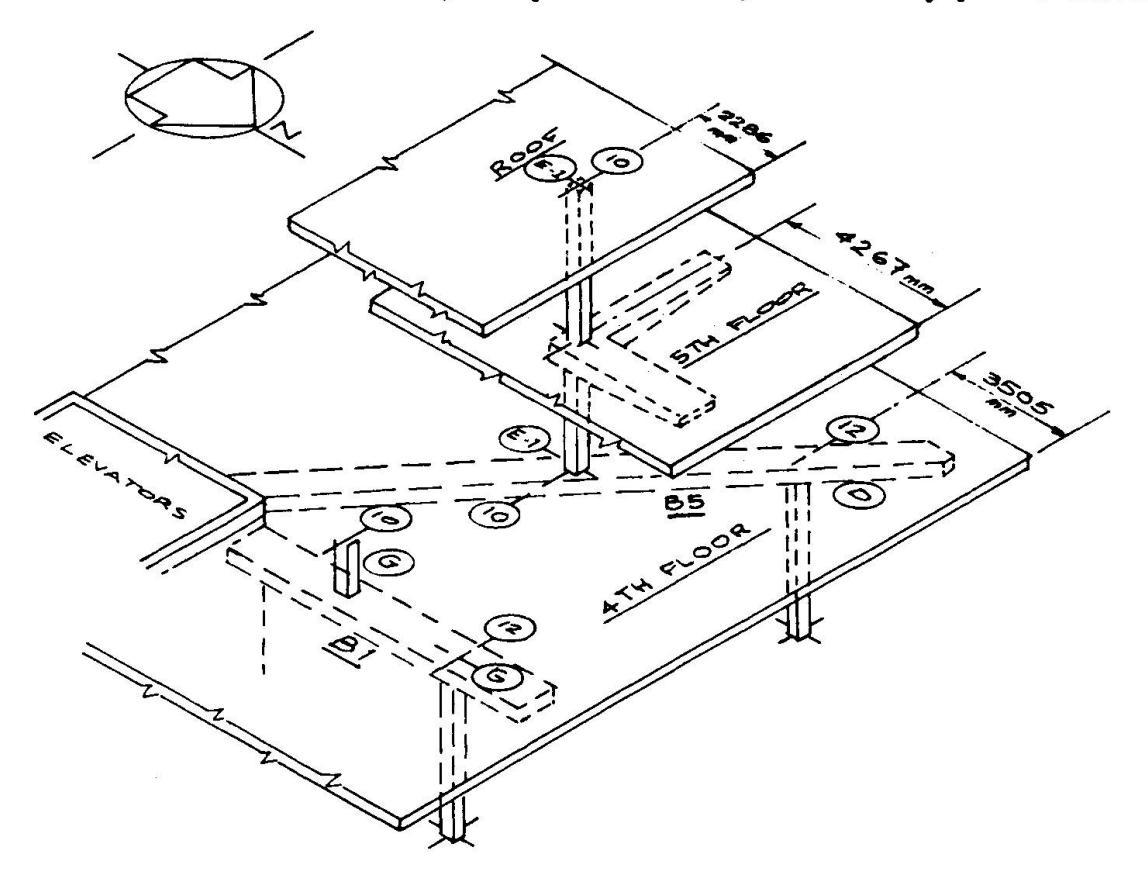
Fig. 1 Schematic view at corner of structure showing upper floors.

Fig. 1 represents the general structural framing of a quadrant of the original asdesigned building. The roof, fifth and fourth floor slabs stepped back for architectural purposes. The third, second and first structural levels (not shown) have supporting columns around the perimeter of the building.

flat plates. Typically, based on US current practice, the post-tensioning strands are uniformly spaced in one direction (north-south) and banded along column lines in the orthogonal direction (east-west). Not typical of current practice was the use of relatively long cantilever overhangs of the roof and fifth level slabs, and the short beams cantilevered from the exterior columns, composite with the fifth floor slab.

The fourth level was constructed as a conventionally reinforced concrete slab and beam frame. As is seen in Fig. 1, the exterior perimeter columns supporting the roof and fifth levels did not extend below the fourth level but, instead, were supported on and transferred their loads to shallow, reinforced concrete transfer girders.

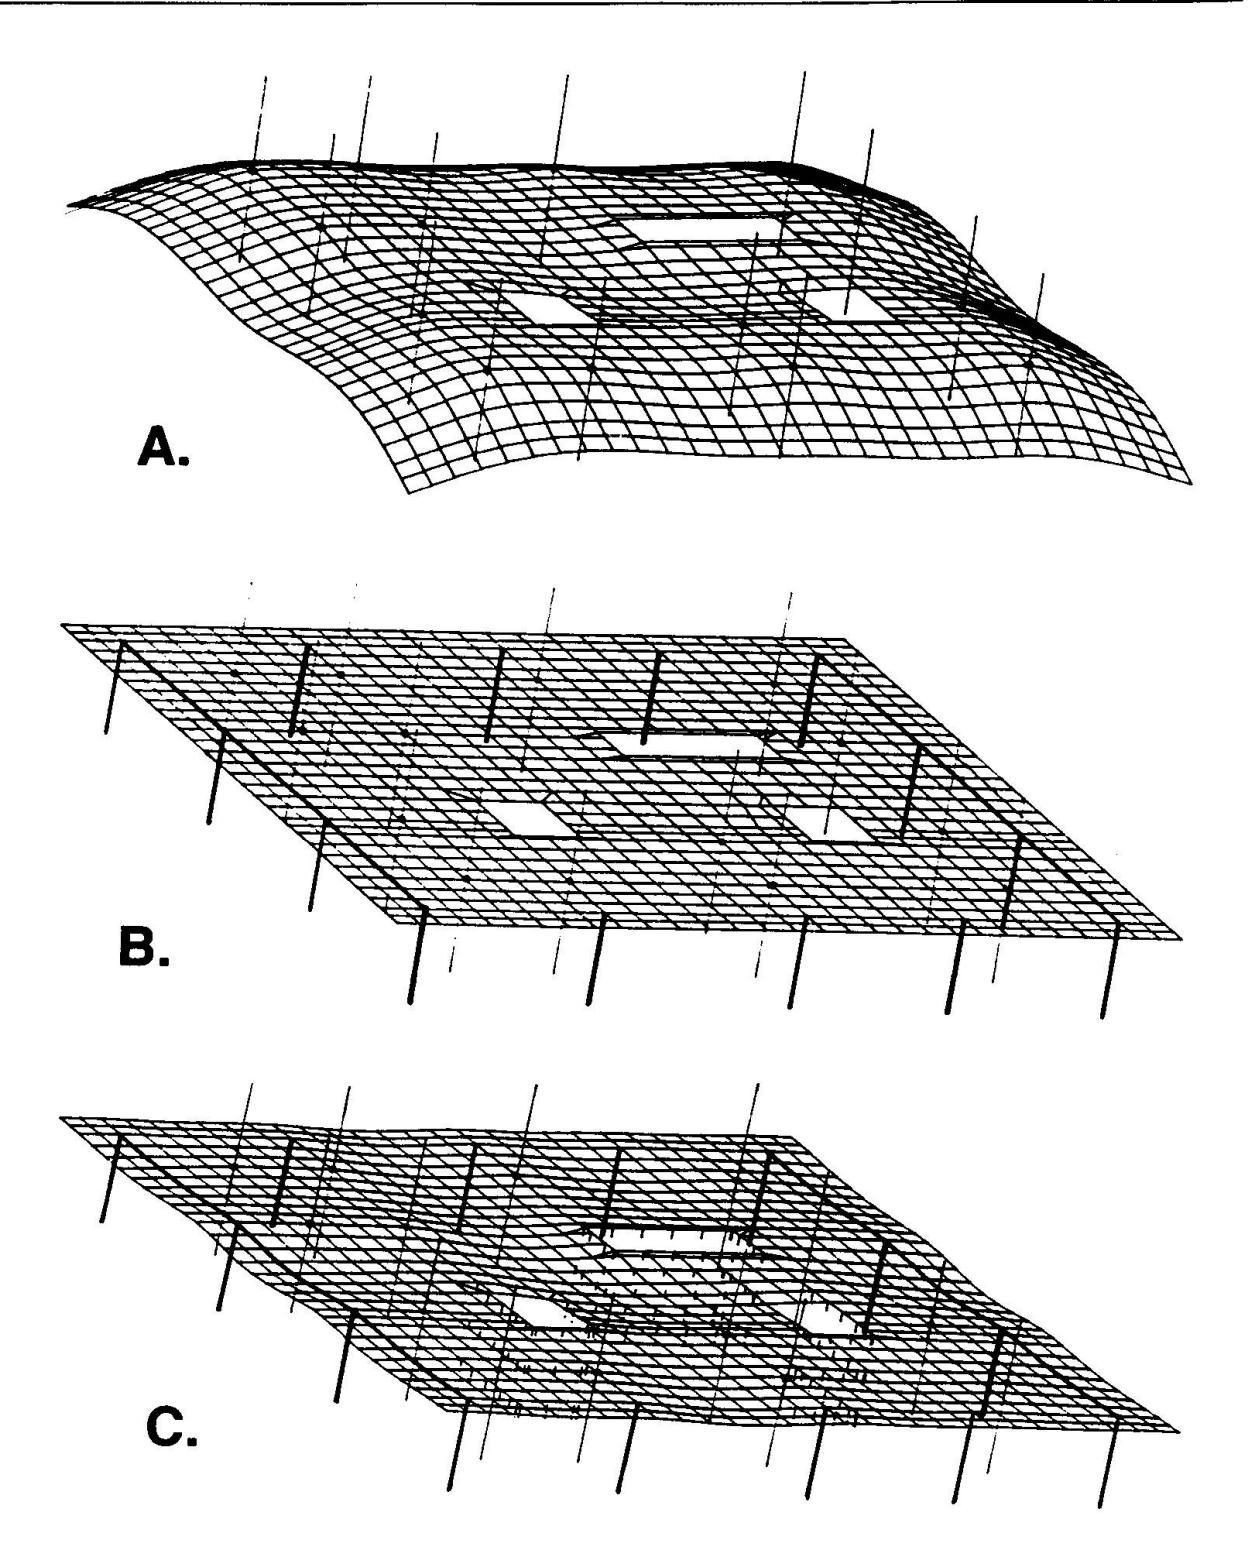
Fig. 2 Finite element models of fifth floor two way posttensioned slab system:

Fig. 2A shows the deflected shape, as determined by analysis, of the fifth floor slab system, as originally designed, under full service load. It is quite apparent that the slab deflections, especially those of the cantilever overhangs, are excessive, possibly implying that the slab is overstressed. There was some visual evidence of this overstress in the form of slab top and column cracking. Fortunately, the fact that the cantilevered slabs had remained shored all along must have limited the amount and size of cracking observed.

- A. Deflected shape under full service loads as originally designed (scale factor = 50).
- B. Location of added steel beams and perimeter columns (shown bold on undeflected model).
- C. Deflected shape under full service load with added steel beams and perimeter columns (scale factor 50).

Fig. 2C represents the deflected shape of the strengthened fifth floor under full service loads. Comparing this figure with Fig. 2A, it is readily evident that the cantilever slab deflection and, thus, tensile stresses, have been substantially reduced. The latter, as shown by analysis, appear to be within allowable code levels.

The major strengthening was accomplished by adding a new line of steel columns (in effect, "permanent" shores) around the periphery of the floor to reduce the slab cantilever (see Fig. 2B). A steel beam was placed on top of the columns parallel to the north and south slab edges in order to control the cantilever deflections in the uniform spaced tendons direction. The new steel beams were preloaded by shimming to predetermined beam deflections, in order to pick up, at least, part of the dead load. The steel columns on the east and west sides were shimmed directly under the short cantilever beams. All the new steel columns sit directly on top of the periphery concrete columns supporting the fourth floor. Consequently, the loads picked up by them is directly transferred down the structure to the footings. This strengthening scheme was chosen because of its relative ease and speed of implementation, and its relatively minor disruption of lease space.

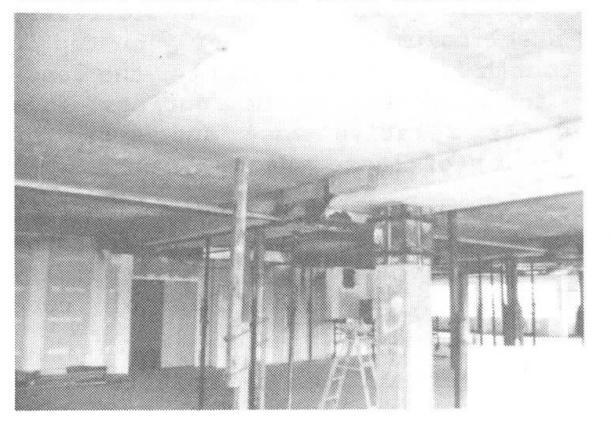
Evidence of the probable distress which could be anticipated in the transfer girders, under full service loads, was the observed extensive flexural cracking

under dead load only, principally under the columns supported by the girders. The magnitude of the cracking of the transfer girders, under partial dead load and relatively light construction loads, clearly indicated a lack of structural strength.

The columns below, supporting the transfer girders, also had evidence of distress under reduced dead load conditions in the form of flexural cracking. Because of the heavy concentrated column load coming down at about midspan of the transfer girders, the top of the supporting columns would bend in towards the center of the building, with cracking thus expected on the outside faces of the columns. This cracking was clearly evident under partial dead load conditions only. Excessive deflections and failure of some structural elements might have occurred had full service loads ever been achieved.

Fig. 3 External post-tensioning of transfer girders and steel. collars confining column tops

The most practical solution to retrofit the transfer girders was determined to be the use of external post-tensioning (see Fig. 3). To fully resolve all structural deficiencies resulting from the analysis would have been impractical. Therefore, a re-analysis of the fourth floor allowing for plastic deformation of the concrete (the creation of hinges) at factored load conditions was carried out. In this way, moments were redistributed to girder and slab regions which would be more convenient to reinforce. Yet, up to factored load conditions, no structural integrity would be compromised.

Based on this re-analysis, using plasticity principles, the external posttensioning was designed to ensure that the transfer girders achieve ultimate strength at factored load conditions. The deficient top and bottom slab regions strengthened with additional were reinforcement bonded to the slab (as was done on the fifth floor level). The reanalysis revealed that the strengthened slab system would perform adequately if the tops of the 7 deficient columns were allowed to develop a plastic hinge as a

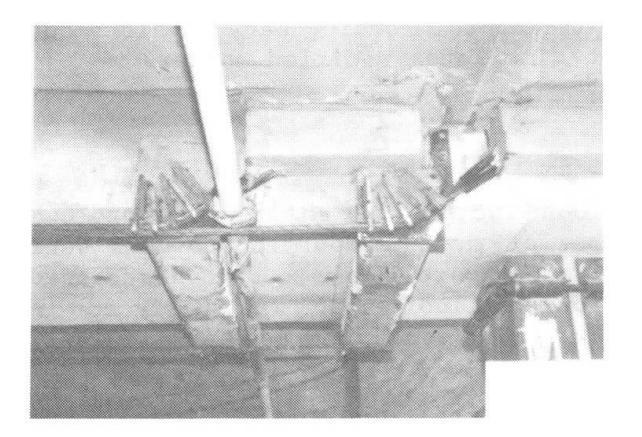
Fig. 4 Close-up of external posttensioning tendon deviation saddles at transfer girder

connection to the concrete beams above. To ensure the safe plastic deformation of the concrete column tops, confinement was provided using steel angle collars tightened together by high-strength bolts to achieve about 3.4 MPa of lateral pressure (see Fig. 4).
