Session C3: General repair of buildings

General Repair of Buildings Aspects généraux de la réparation des bâtiments Allgemeine Fragen der Instandsetzung im Hochbau

Extending the Lifespan of the Architectural Heritage

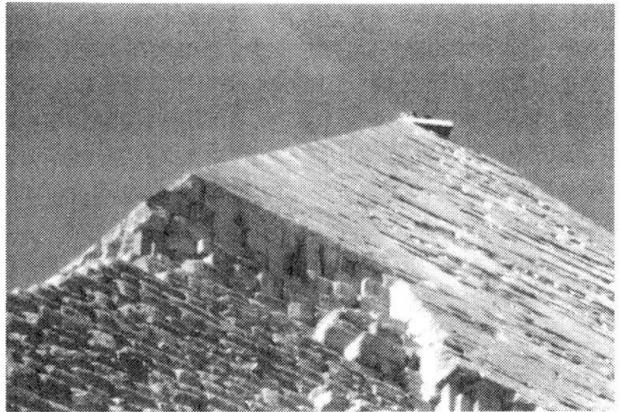
On 17 November 1994, a scientific mission made an ascent of Chephren's Pyramid (Figure 1) to evaluate the role of temperature and wind in the decay of the stone and to assess the stability of some blocks that have been shifted by earthquakes in the past (Figure 2). On the one hand the survey contributed new and important elements for deeper understanding of the construction of the pyramid and, on the other, showed that, apart from the problem of weathering, no radical structural interventions were necessary, it being sufficient to add some supports in the same limestone to ensure the stability of blocks at risk.

Fig. 2: Shifting of a block on the top of Chrephren's Pyramid

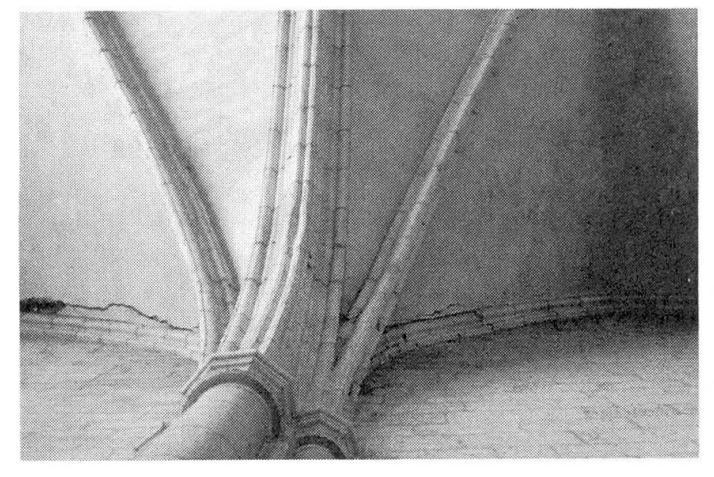
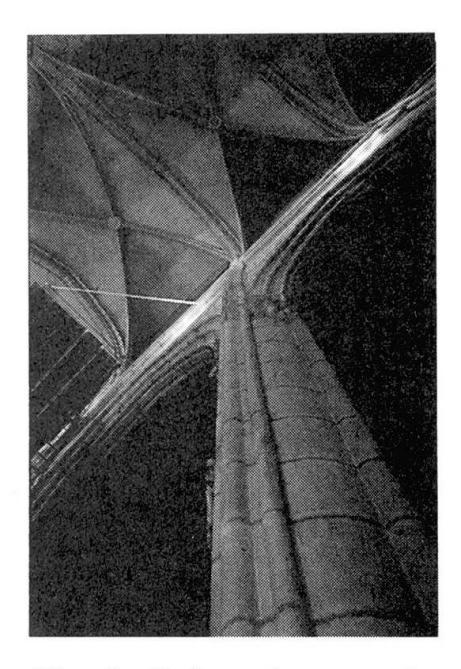
In the cathedral of <u>Vitoria in Spain</u> the main columns have been affected by significant levels of curvature and deformations: at mid-column level, these measure about 30 cm (Figure 3) and the deformations have detached some of the voults (Figure 4).

Fig. 3: Deformations on the columns of Vitoria Cathedral

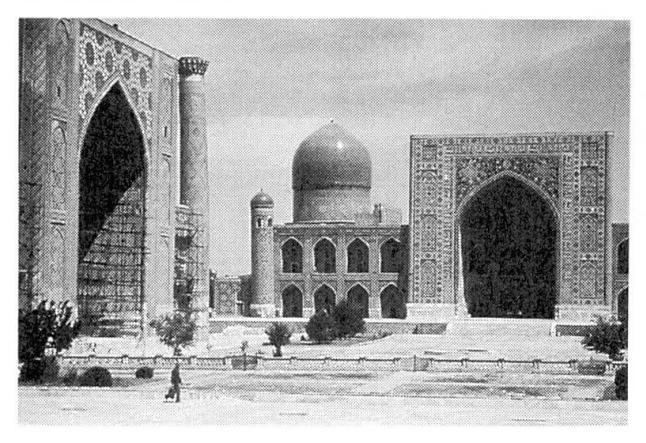
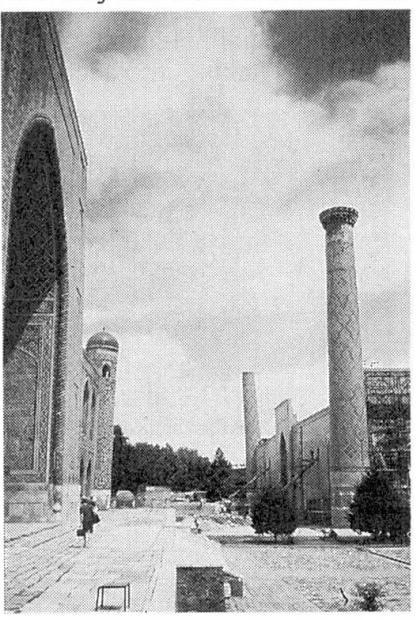
Tilla Kari Mosque on Rejistan Square (Figures 9 and 10) is an example in which the outward top displacements amount to tens of centimetres, creating unstable situations for both the walls and the connected vaults.

Figg. 9, 10: Leaning and deformations in minarets and mosques, Samarkand

The solution consists in removing a certain amount of soil inside and outside the walls of the mosque and filling the spaces with empty

reinforced concrete boxes, which are connected to the masonry foundations, so as to create a continuous rigid raft.

This has the dual advantage of reducing the weight and enlarging the foundations. A further significant advantage is obtained by placing a movable foundation slab on the bottom of the concrete boxes, loaded using provisional jacks (Figure 11 and 12) in order to induce and regulate the pressure necessary to correct the leaning on the basis of the data recorded.

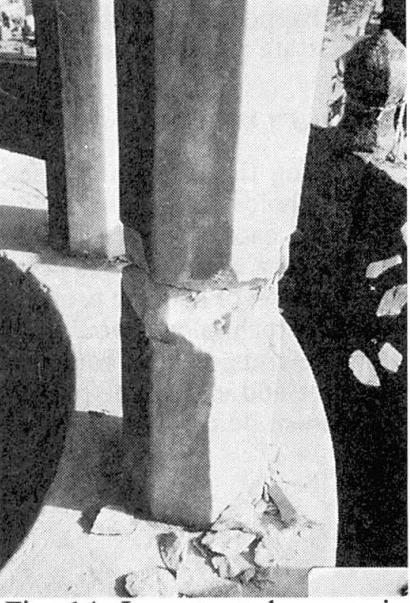
Fig. 14: Important damages in the upper part of a minaret

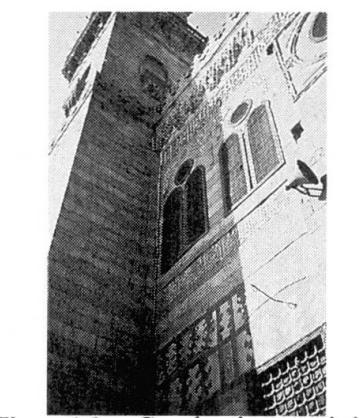
Fig. 16: Crack in a joint between the minaret and the mosque

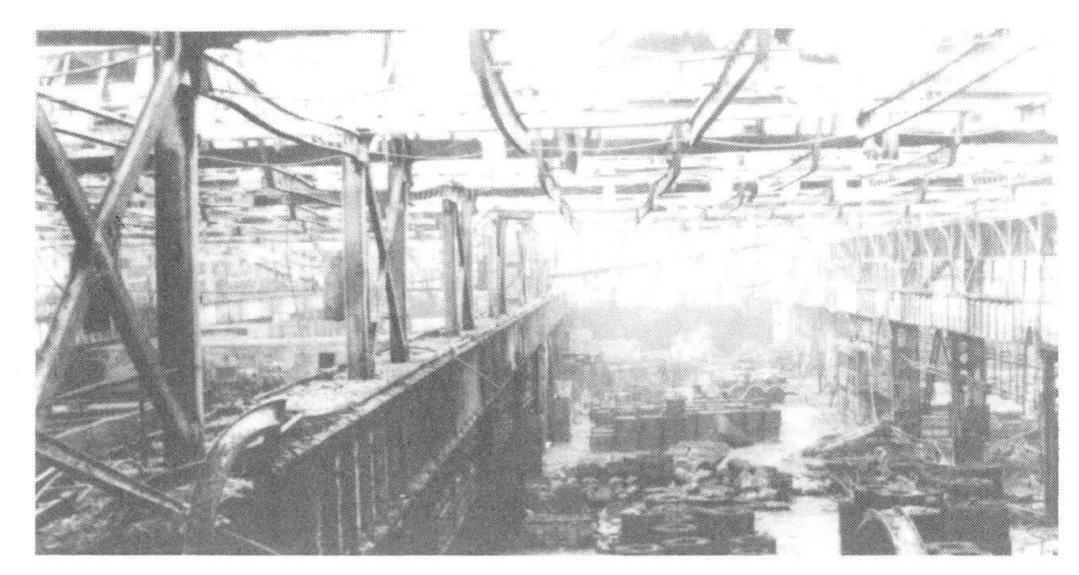
The second building stage, was about to finish when the fire accident occurred and caused a lot of damages of structural steelwork and equipment as well. Next day after the fire accident the special technical commission for building rehabilitation was formed by team of experts (including the co-authors of the paper). The detailed geodesic measurements were carried out in order to determine exactly the actual state of the structural steelwork. The special photogrametric method from air (by plane) was used as well.

Fig. 4 Building structure damaged by fire

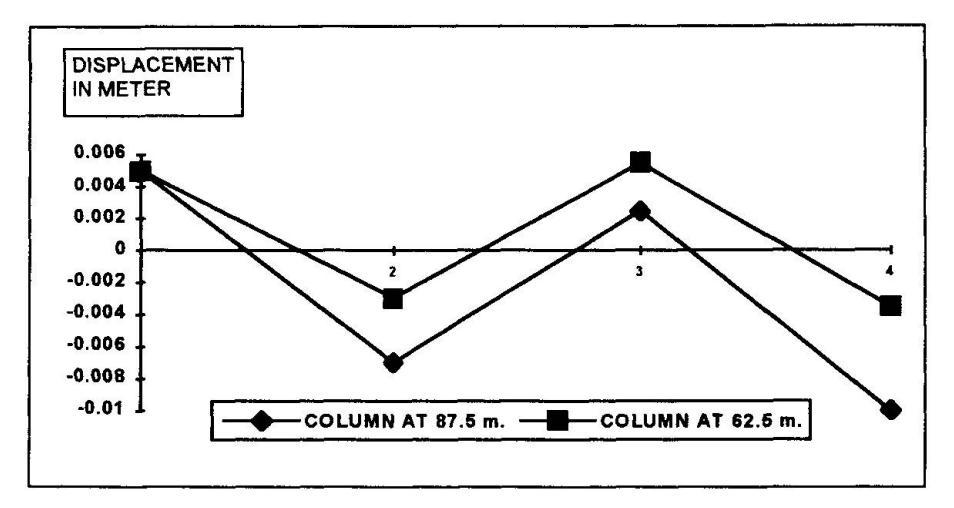
Fig.(2) : Displacement of the columns
