Zeitschrift:	IABSE congress report = Rapport du congrès AIPC = IVBH Kongressbericht	
Band:	12 (1984)	
Artikel:	Rehabilitation of post-tensioned bridge deck	
Autor:	Ostenfeld, Klaus H. / Jonsen, Leif	
DOI:	https://doi.org/10.5169/seals-12281

Rehabilitation of Post-Tensioned Bridge Deck

Klaus H. OSTENFELD	Leif JONSEN
Head of Bridge Dep.	Chief Bridge Eng.
Cowiconsult	Cowiconsult

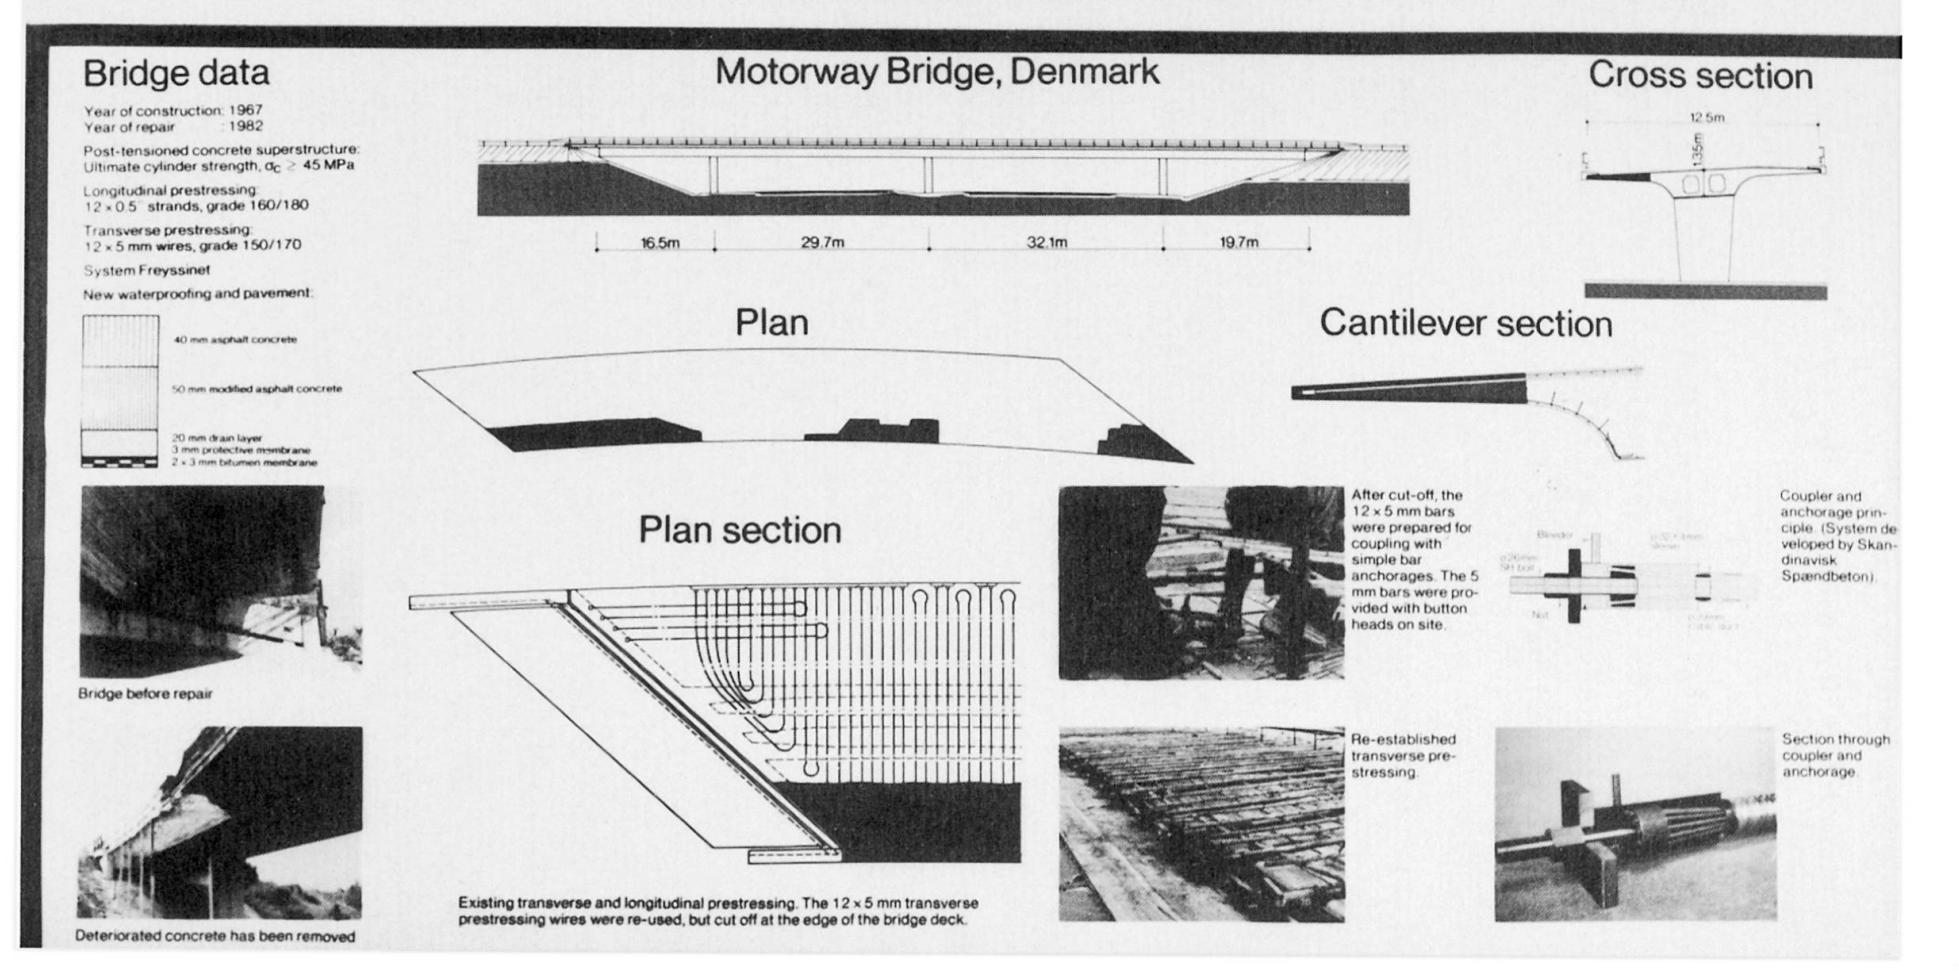
REHABILITATION OF POST-TENSIONED BRIDGE DECK

The bridge was constructed in 1967 and hereafter regular routine inspections were carried out. In 1981 a major examination took place. Larger zones of deteriorated concrete were found in one of the cantilevered flanges, especially in areas near the abutments.

The bridge deck surface has a cross slope of 6% and consequently damage had only taken place in the lower cantilever, and fortunately not in the central part of the girder where the longitudinal main tendons are positioned. This distribution of the damage made repair possible. A full replacement of the superstructure would have resulted in an expenditure of more than 250% of the repair cost and almost total closure of one of the major motorways in Denmark.

The deterioration had started due to a leak in the waterproofing membrane. Unfortunately, the underneath concrete was not resistant against alkaline reactions.

After removal of the bridge deck pavement and water proofing, the deteriorated areas were surveyed by core drilling.

The deteriorated concrete was removed, however, in such a way that the reinforcement and prestressing tendons were not harmed. In this context it was very important that the transverse prestressing in the cantilevers could be reestablished. The transverse prestressing tendons consist of 12 dia. 5 mm wires. In order to protect these wires, the original sheath and grout were not removed until just before the new sheathing was ready to be installed. As it can be seen from the original transverse tendon arrangement, it was not possible to reuse the existing anchorages.

A new system was developed by Skandinavisk Spændbeton. A simple bar anchorage with thread and nut was connected to the wires. The details are shown on the poster. After casting the deck the wires were re-stressed and grouted.

Due to the repair work the longitudinal prestressing forces were lost in the cantilever. Consequently, it was necessary to place some additional ordinary reinforcement in the longitudinal direction, especially at the end of the bridge deck.
