# RECORDED FAILURES OF ELECTRICALLY WELDED WROUGHT-IRON AND MILD STEEL BRIDGES.

### H. J. L. BRUFF, Bridge Engineer, North Eastern Area, London and North Eastern Railway, York.

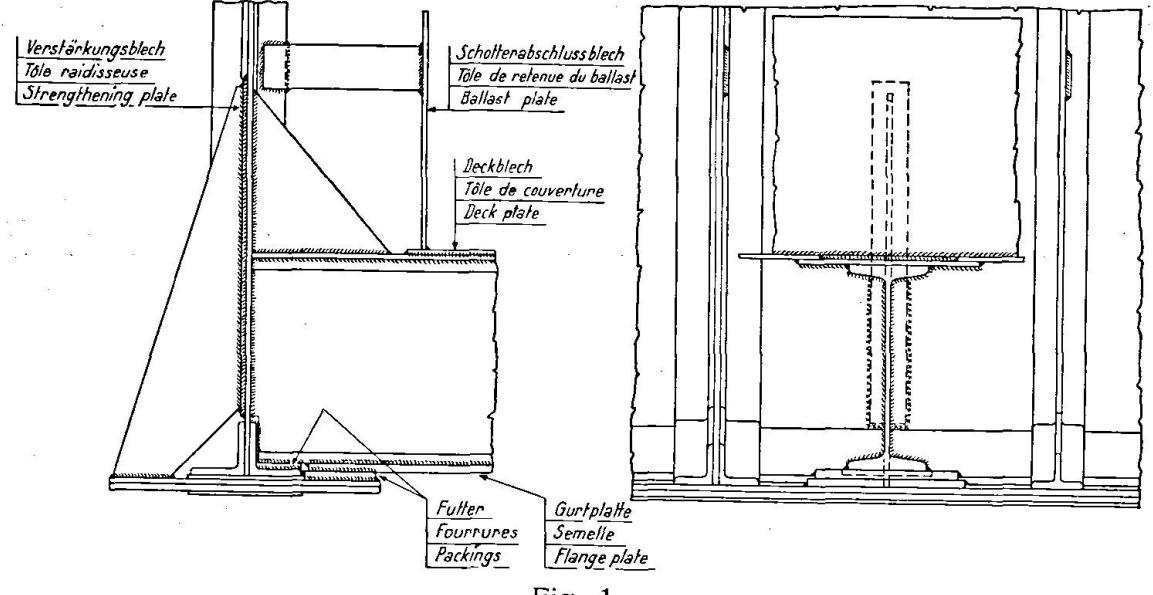
Einzelheiten von Knotenblech- und Stegblechaussteifungen (Brücke No. 32, South shields Linie). Détails des goussets et raidisseurs de l'âme. (Pont n° 32, ligne South shields). Details of gussets and web stiffeners. (Bridge N° 32, South shields branch).

Welding stresses which are set up by the contraction of the weld metal itself cause distortion; indirectly the heating up of the welded parts sets up contraction stresses inasmuch as in the heated condition the parts to be joined become rigidly fixed and when cooling down they may contract unequally and thus also cause distortion. When such jointed parts, which are in a state of internal stress, are subjected to exterior forces which produce bending, tensile or compressive stresses, previously highly stressed welded parts may become overloaded to the extent of actual fracture. The first experience of this type of failure occurred in the case of the reconditioning of a large plate main girder of a wrought iron bridge the floor of which was entirely renewed. As it was necessary to place the new cross girders between the old cross girders, where there were no web stiffeners, provision had to be made at these points for proper distribution of end fixing moments and shear from the cross girder ends. A strengthening plate was therefore welded to the outside of the web of the main girders and a triangular gusset plate welded on to it directly opposite the new cross girder end, as shown on Fig. 1.

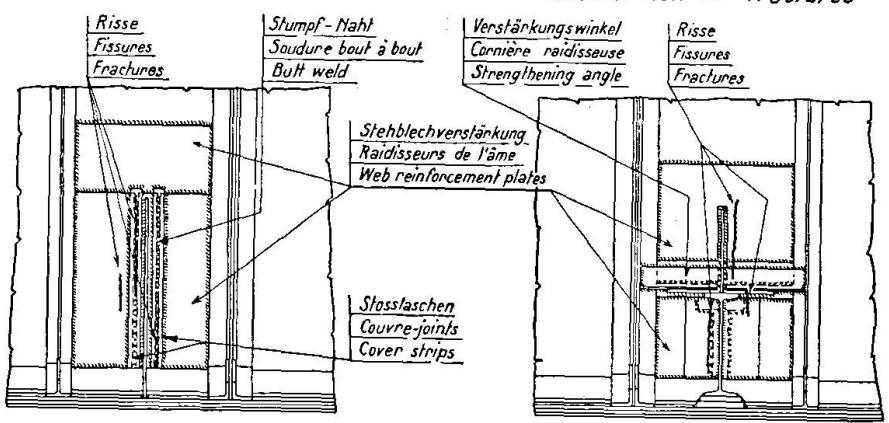
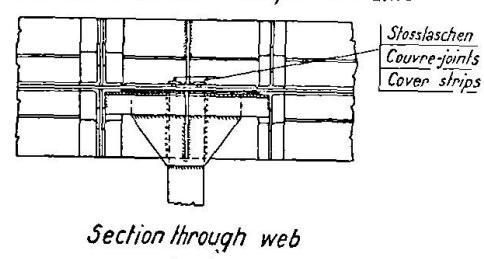
Fig. 2.

Einzelheiten eines reparierten gerissenen Stegblechfeldes. Détail d'un champ réparé de l'âme où celle-ci était fissurée. Details of repaired panel of fractured web.

The webs of the main girders were badly corroded and in places reduced down to 1/16" and less in thickness. On welding the flat strengthening plates to the main girder web plates, fractures developed in two instances, which travelled up the web plate at the same rate as the weld was run. As the crack formed while the weld metal was being deposited and not during the cooling down of the heated part of the girder, it is reasonable to assume that the stress set up by the contraction of the weld metal added to the existing shear stress brought the total stress up beyond the ultimate strength of the web plate. Fig. 2 shows the repairs.

Extra web cover plates were therefore tack welded to the "T", angle stiffener and strengthening plate, the fracture having been "V' d" out and butt welded previously. The new web reinforcement plates were then finally butt

welded to the strengthening plate and the toes of the "T" and angle stiffeners of the girder.

In the case of repair work like this, where the webs are thin, web strengthening plates are now always provided, which are welded to the adjoining main angles and stiffeners.

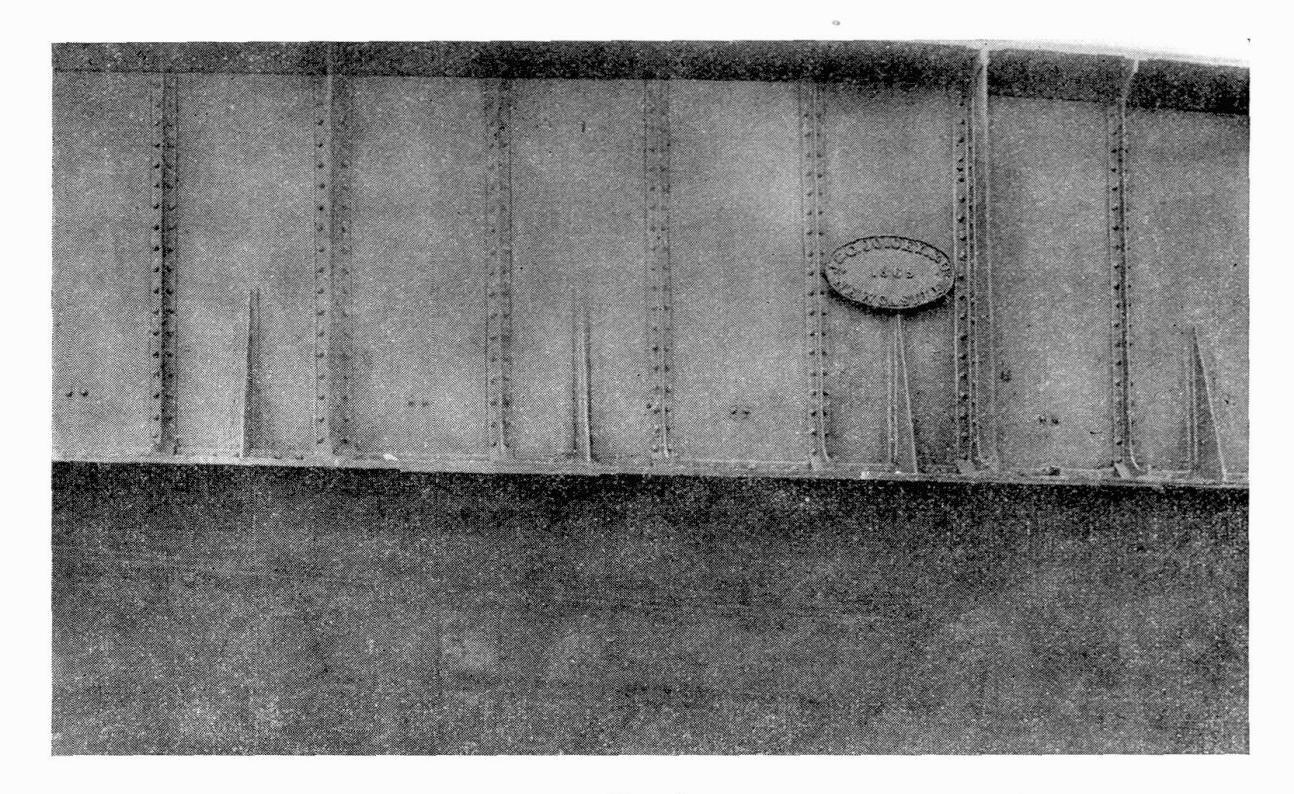
Fig. 3. Lichtbild des reparierten Stegbleches. Außen- und Innenansicht. Ame réparée. Vue extérieure et intérieure. Photograph of repaired web; outside and inside.

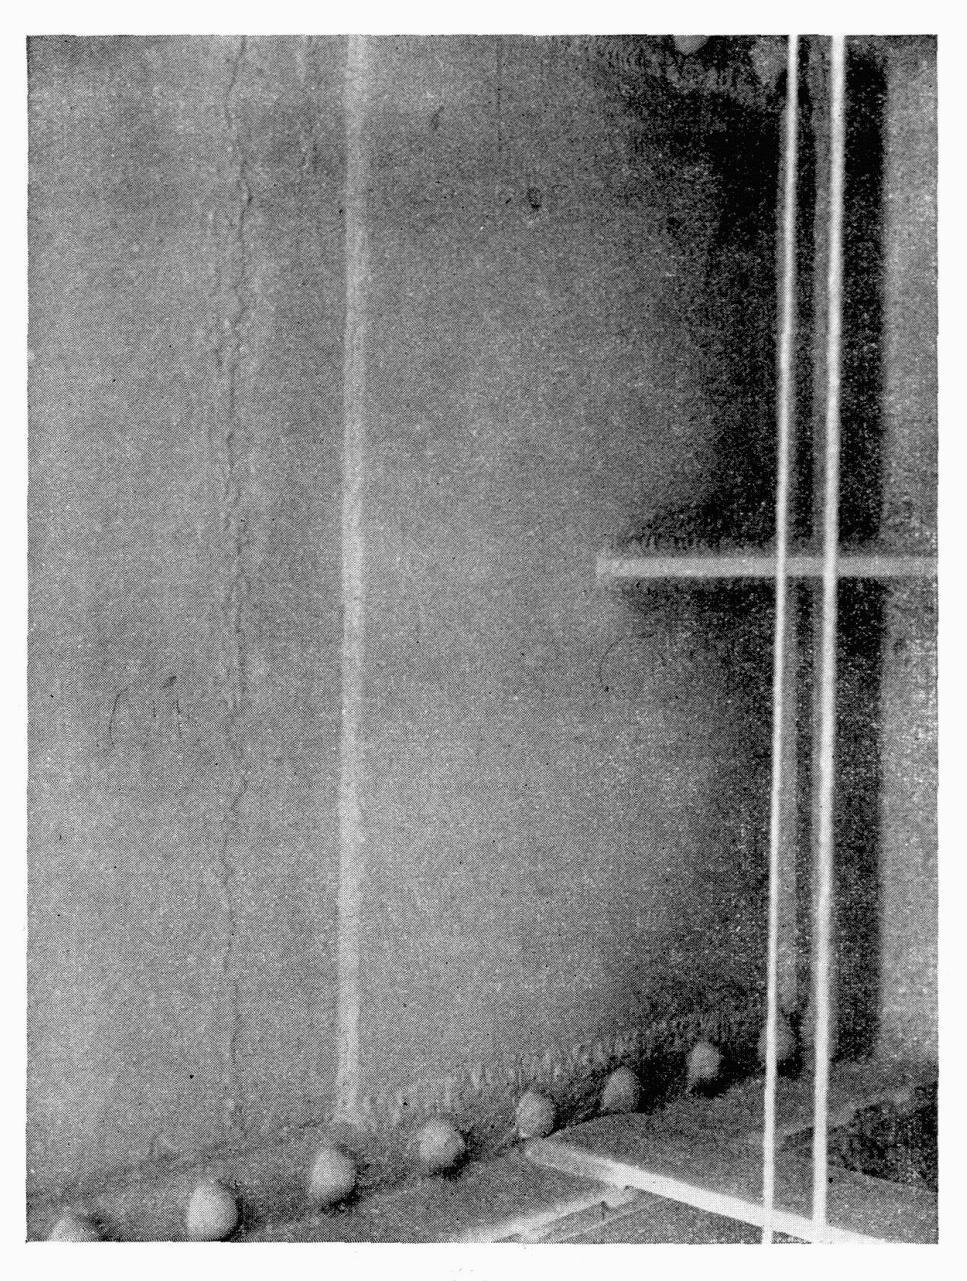
Fig. 4.

In another instance where the webs of the main girders had been holed through corrosion and the webs required to be repaired, fractures took place along the welded seams which were probably due to the contraction of the heated parts of the girder. The failures which were fairly numerous were all identical, being fractures of the vertical butt welds between the new web streng-

thening plate and the toes of the "T" and angle stiffeners. Fig. 4 shows details of construction.

As will be seen from the section it was intended that the welds should not only unite the strengthening plates and the toes of the "T" or angle stiffeners, but also the old web itself. On cutting out the fractured welds, as shown in Fig. 5, it was found, that good penetration had been obtained between the strengthening plate and the "T" but that there was no penetration in the case of the web, as will be seen from the photograph of a part of the "T", strengthening plate and web which were cut out in order that the cause of the fracturing might be ascertained.

The gap between the strengthening plate and the "T" had been prescribed to be 1/16", but apparently this had not been worked to in all cases, the weld cut out was barely 1/16" and it appeared that the strengthening plate had not

been in full contact with the web plate. Out of 48 welds 17 were found to be fractured, these were all cut out and in not a single instance had penetration with the web been secured. The practice is now to make the gap 1/16'' min. the face of the chamfer the same, using a No. 10 electrode with a slightly higher

Einzelheiten von Stegblechreparaturen. (Brücke No. 2, Monkwearmouth Güter-Linie). Details de réparations de l'âme. (Pont n° 2, ligne Monkwearmouth — trains de marchandises). Details of repairs to web. (Bridge N° 2, Monkwearmouth Goods Branch).

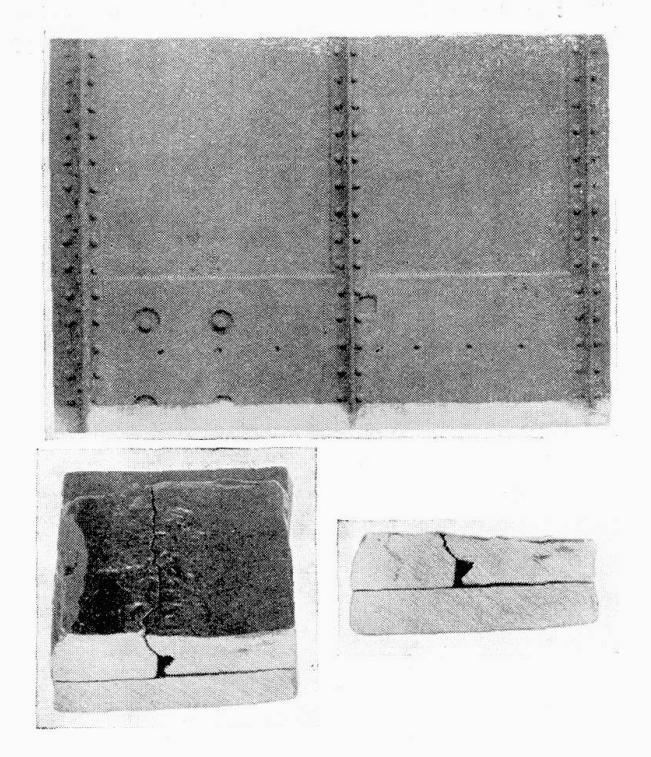
Fig. 5.

Schnitt durch die gerissene Schweißung. Coupe à travers la soudure rompue. Section of fractured weld.

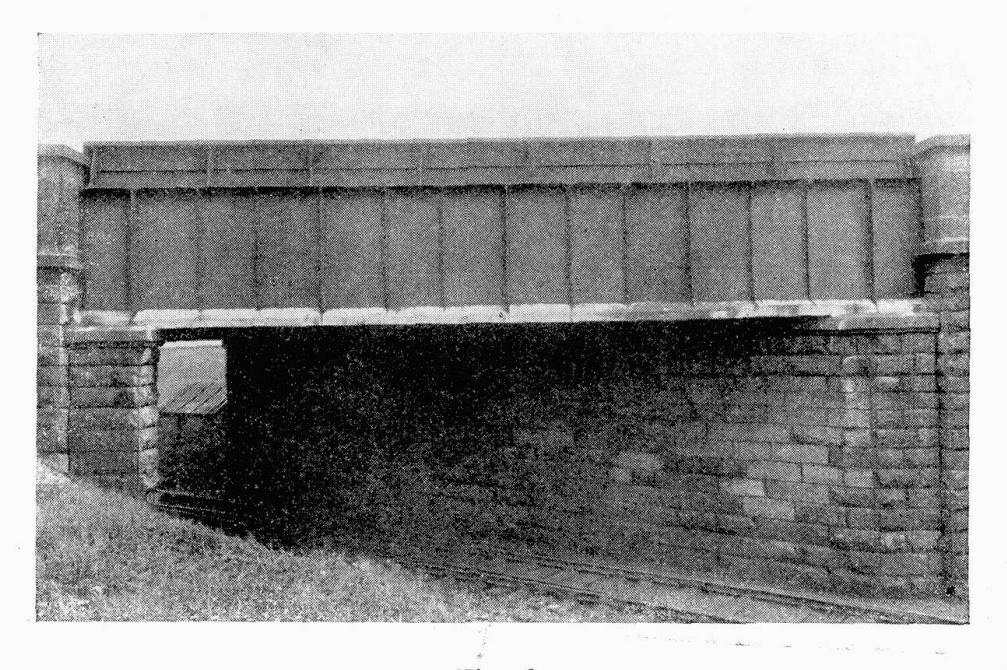
amperage than normal, which in the case of so light a run is not likely to overheat the mild steel. Fig. 6 shows the repaired girder with removed section (Fig. 5) which was not replaced, the hole was merely fillet welded round the edges as there was ample section left for strength. The bottom flange, which the photo shows covered with gunite, was badly wasted by blast from engines, had new flange plates welded on, but as this work was perfectly successful it does not concern us at present.

Fig. 6. Träger mit repariertem Stegblech. — Poutres dont l'âme est réparée. Girder showing repaired web.

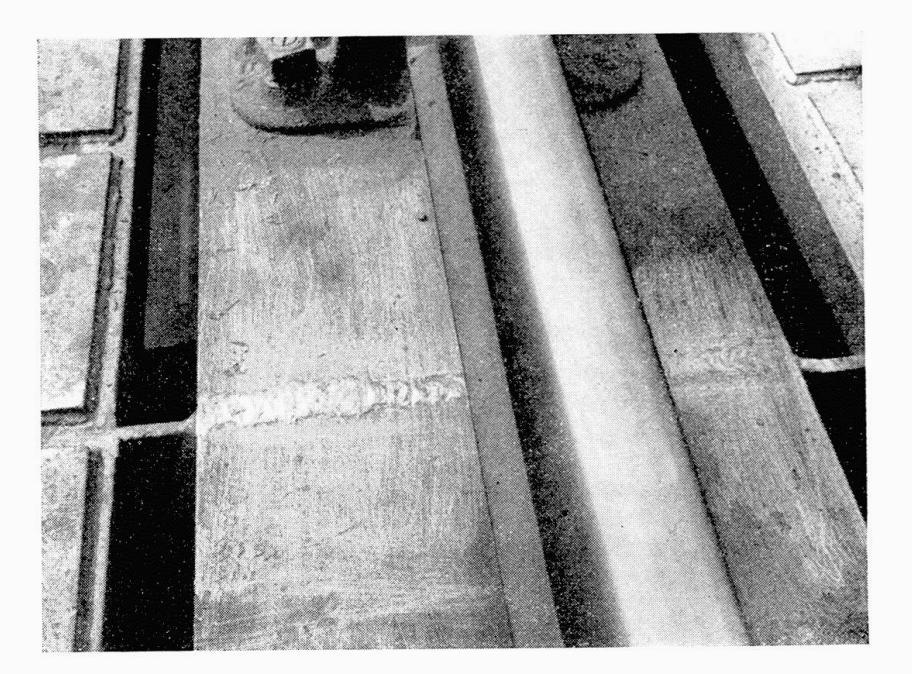
### Fig. 7.

Another failure of similar nature was the fracturing of the butt weld between two channel way beams, of construction as shown in Fig. 7.

The gap intended to be 1/16'' wide was somewhat wider when fitted and to expedite the work two welders were put on to make the weld. One of the

men had advanced further than the other when they left off for a meal, when shortly afterwards the weld fractured with a loud report. The weld after all the old weld metal had been removed and the butt prepared afresh was rewelded by one man commencing at the centre, working slowly without unduly heating the channels, as it was thought that the unequal and rapid cooling off of the overheated weld had been the cause of the fracture. As this, as well as all the other welds of this construction, all have remained perfect, it is clear, that butt welds of free ended sections must not be allowed to become too hot when being run.

Stumpfschweißung an Längsträger (Schienenträger). (Brücke No. 41, Denaby Linie). Soudure bout à bout des longerons (sous les rails). (Pont n° 41 de la ligne Denaby). Butt weld of way beam. (Bridge No. 41 Denaby Branch).

As will be seen the rails and chairs were bolted to the webs of the steel channels, which again were welded to rolled steel beams resting on the top flanges of the old rail bearers to which they in turn were welded. At each cross girder gusset plates were welded to the vertical channel flanges and to the top flange plates of the cross girders, for the purpose of taking up any side sway of the steel way beams (consisting of the rolled steel beam and the channel). Two of these gussets at one end of the bridge, where there is a switch, have fractured. The position of the fractures are indicated on Fig. 7 and on the photograph of the bridge end, Fig. 9.

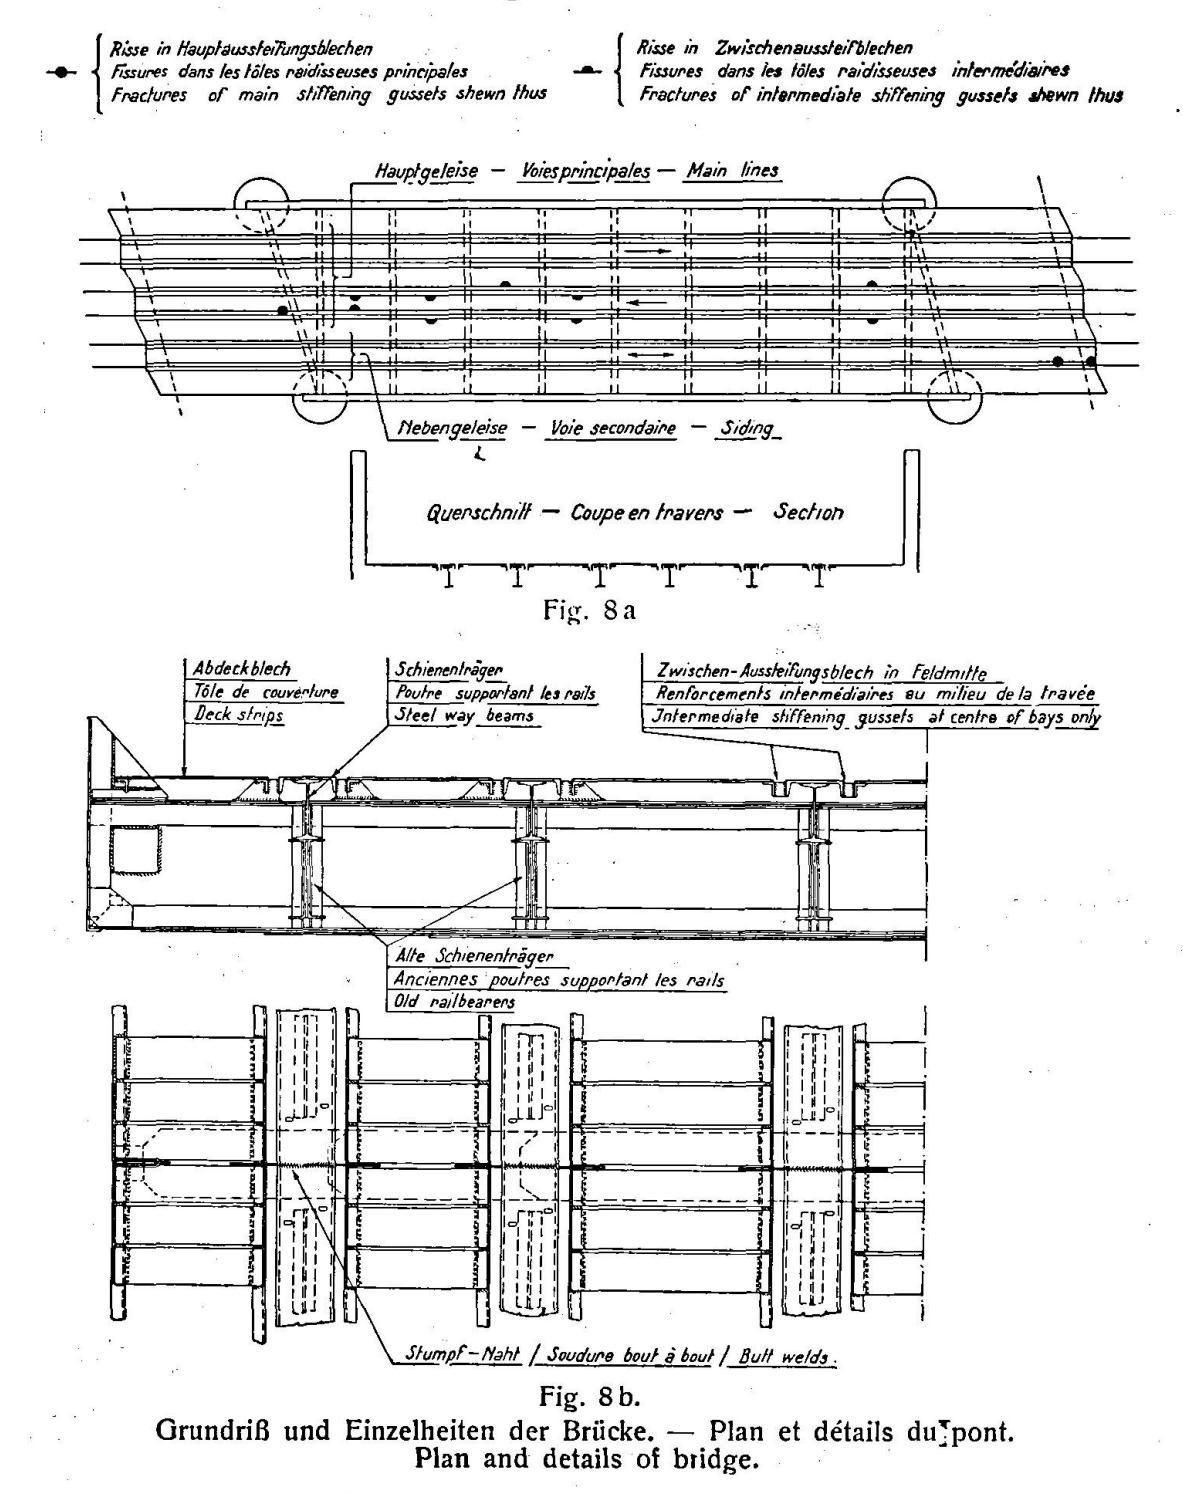
The welded work in question comprised the connections of a welded way beam, illustrated in Fig. 7, further details are shown in Fig. 8.

Similar fractures have also developed where some small tie plates have been welded on to the way beam channels, for the purpose of adding support to the angles carrying the deck strips, the ties being welded on between the deck angles and the channel flanges along four of the channels (see Fig. 8). These ties also take up some side sway of the way beams. Of 348 welds (two to each tie) 10 have fractured, probably due to shock, as they fractured shortly after the centre track, where they were located, was brought into use. On close examination of the fractures it has been found that the welds are all indifferently

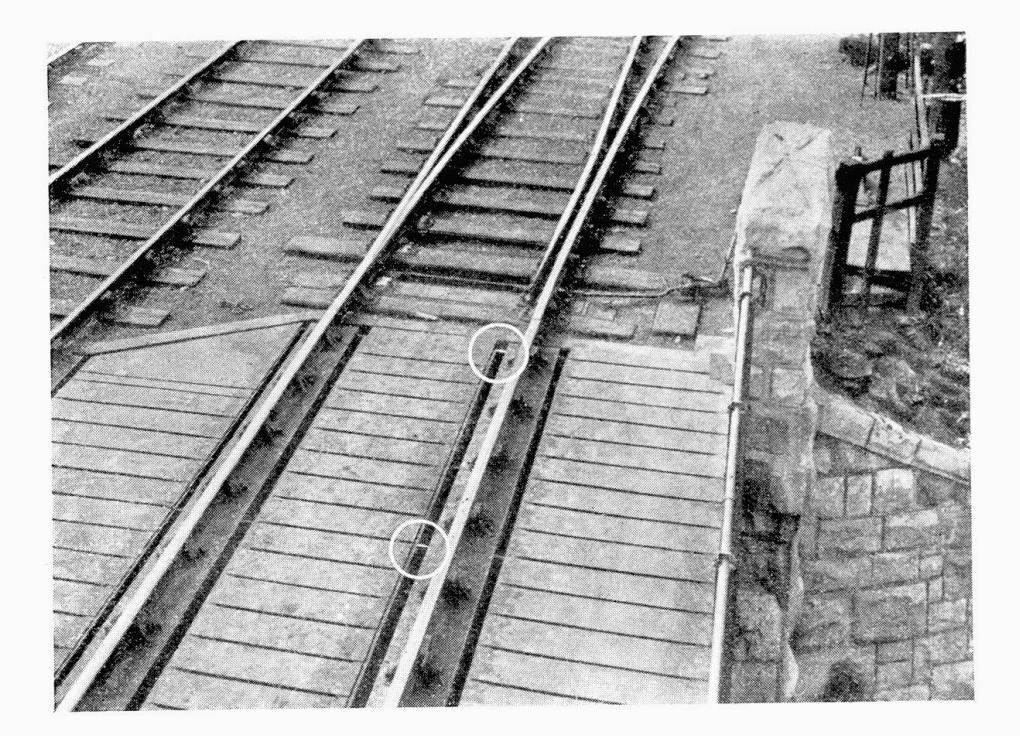
As will be noted the position of the fractured gussets occur on the convex side of the curve, where tension will be produced through the rigidity of the wheel base of engine counteracting the centrifugal action. A close up photograph of the fracture is shown in Fig. 10.

Fig. 9. Brückenende und Weiche. Lage der Risse. Extrémité du pont et aiguille. Emplacement des fissures. Bridge end and switch. Position of fractures.

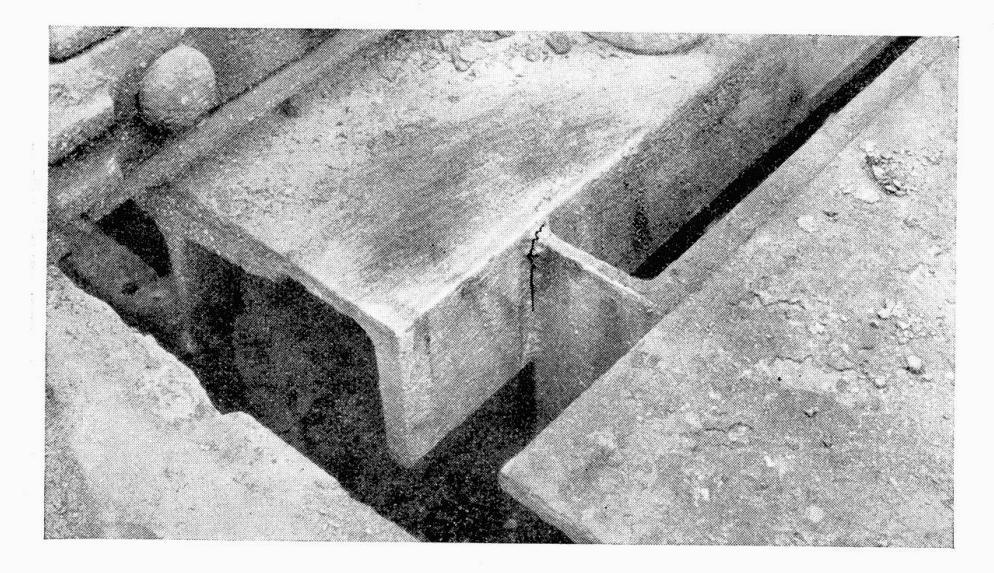
Fig. 10. Gerissenes Knotenblech. — Tôle fissurée d'un gousset. — Fractured gusset.

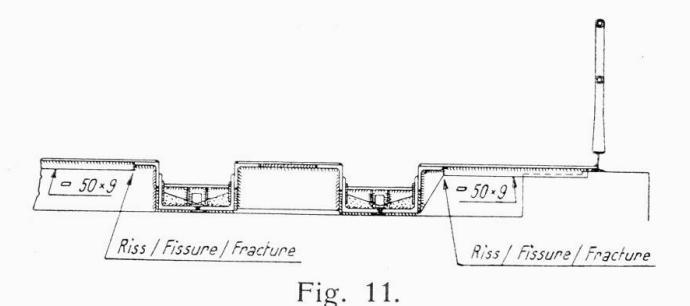
The bridge shown in Fig. 11 has a steel deck which is stiffened with  $2'' \times 3/8''$  flats on edge. Besides these there are transverse diaphragms between the two sets of troughs. When erected it was found that the brick abutments

Halber Schnitt durch die Brücke. (Brücke No. 25, York und Doncaster). Demi-coupe à travers le pont. (Pont nº 25, York et Doncaster). Half section through bridge. (Bridge Nº 25, York and Doncaster).

As mentioned above the bridge carries two separate main lines, and is therefore very busy, the average number of trains per 24 hours being 250 representing about  $5\frac{1}{2}$  million stress variations annually, the traffic being about the same in both directions. Under these circumstances it will be realised that the enormous frequency of stress reversals which occur will tend to produce fatigue effects in parts unduly stressed. From the construction it will be appreciated that severe stresses must be set up in the transverse stiffeners of the deck plates duo to such unequal deflections, which are enhanced by the settlement of the bedstones. The welds connecting the deck plates and the  $2'' \times 3/8''$  stiffeners are not very large and even normally they are rather heavily stressed, with the consequence that 19 out of 20 have fractured.

heavy steel grillages embedded in concrete are now always provided. These grillages are most carefully and truly set, so as to reduce unequal settlement of adjoining troughs to a minimum. In addition to the grillages the stiffeners for the deck plates are not carried through and welded to the flanges, thereby permitting the deck plates to flexure and so give a little play which absorbs unequal deflections.

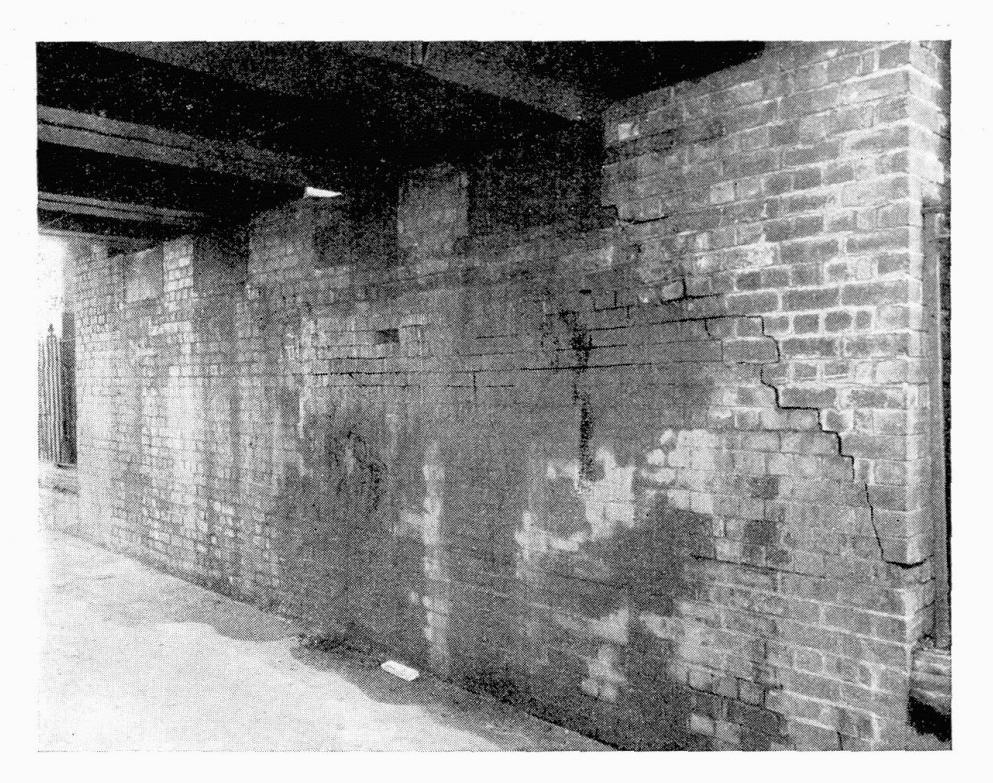
when bared were not very good, showing fractures below the bedstones on which the troughs would be seated. The bedstones were carefully levelled before the girders were erected on them, but possibly owing to the more rigid construction and absence of cushioning due to steel bearers instead of timber way beams in the troughs, the fractures in the abutments increased and caused unequal depression of the girder ends which set up transverse bending moments

Fig. 12. Gerissenes Widerlager. — Culée fissurée. — Fractured abutment.

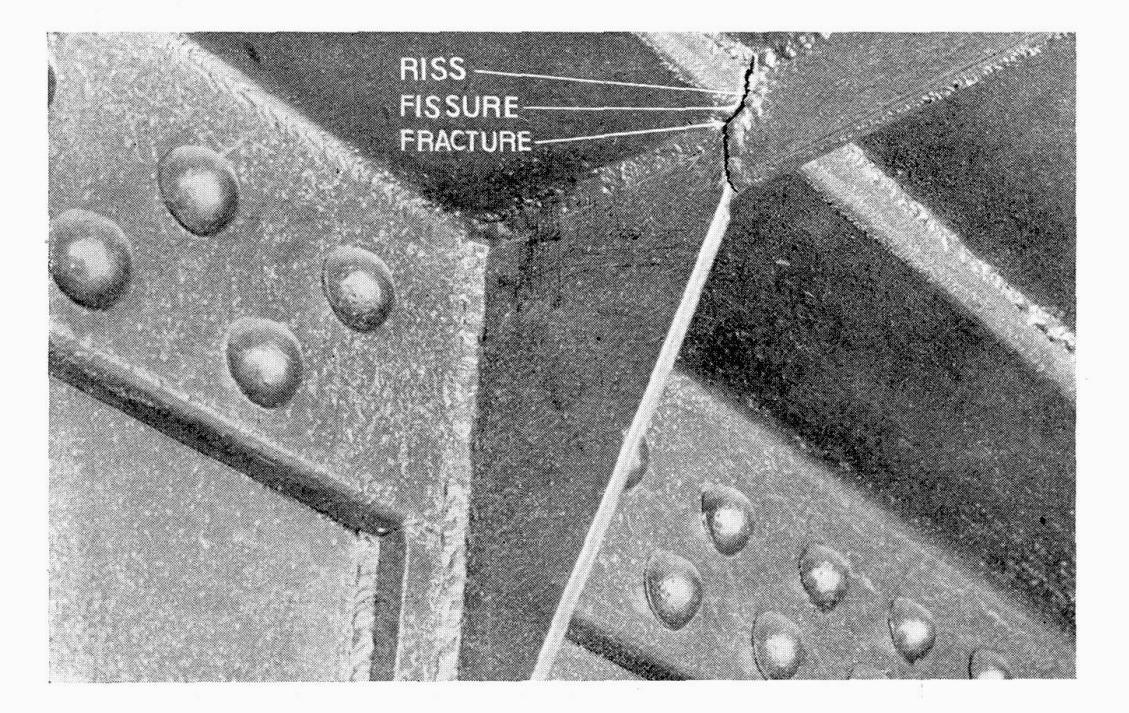
Fig. 13. Gerissene Schweißung. — Soudure fissurée. — Fractured weld.
