STRUCTURAL BEHAVIOUR OF THE DAMAGED BUILDING DURING THE FRIULI EARTHQUAKES BETWEEN MAY $\acute{0}$ AND SEPTEMBER 15, 1976

by Ewald Heimgartner, Structural Engineer ETHZ/SIA BASLER & HOFMANN Consulting Engineers and Planners CH - 8029 Zurich, Switzerland

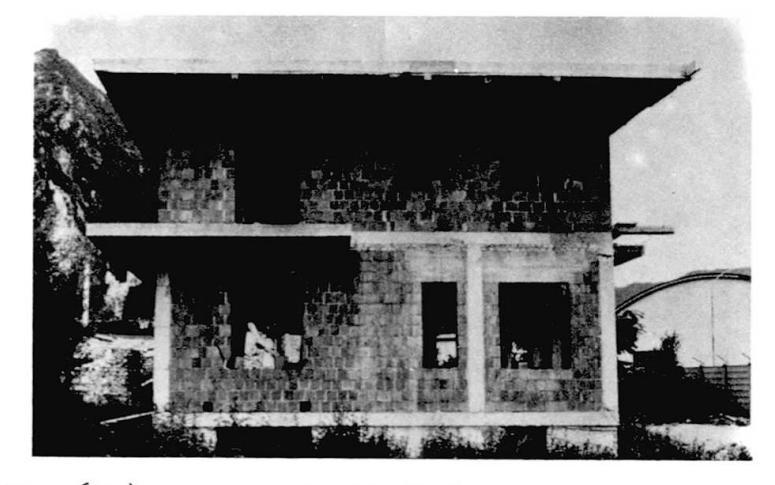
Figure 1: (after May 6th): Uncompleted building in Gemona with groundfloor open on three sides and living floor above. The supporting framework of the groundfloor consists of reinforced concrete columns, partitioned on one of the narrow sides by brick walls. The upper floor is exclusively brick. Due to the ear hquake load, the building rotated around the partitioned transverse wall in the groundfloor. The fixing points of the columns were badly damaged in the cellar and groundfloor ceilings. The brick walls on the transverse side on the groundfloor were slighthly cracked: the upper floor remained undamaged.

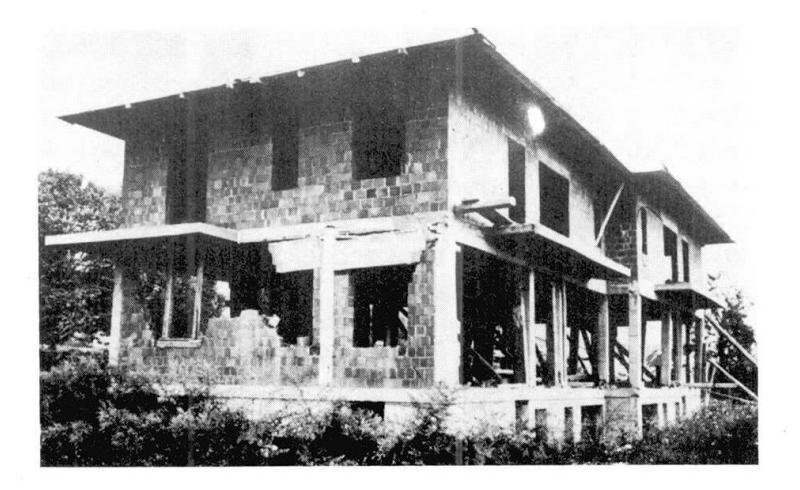
Figure 2: (after September 15th): Uncompleted building in Gemona after renewed earthquake stress. The reinforced concrete columns in the groundfloor were completely destroyed at their fixing points, connection being maintained by the reinforcement only. The massive wooden struts in the groundfloor saved the building from colapse during the second strong earthquake. The already damaged brick wall in the groundfloor was additionally strained due to the strenghtening effect of the wooden struts in the open groundfloor area. The wide brick window jamb was broken out and the reinforced concrete window supports shaken from their rests.

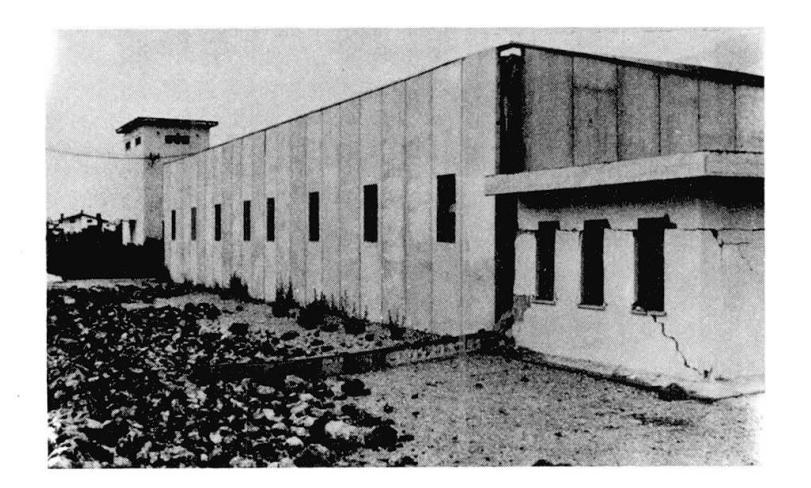
Figure 3: (after May 6th): Prefabricated shed with brick annex in Gemona. The supporting framework of the shed is undamaged. The concrete elements of the side wall, on the other hand, were slightly caved in by the impact of the rigid annex. The plastic material of the wall joints was torn by the large deformation. The roof of the annex was shorn off and pushed over at window level by the impulse load of the impact due to insufficiently wide joints.

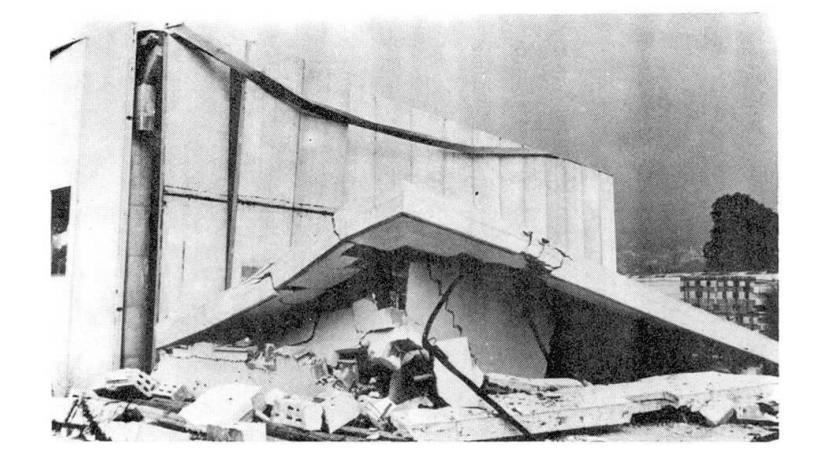
Figure 4: (after September 15th): Prefabricated shed with collapsed annex. The renewed earthquake load caused damage of the supporting framework of the shed at the fixing points of the columns and rests of the bars. The façade slabs of the side wall were severely caved in by the renewed impact: the annex itself collapsed. The increased displacement, as compared with the first earthquake, can be traced back to the reduced structural rigidity due to the destruction of one of the concrete block walls.

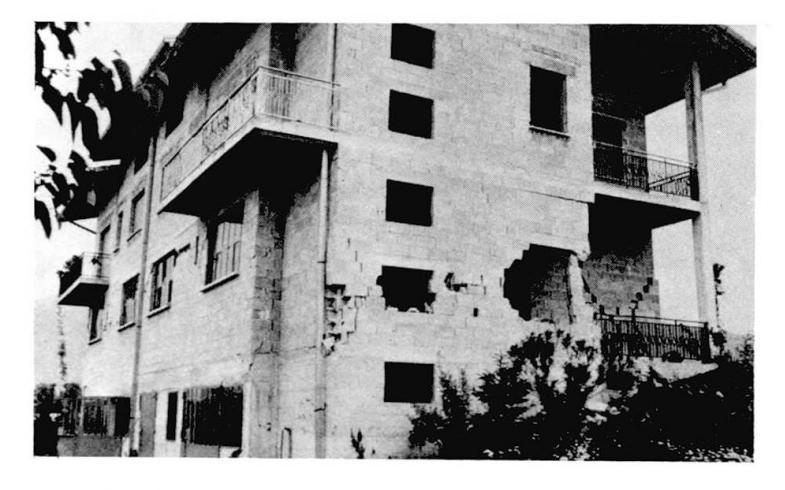
Figure 5: (after May 6th): Residential building with workshop near Artegna with a reinforced concrete cellar and two floors in concrete blocks. The side walls by the entrance incurred gaping X-shaped diagonal cracks due to the high shear stress. These cracks led to partial collapse of the masonry. The highly strained window jambs on the longitudinal façade were badly cracked.

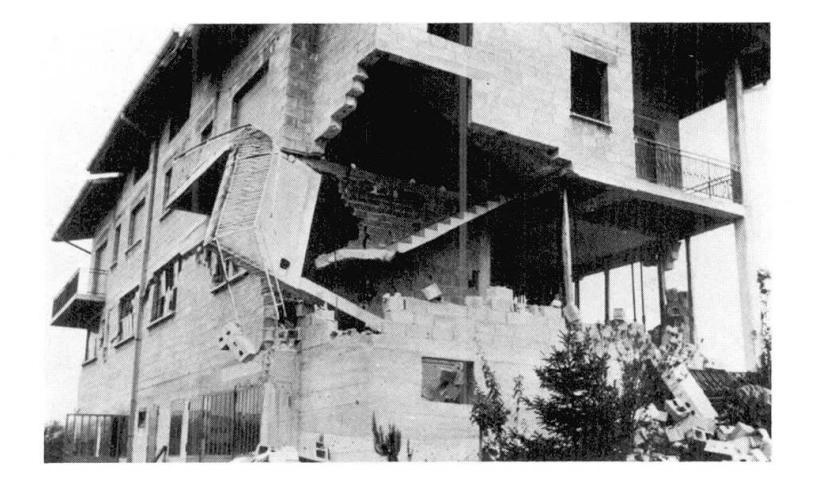
Figure 6: (after September 15th: Residential building with workshop near Artegna after renewed earthquake stress. The side wall in the middle floor collapsed under further earthquake load. The door and window jambs on the longitudinal walls shattered and partially collapsed. The shear resistance of these concrete block walls was minimal due to failure of the mortar joints to prevent the layers from shifting.

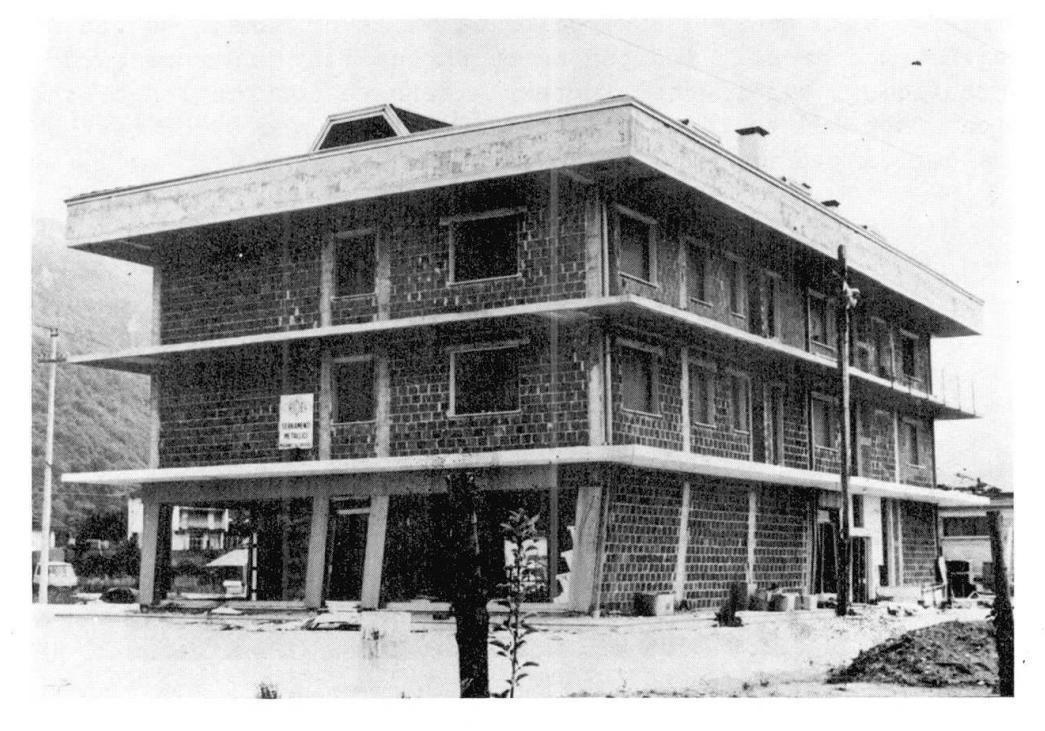
Figure 7: (after May 6th): Residential building with shop near Artegna. Reinforced concrete frame building with brick partitioning in the two upper storeys In the groundfloor, open on three sides, only the rear longitudinal wall and the staircase are braced. The destruction was concentrated on the groundfloor were a rotating motion of approximately 40 cm maximum displacement occured around the staircase core. The brick walls of the staircase were badly destroyed, while those of the upper floors remained undamaged.

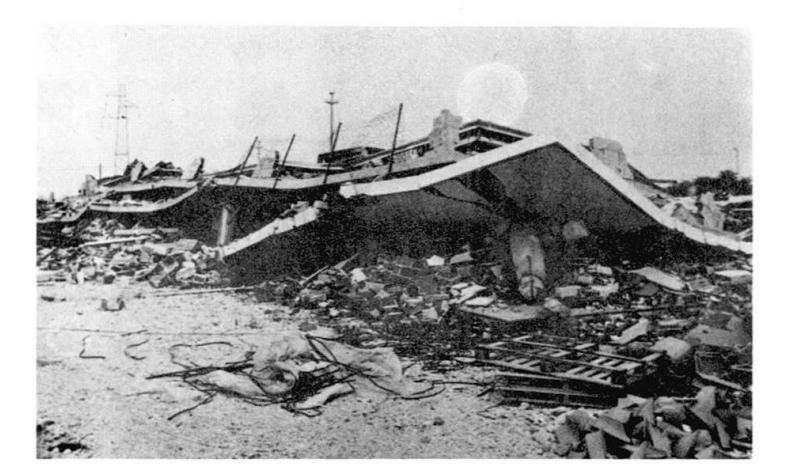
Figure 8: (after September 15th): Wreckage of the residential and business house near Artegna. The groundfloor of the building collapsed during the earthquake of September 11th. Through the impact, the undamaged living storeys also collapsed. The destroyed fixing points of the reinforced concrete columns in the groundfloor as well as the cracked brick walls of the staircase were not enough to carry the renewed strong earthquake stress. The experts had hoped, despite the doubts of the owner, to be able to repair the building.

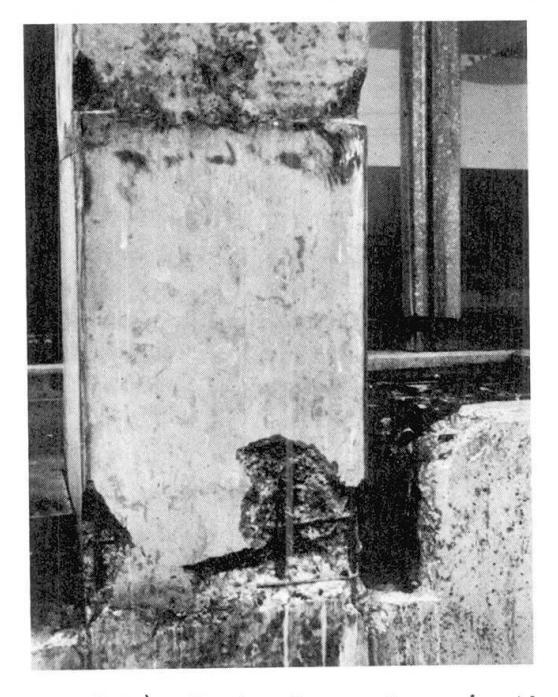
Figure 9: (after September 15th): Foot of a column in the Fantoni furniture factory in Rivoli di Osoppo. By repairing the cracked column foot it was hoped to restore the original carrying capacity. The renewed earthquake load caused the same damage as the first shock, the repaired fixing points of the columns were again cracked and the concrete crumbled in the most highly stressed areas.

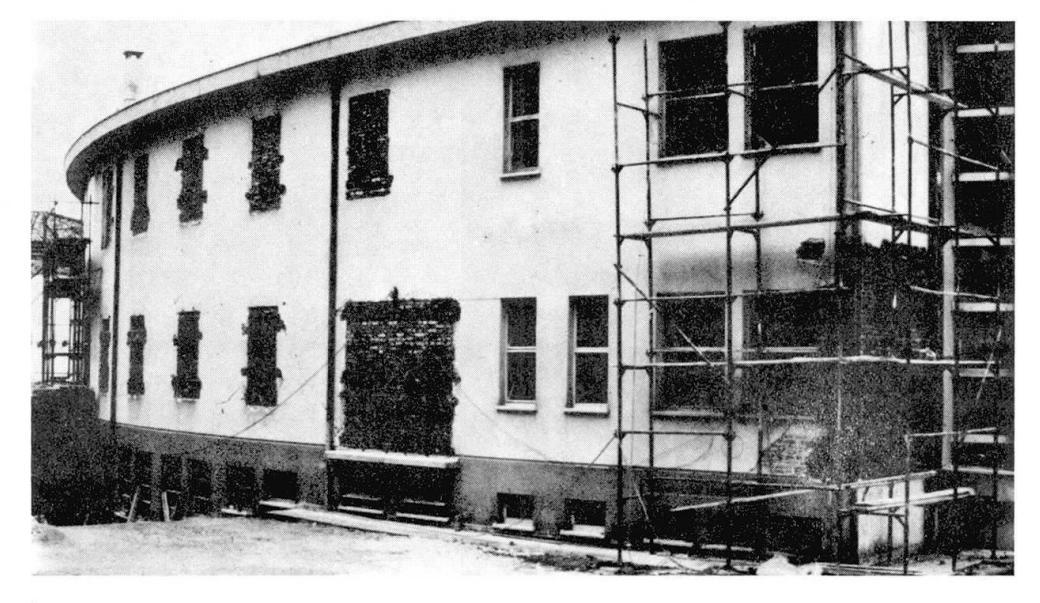
Figure 10: (after September 15th): Business building SBUELZ in Tricesimo. To strengthen the carrying capacity, the door and window openings were walled in. The vibration behaviour of the building was so improved that, during renewed earthquake stress hardly any further damage occured as opposed to the destruction which occured during the earthquake of May 6th.

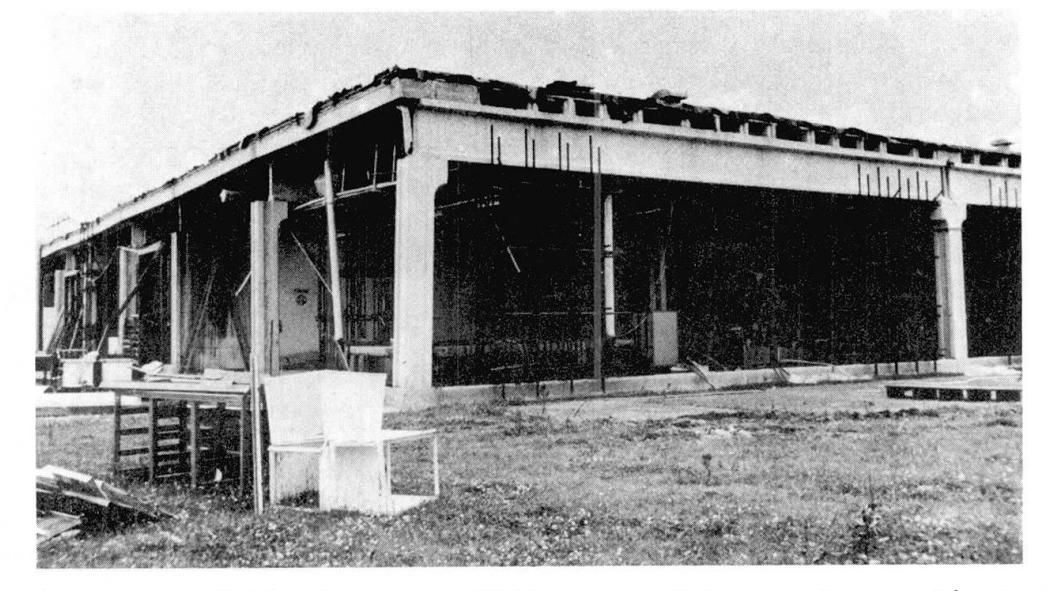
Figure 11: (after May 6th): Factory building near Artegna. Severe displacement of the prefabricated reinforced concrete framework together with distortion of the foundation and tilting of a corner column. A large number of the only lightly secured reinforced concrete façade elements were thrown off.

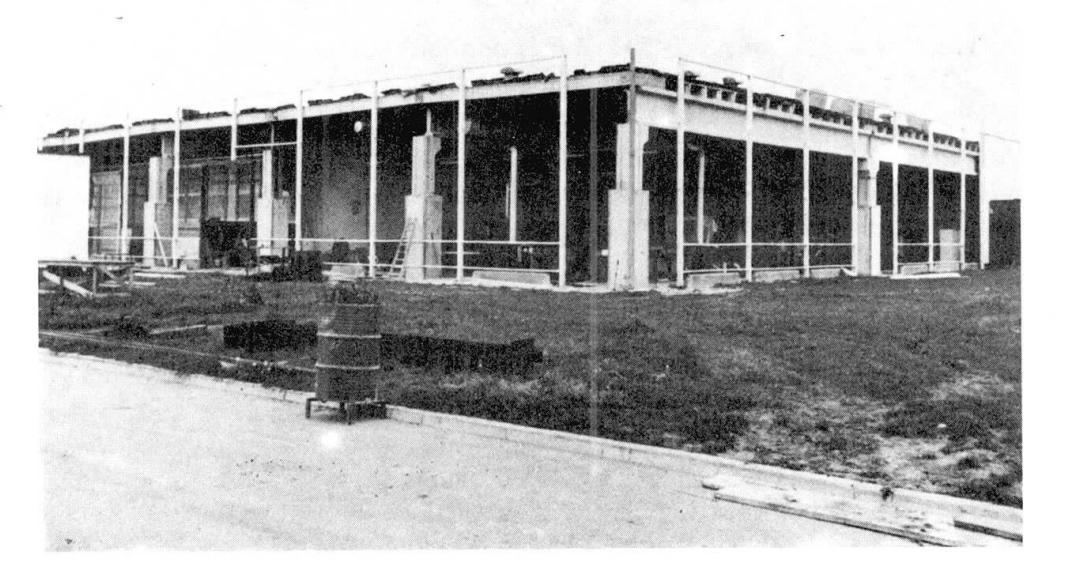
Figure 12: (after September 15th): Factory building near Artegna, after repair, without further earthquake damage. In order to increase the carrying capacity, the concrete columns were surrounded with a 15 cm strong concrete sheath. The earthquake load was reduced by replacing the heavy concrete façade elements by a Tight metal façade.

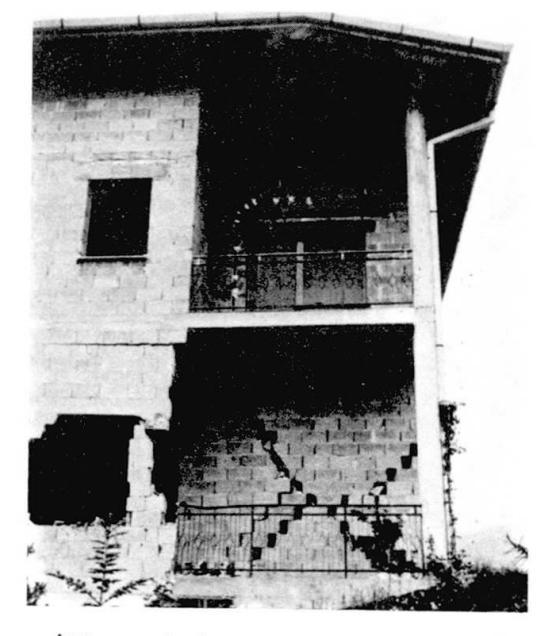
Figure 13: Dwelling house with workshop near Artegna. Basement in reinforced concrete and the upper stories in masoning without framing. Typical diagonal cross cracks in a wall of the ground floor.

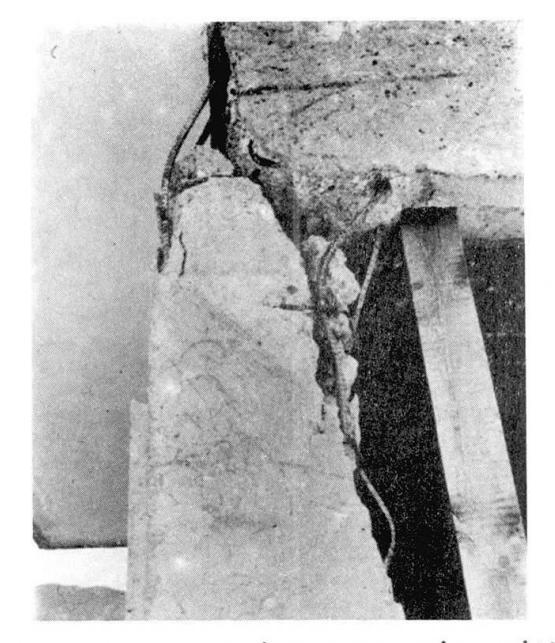
Figure 14: Shearing-off of a column at its connection with the crossbrain due to insufficient stirrups.

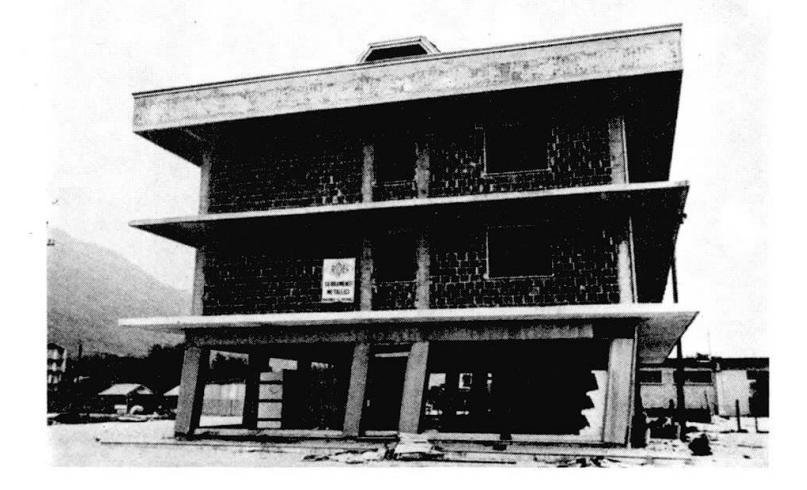
Figure 15:

Three-storey dwelling house with shop in the ground floor near Artegna. Reinforced concrete frame with brick partitioning walls in the upper floors and mostly open ground floor. Plastic hinges at bottom and top of the ground floor reinforced concrete columns caused large deformations. No damage in the upper floors.

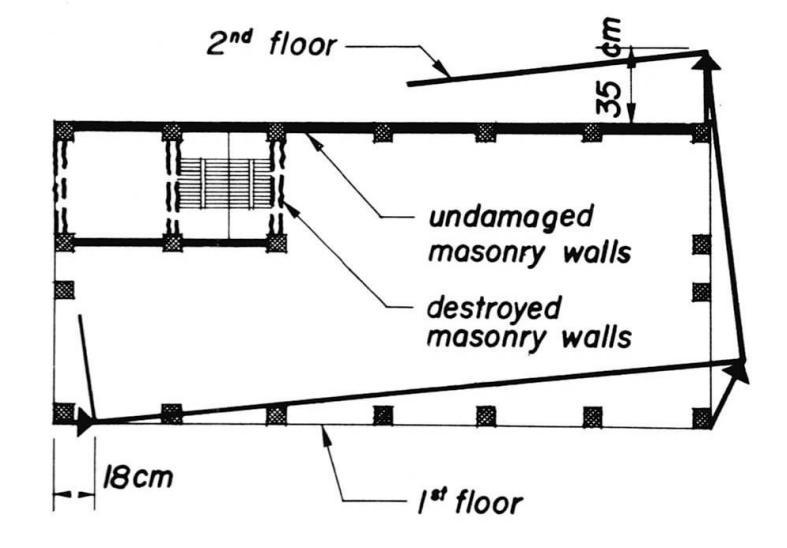
The ground plan of the dwelling house with the open ground floor shown before. Twisting of the building around the staircase stiffened with masonry walls.

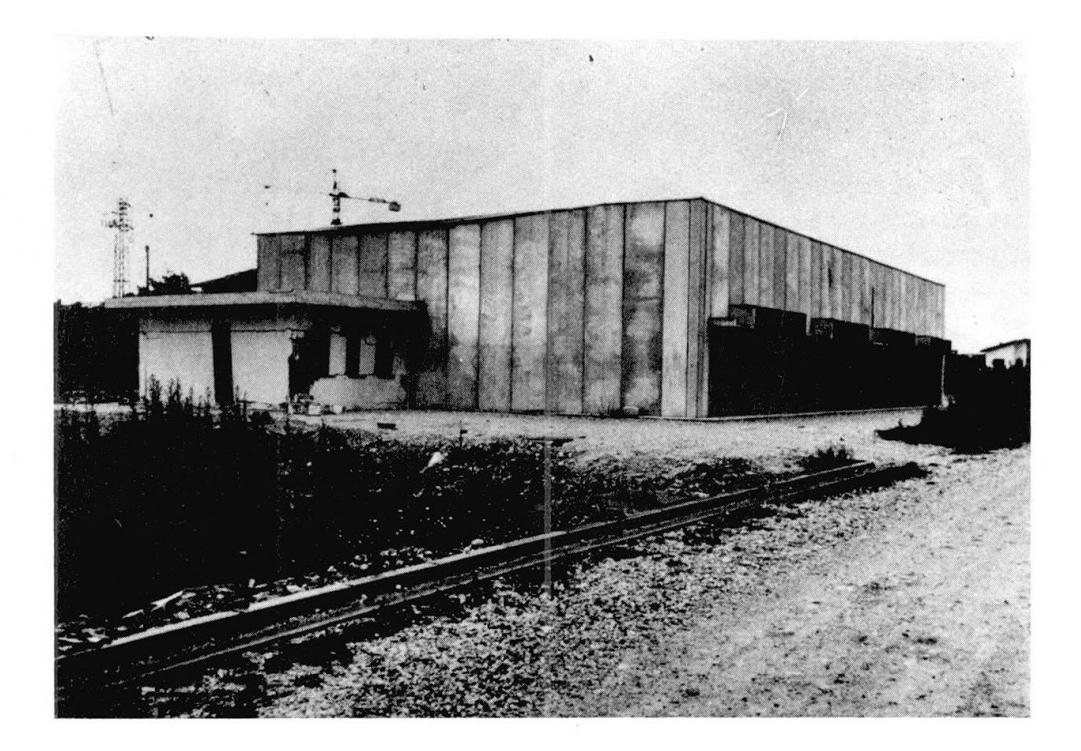
Figure 16: Prefabricated storage shed with brick annex in Gemona. Side wall panels slightly caved in by impact with rigid annex. Upper part of the annex shorn off and pushed over by the impact force due to insufficiently wide joints.

This problem can be overcome by arranging the joints as to divide the structure into sections, each with its own clearly distinct vibration behaviour. The joints should be made adequately wide since numerous uncertainties make an exact calculation impossible. It must be taken into consideration that, for example, the deformation usually provided for in a homogenous supporting structure can turn out to be considerably larger due to the formation of cracks or plastification. An adequate freedom of movement, therefore, allows for greater plastification and a larger capacity to carry earthquake stress.

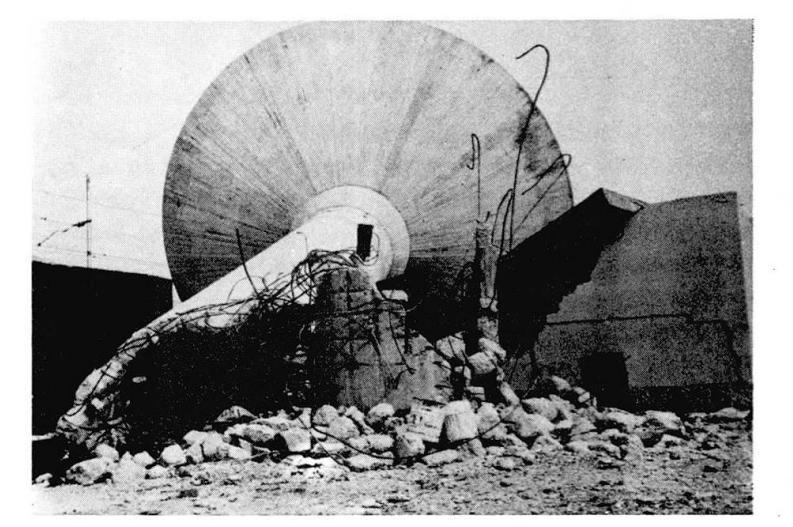
Figure 17: Overturned water tower belonging to the Italian State Railways in Gemona station. Foot of the shaft completely destroyed and concrete shattered.

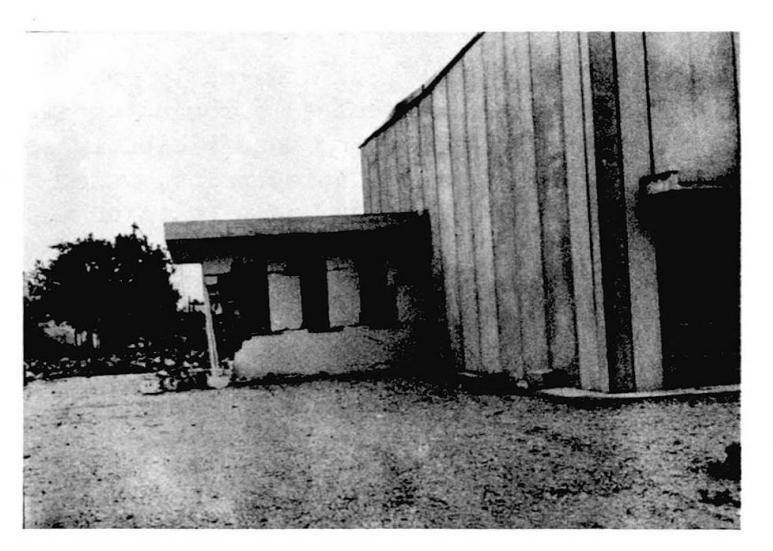
Figure 18: Prefabricated storage shed in Gemona as shown before. The supporting frames and the wall panels generally not damaged because of energy absorption in the material of the joints between the single panels.

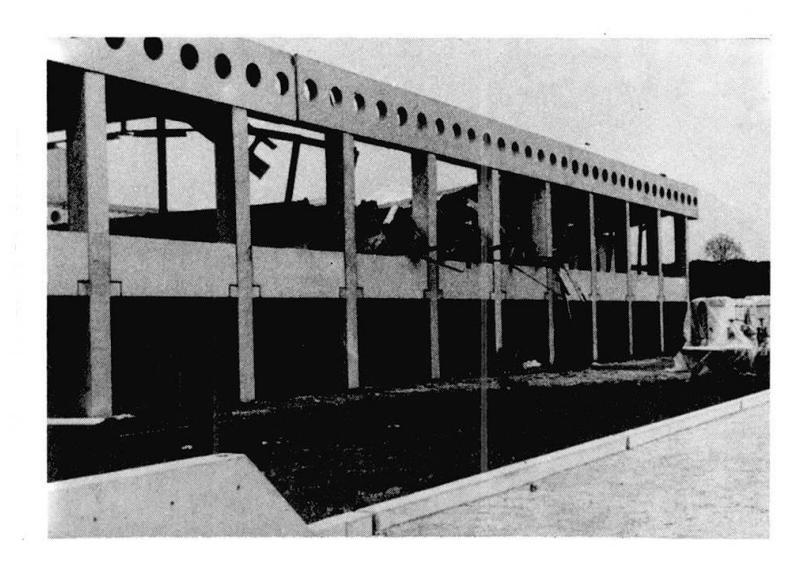
Figure 19: Heavily damaged prefabricated factory shed near Osoppo with roof girders fallen down. Friction joints insufficient to provide structural stability.

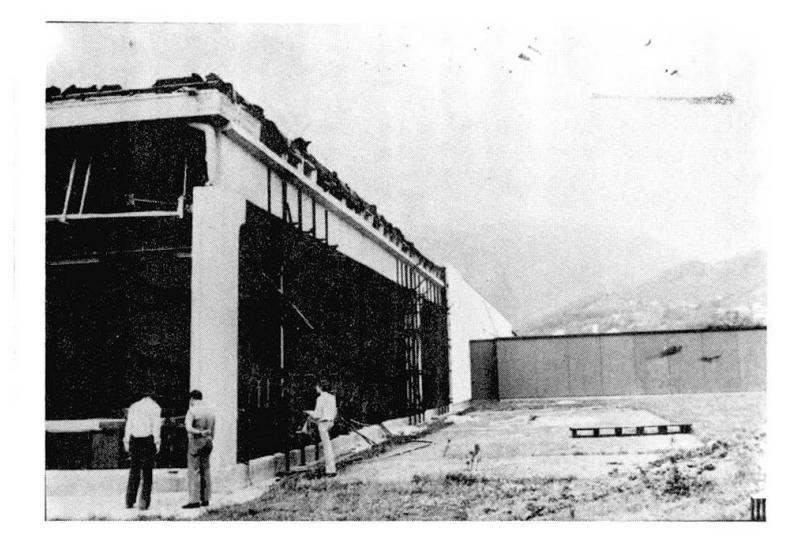
Figure 20: Prefabricated factory shed near Artegna. Wall panels fallen out during the earthquake because of insufficient fixation.
