QUANTITATIVE APPRAISAL OF DESTRUCTIVE EARTHQUAKES

by Dimitri Papastamatiou - Senior Engineer

This presentation is concerned with direct correlations of the field measurements with damage on engineering structures. The first part is a discussion of the set of simple structures that have the characteristics of field indicators. In the second part correlations are indicated between the field measurements and the inflicted damage. All the illustrations were obtained in the epicentral region of the May 6, 1976 Friuli earthquake.

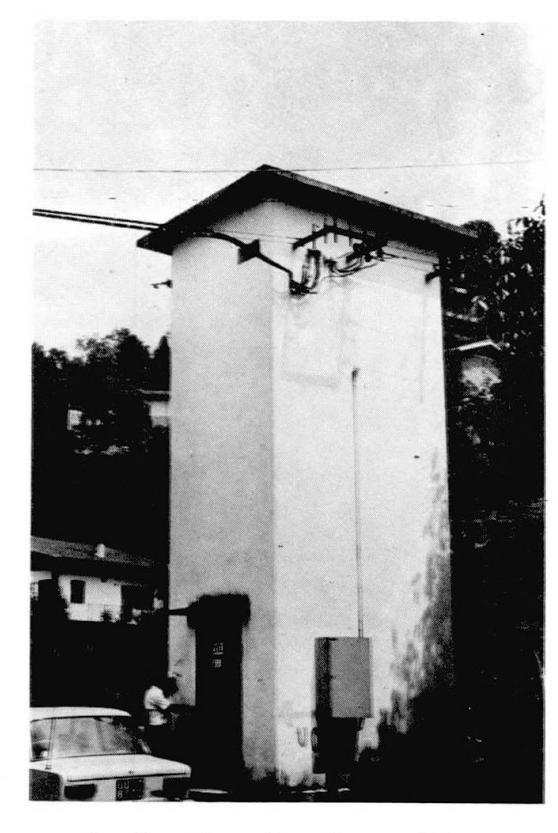
Fig 2. Distribution cabin at Bilerio.

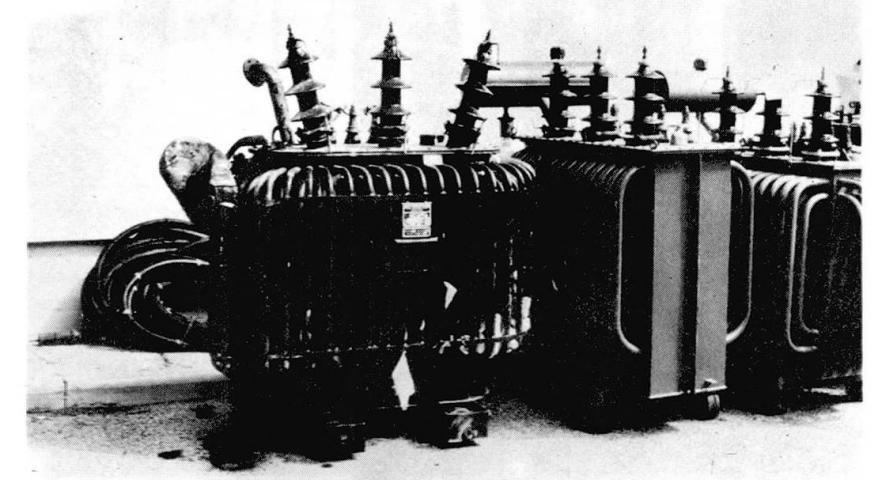
Fig 1. Damaged and new distribution transformers.

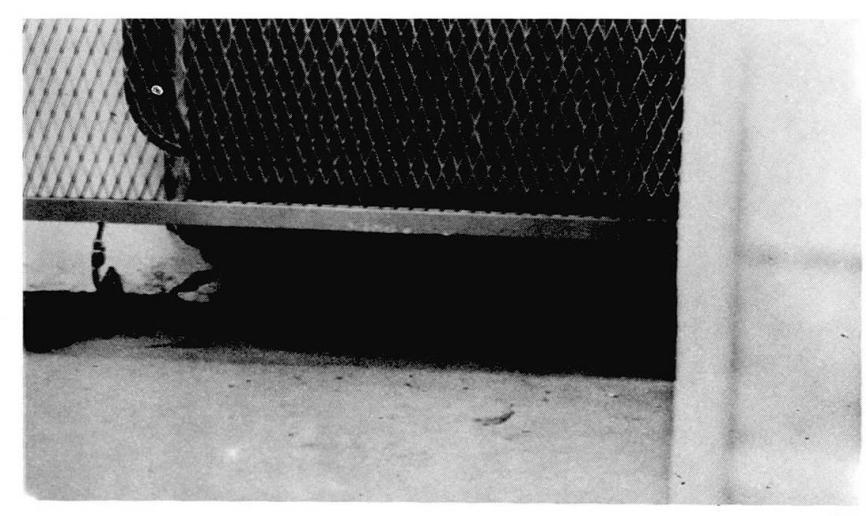
Fig 3. The transformer inside the cabin has moved during the earthquake; one of the back wheels fell into the oil drainage well.

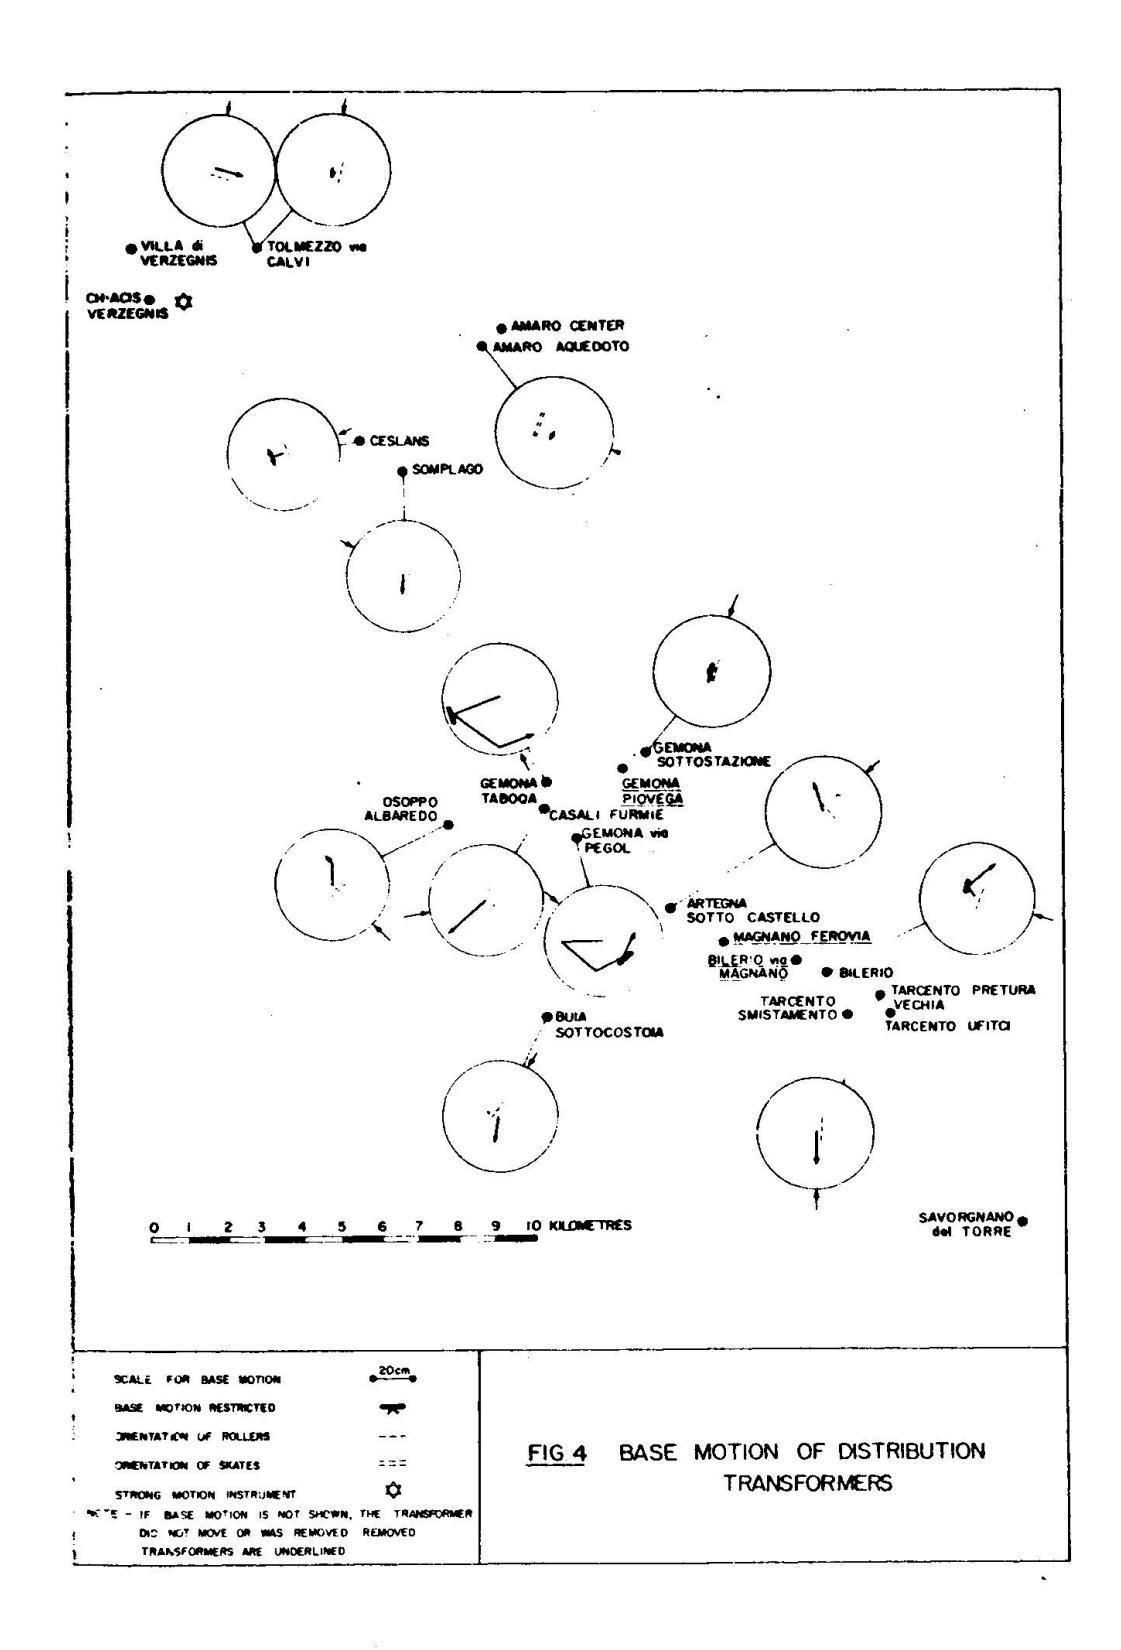
Field measurements in the epicentral area of the May 6, 1976 earthquake were restricted in a zone running NW-SE The slip vectors of the transformers that were studied in this zone are shown on Fig. 4. The transformers at the NW end of the zone surround the nearest strong motion instrument that recorded the main shock at Diga de 1' Ambiesta. The measurements have been described elsewhere (1,2). The transformers, in general, moved in a N-S direction. Exceptions were found on recent alluvium where motion was in both directions. Displacements were also larger on recent alluvium.

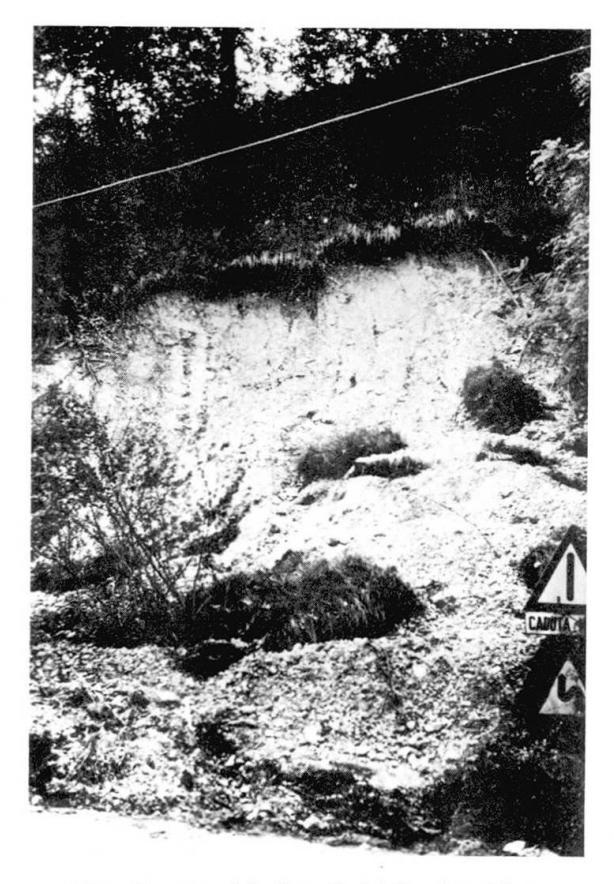
Natural slopes were unstable enough to be triggered by relatively small horizontal dislocations. Of special interest were small landslides, like the one by the road at Cornino (Figure 5); similar landslides might have been responsible for foundation failures in the badly hit villages on alluvial slopes.

Fig 5. Small landslide by the road at Cornino.

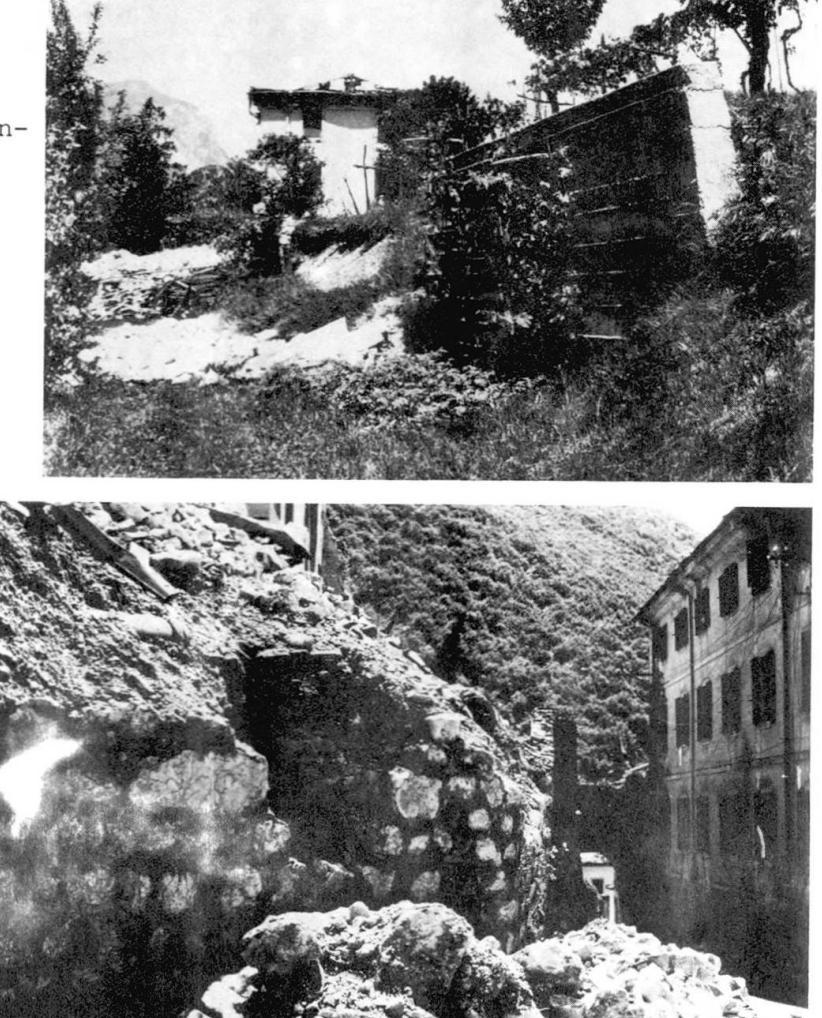
Fig 6. Failure of masonry retaining wall at Gemona.

Fig. 7. Duomo Gemona; Failure of the retaining wall.

large as in the valley. The slip vectors, however, were large enough to cause the failure of retaining walls. Figure 6 was taken from Gemona. The low strength masonry wall could not resist the slip vector as did the concrete wall sitting next to it.

Figure 7 shows the failure of the retaining wall at Duomo, Gemona. Was this failure responsible for the collapse of the southern wall of the Duomo?

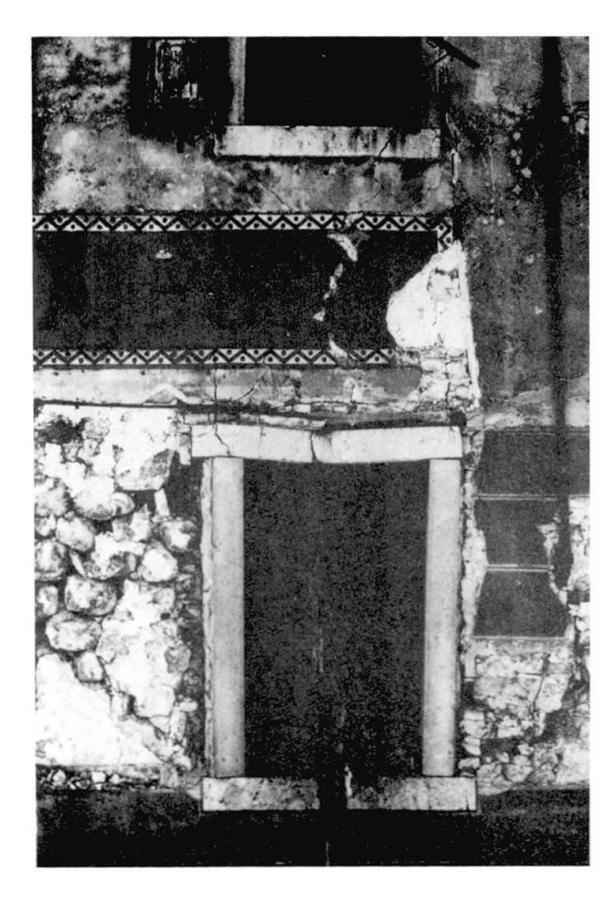
Figure 8 freezes an early stage of collapse of a masonry building at Gemona. This mode of failure looks similar to the failure of the mass behind a retaining wall and indicates that failure was initiated by the large rotations of the window-frame. The same mode of failure could be interepreted as the result of large vertical component of motion. This component of motion, although sensed by the transformers, could not be decoupled from the rocking mode.

Fig. 8 Collapse mechanism of masonry wall at Gemona.

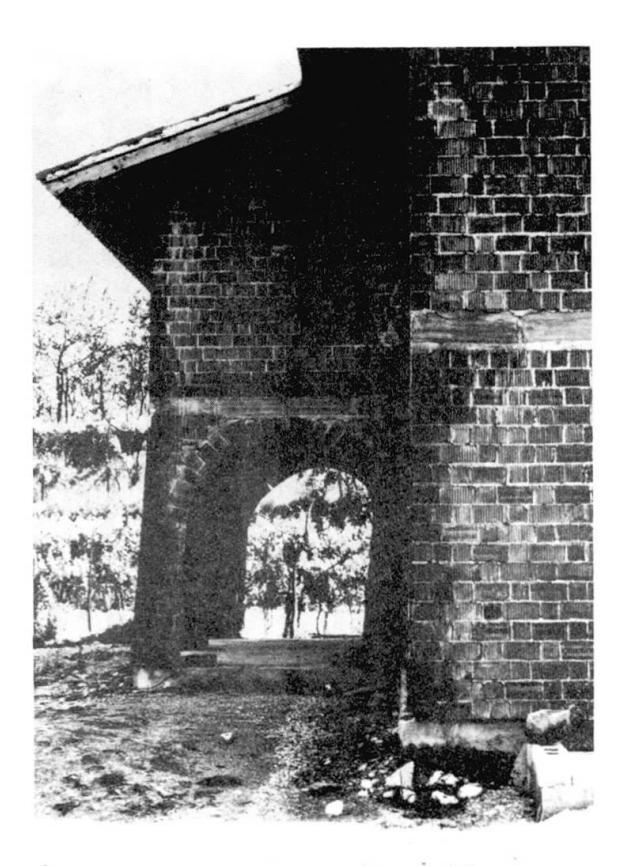
An unfinished brick building in Gemona moved on its concrete foundation like the transformers in the region (Fig. 9).

Fig. 9 Gemona; the building moved back and forth on the concrete base.

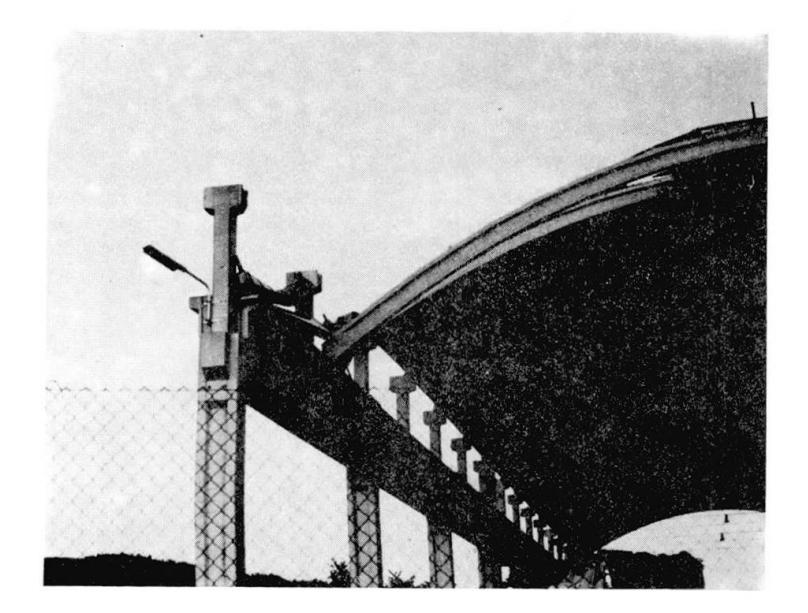
Figure 10 shows the mode of collapse of an industrial hangar. In this case the relatively small slip vector measured on the ground was amplified by the elastic deformation of the column.

Fig. 10 (above) Industrial hangar at Magnano; collapse mechanism.

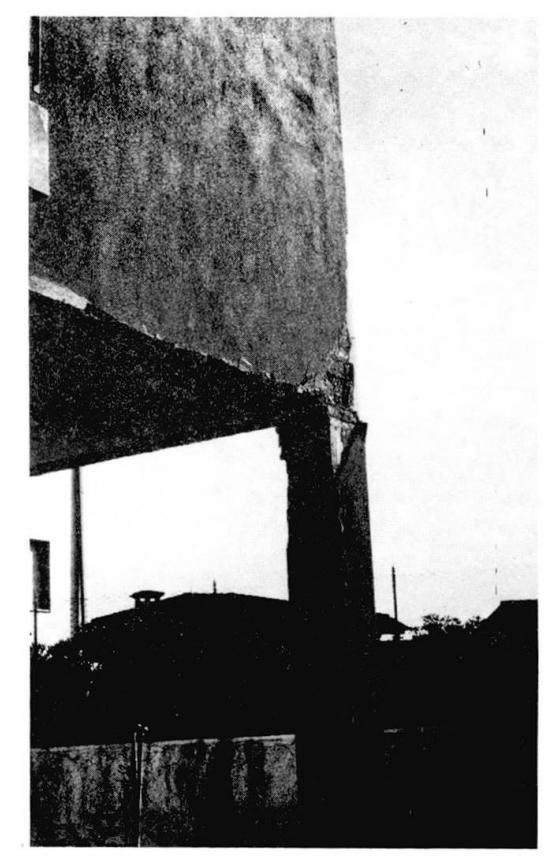
Dislocations along joints in prefabricated buildings may be critical in their earthquake performance as shown on Figure 11. The building is in Majano across the road from another building that collapsed. A variation of the joint strength in one direction could have set up the collapse mechanism.

Fig. 11 (right) Slip at the joint of a prefabricated building at Majano.

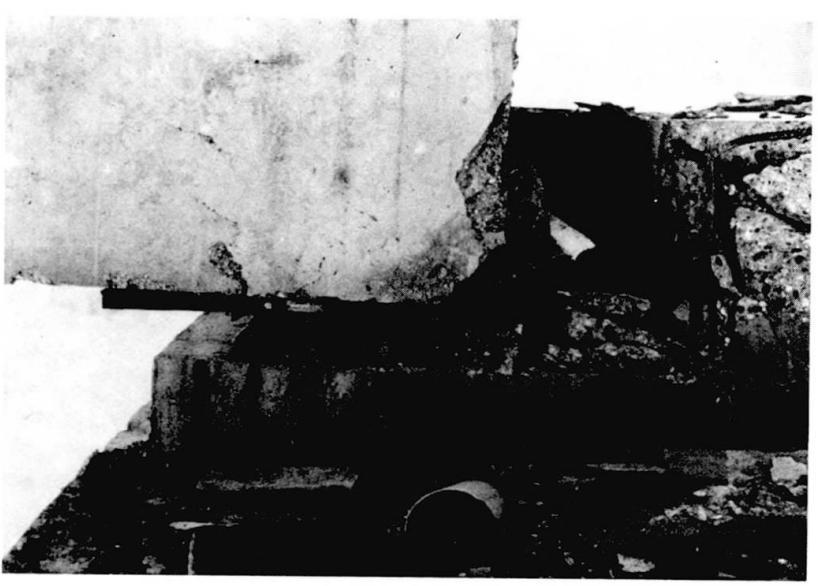
On the recent alluvium the transformers showed large displacements. The same large dislocations could be seen along the supports of the prestressed bridge across the Tagliamento River (Figure 12).

Fig. 12 Prestressed bridge over the Tagliamento River; slip of the supports.
