SESSION III

Construction, Performance, Renewal Construction, performance, rénovation Bau, Bewährung, Erneuerung

Bridges - Construction techniques and methods (concrete and steel)

Ponts — Procédés de construction (béton et acier)

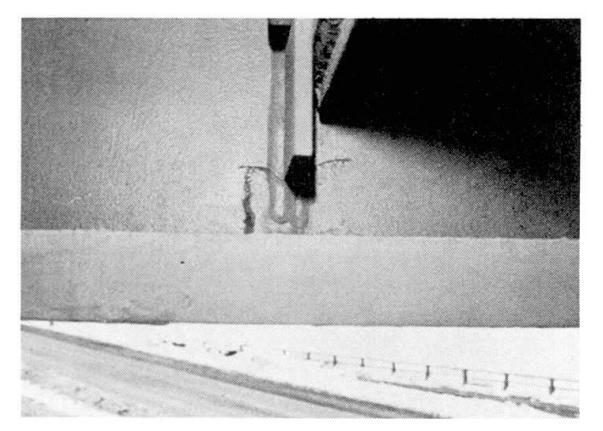
The first group of problems to turn up on our railway on welded structures were cracks at the bottom of stiffeners on skewed structures. Figure 4 is typical of this detail with a diaphragm or brace frame attached to the stiffener. Note that the stiffeners are not extended to the bottom flange. This was in blind obedience to the dictum of an early researcher in welded construction that one should not weld to the tension flange. Because of the stresses introduced by the differential deflections of the connected girders, and to small out-of-plane movements, the first cracks appeared in less than 5 years on heavily travelled lines.

Fig. 4 "U" shape crack

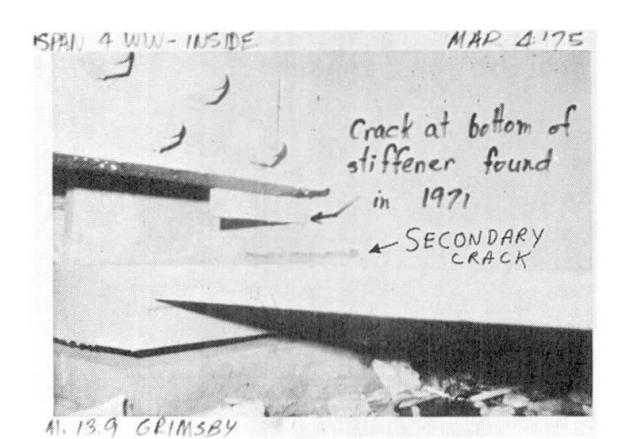
After cracks have occured as described above, the next point of rigidity is between the web and flange. If there is any out-of-the plane of the girder motion, it is only a matter of time before cracks will occur in the web to flange weld below the stiffener (Figure 5). Stopping these cracks is very important.

Fig. 5 Secondary Cracking

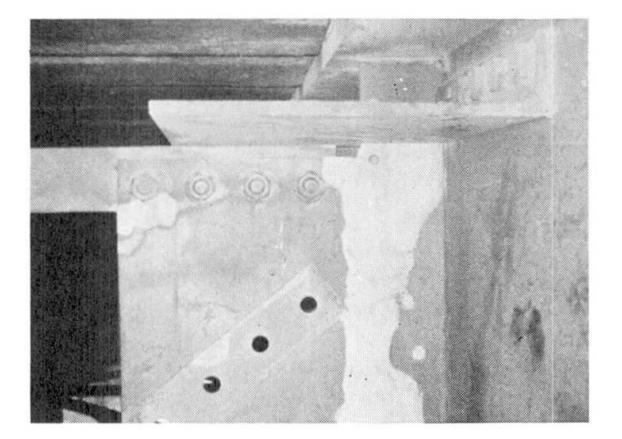
Another detail that has given trouble is the connection of brace frame angles to stiffeners (Figure 6) with the gussets groove welded to the stiffener. Referring to Figure 7, the critical detail has a zero radius. The stress causing crack growth is the lateral force from trains. Since maximum lateral impacts often occur due to hunting (side to side snaking) of empty cars, it took less than five years for these cracks to develop.

Fig. 6 Gusset to Stiffener

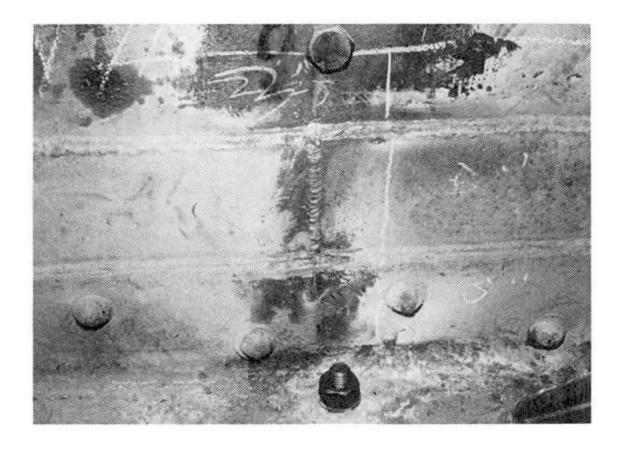
In the late 60's, it was decided to repair the corrosion that occurs in deck plate girders at the web-bottom flange junction on a number of our structures. Because of the production operation, patch plates were of various lengths, and were butt welded as required. After 10 years these welds started to crack under very low stress ranges. The maximum measured stress range was 36.2 MPa (5.25 ksi) with a mean peak per train of 31.92 MPa (4.63 ksi). There was little if any apparent dynamic augment.

Fig. 8 Crack in Patch Plate

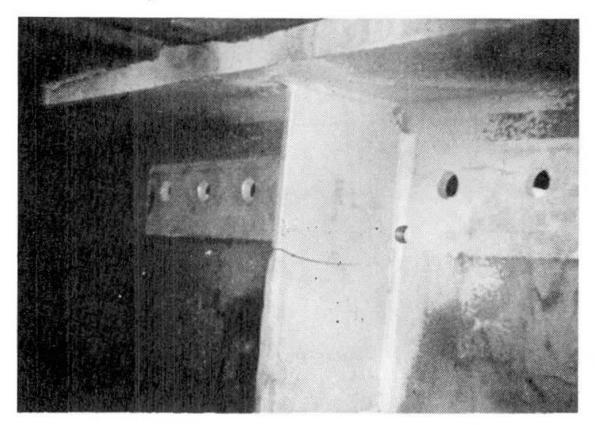
Fig. 11 Hole at Stiffener

- The resulting hole in the web should be reamed from the outside using a reamer of the same diameter throughout.
- Attention should be taken so that all rough edges are made smooth even though a truly circular hole is not obtained. Hand filing may be necessary.

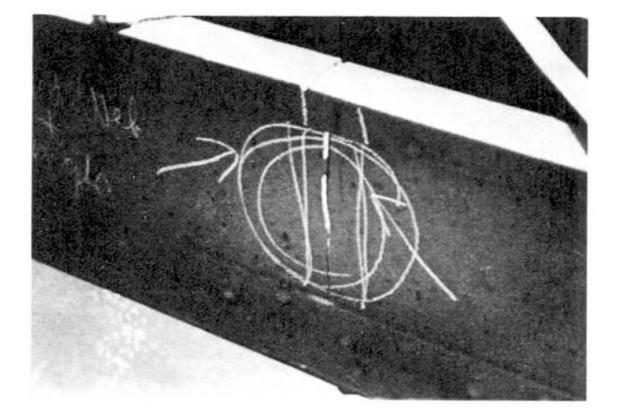
Fig. 13 Crack in chord

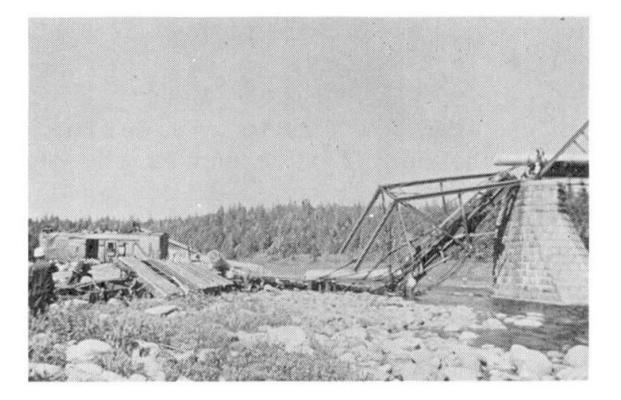
Fig. 15 Insufficient Redundancy

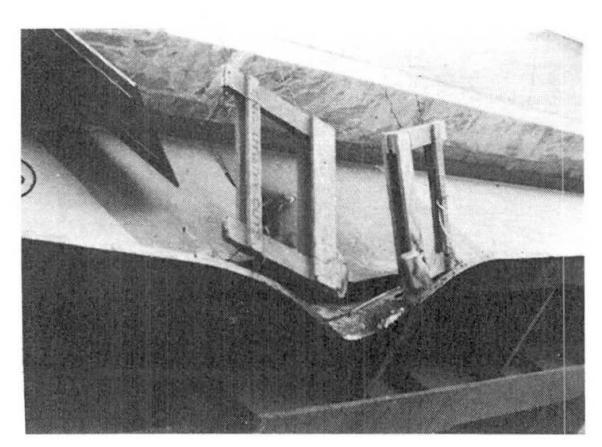
Fig. 16 Hit by Vehicle

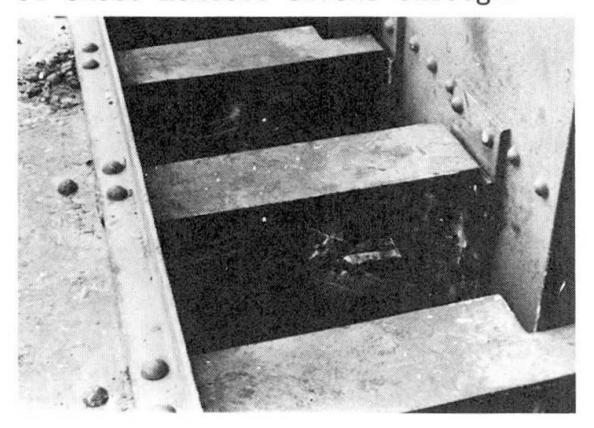
Fig. 17 Torsional loading

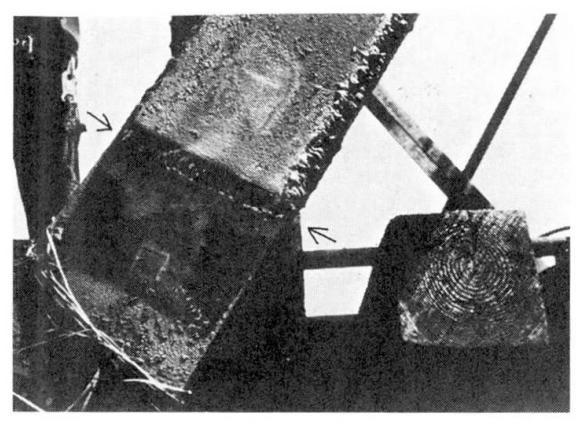
The type of repair shown in Figure 18, the addition of welded plates to an eye bar member could be a disaster in a non-redundant load path structure. The crack is illustrated by the light line of magnaflux at the toe of the weld. In this bridge, because of its multiple load paths, collapse will not occur if one of these members cracks through.

Fig. 18 Eye Bar Weld

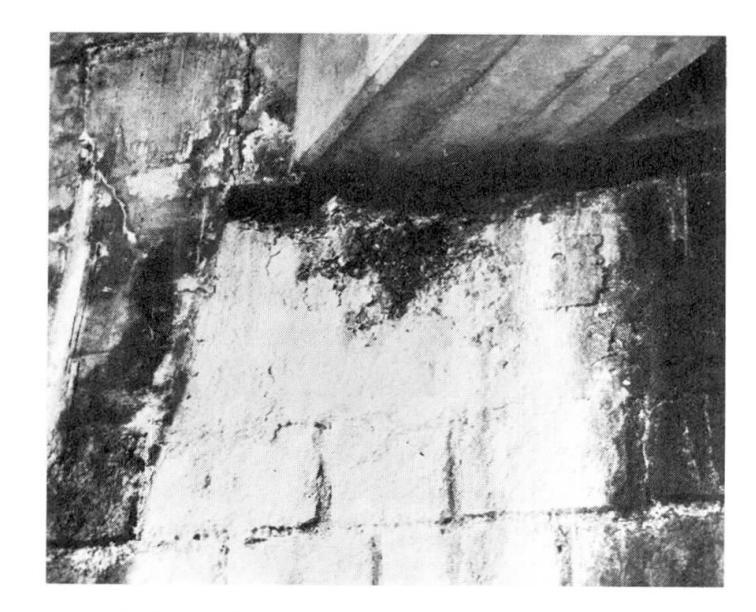
Pont sur le ruisseau de Suretta à Sufers, altitude 1420 m, N 13c, section Andeer - Splügen. Année de construction: 1959. Les désordres ont été réparés en 1972.

Fig. 1 Dégradations à l'infrastructure

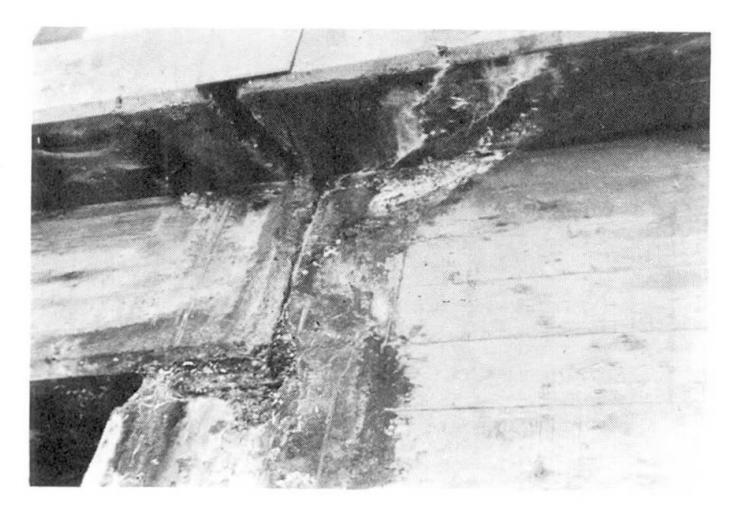
Fig. 2 Exemple de dégât de gel

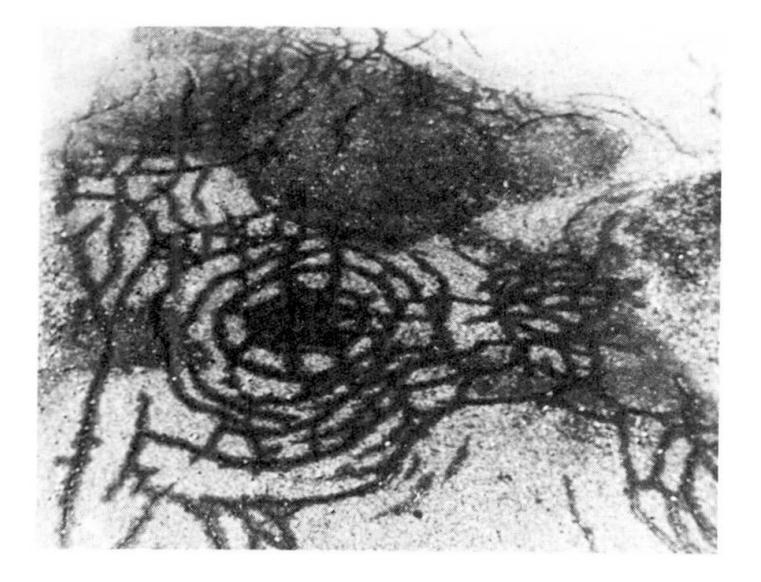
Fig. 3 Destruction du revêtement

La remise en état a entraîné la démolition du revêtement en mortier bitumineux, le piquage du béton sur 10 cm d'épaisseur et son remplacement, le renforcement de l'armature de la dalle de roulement et la pose d'une couche d'étanchéité en lès de nylon enrobés d'une masse bitumineuse, adhérente sur le béton de la superstructure. Les désordres ont été réparés en 1974.

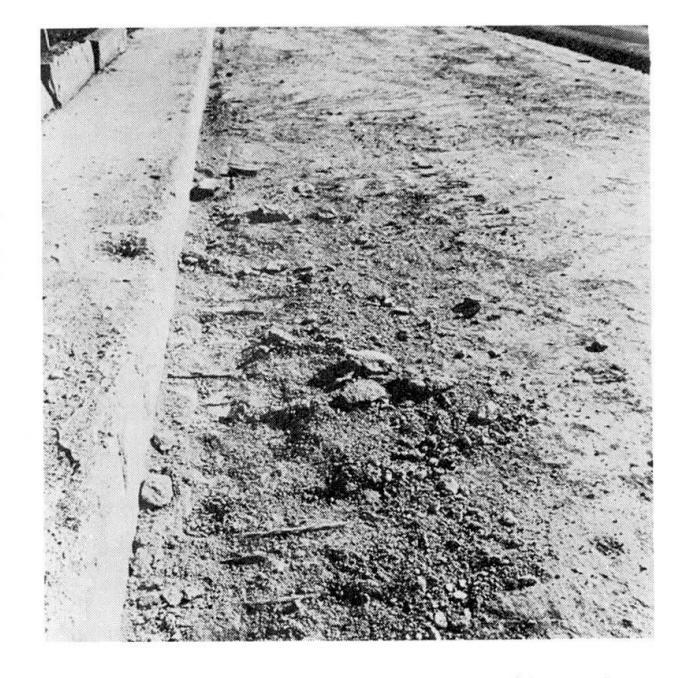
Fig. 4 Dégât de gel sous le revêtement

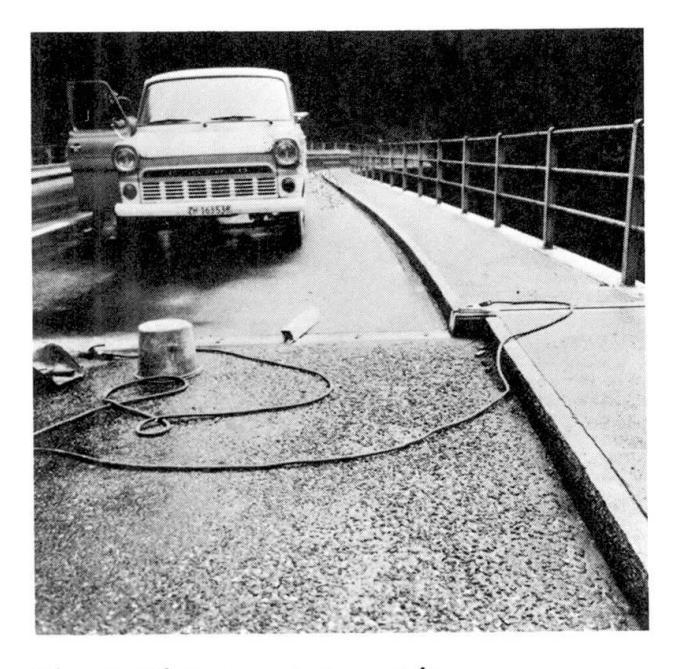
Fig. 5 Déplacement de culée

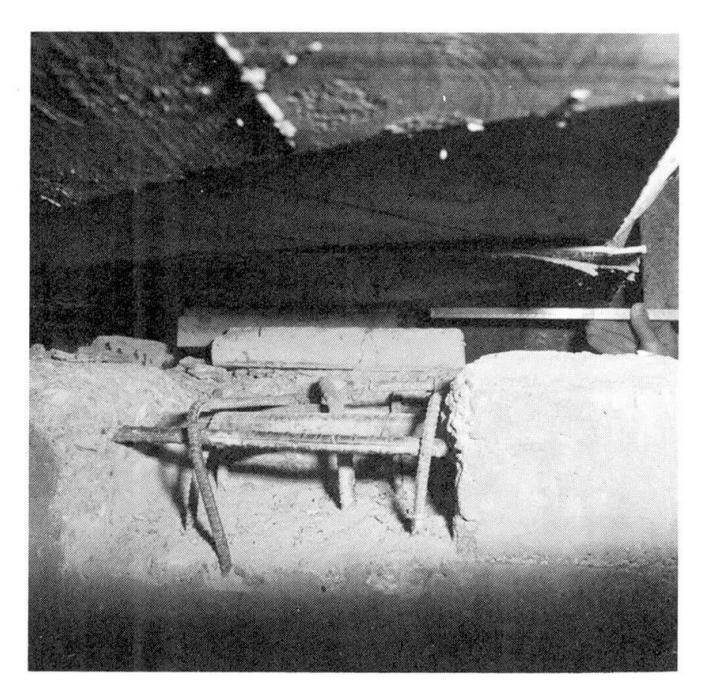
Fig. 6 Appuis déplacés

La remise en état a nécessité le remplacement des appuis glissants linéaires décalés (fig. 6) par des appuis-pots mobiles en tous sens, les gros efforts dus aux effets d'ordre secondaire ne pouvant pas être repris. Les opérations de remplacement ont été difficiles en raison des mauvaises conditions d'accès aux appareils d'appuis. Les désordres ont été réparés en 1973.

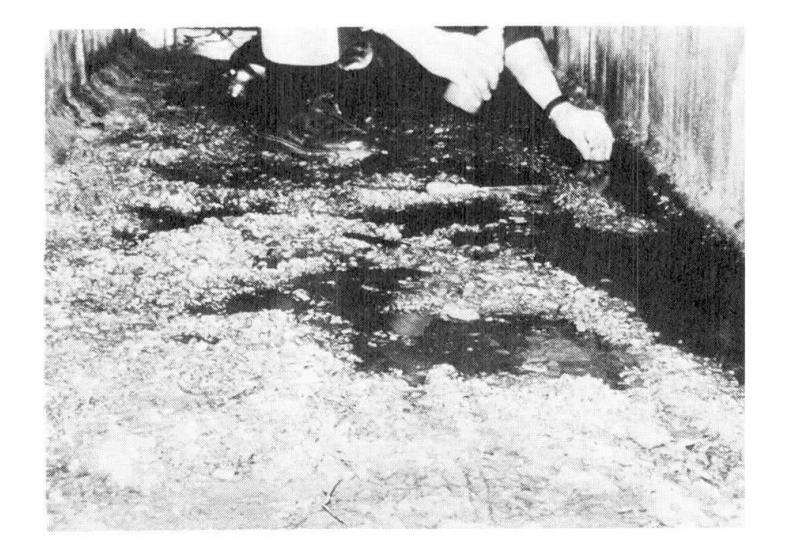
Pont sur le Rhin postérieur à Splügen, altitude 1450 m, N 13c, section Andeer - Hinterrhein. Année de construction: 1962. La remise en état a nécessité le remplacement du cordon et l'application d'une étanchéité de protection. Les désordres ont été réparés en 1978. Dégâts de gel au plancher de caissons inaccessibles (fig. 8). Les désordres sont causés par l'action corrosive des sels de dégel. Par suite d'un déboitement de canalisation, l'eau s'est accumulée dans les caissons. La corrosion du béton a atteint 7 cm de profondeur.

<u>Fig. 8</u> Dégât de gel au plancher de caissons inaccessibles

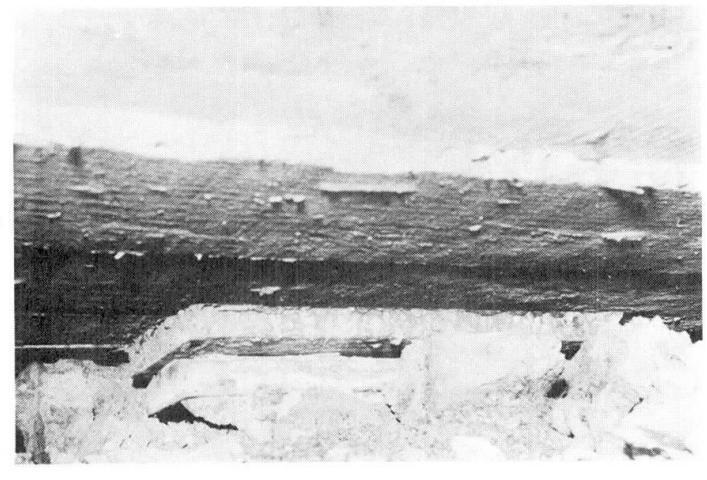
Fig. 9 Désordres aux assises d'appuis

Pont du Steilerbach, Sufers,N 13c, altitude 1420 m, section Andeer -Hinterrhein, année de construction 1959. La remise en état, exécutée en 1972/73, a nécessité le renouvellement de l'étanchéité, le drainage des caissons et le remplacement des appuis et des joints de dilatation.

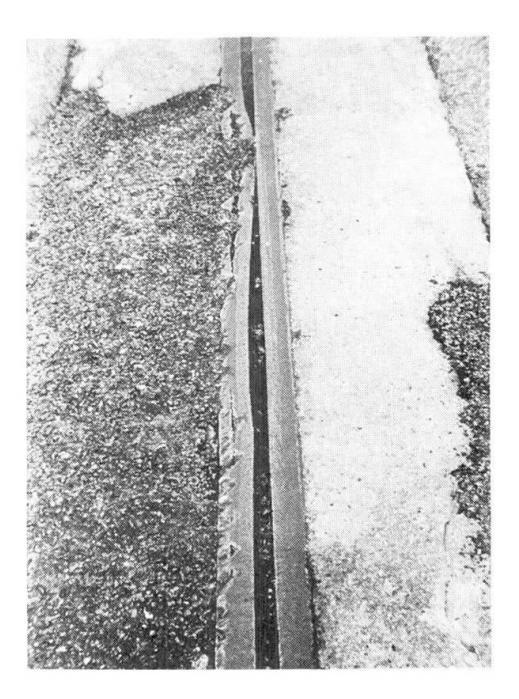
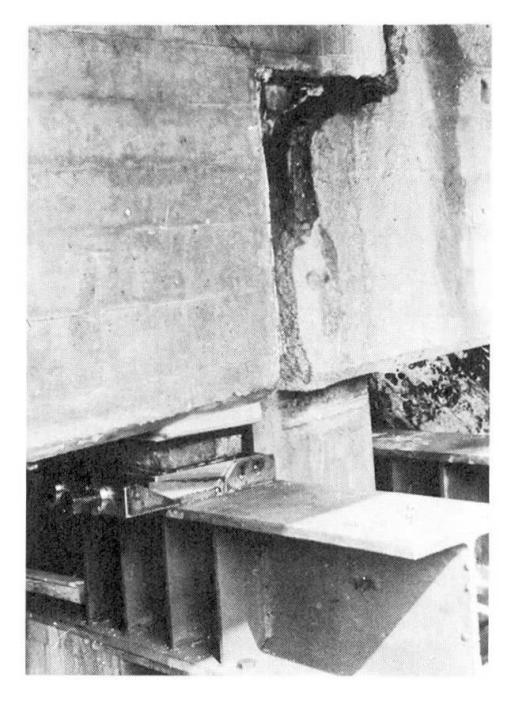
Fig. 10 Joint de dilatation endommagé

En outre, les articulations Gerber du même ouvrage ont été gravement endommagées par suite des infiltrations d'eau de ruissellement pénétrant dans la structure par les ouvertures des joints de dilatation s'ajoutant aux fuites des canalisations (fig. 11 et 12).

La remise en état de l'ouvrage a nécessité le remplacement des appuis endommagés, la pose de nouveaux joints de dilatation étanches ainsi que le renouvellement de l'étanchéité et du revêtement du tablier. Les désordres ont été réparés en 1972/73.

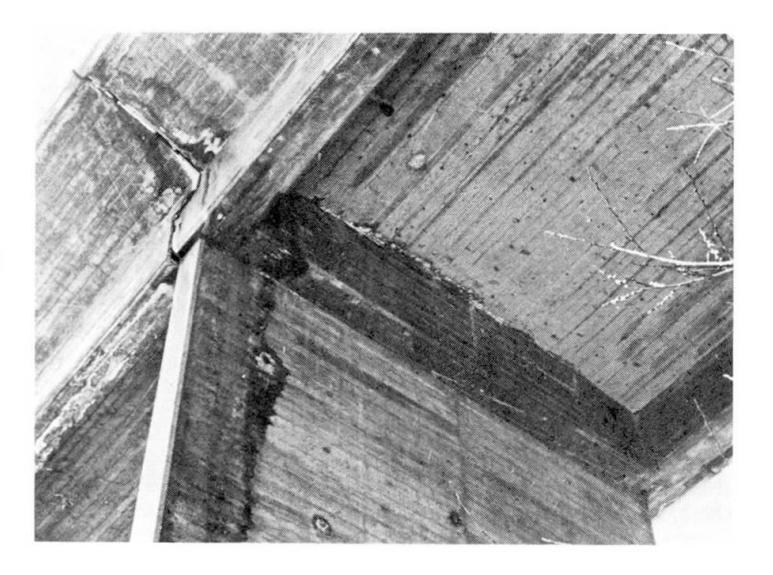
Fig. 12 Vue de l'articulation depuis dessous avant sa remise en état

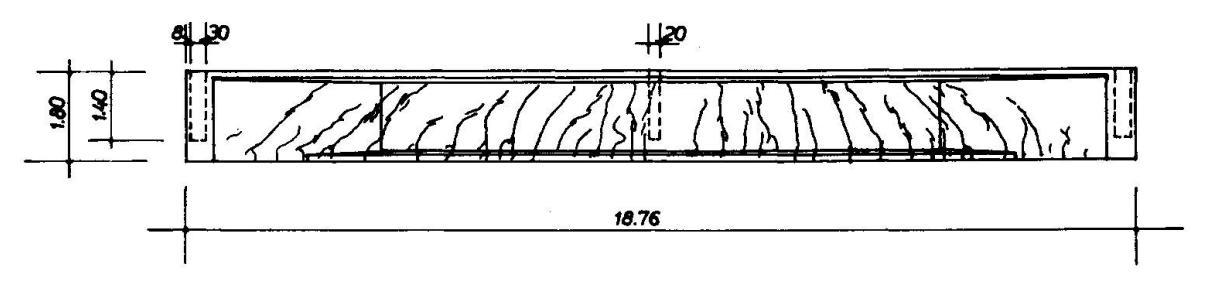
As an example, figure 2 shows the cracks of the external rid of bay No. 21.

Fig. 2 - Crack pattern on the external rib of bay No. 21

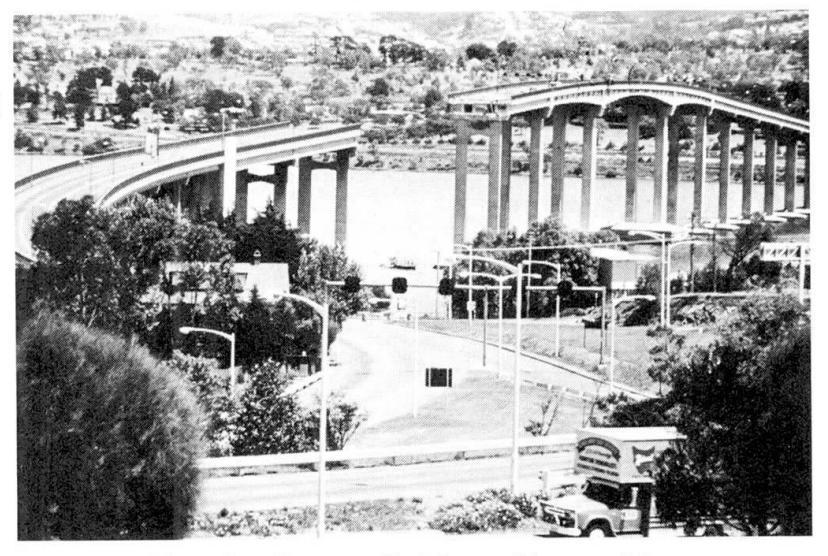
eastern main viaduct. The Fig. 1 Tasman Bridge after collapse original design recognised the possibility of a ship collision although the
