| Zeitschrift: | IABSE reports of the working commissions = Rapports des commissions de travail AIPC = IVBH Berichte der Arbeitskommissionen |
|---|---|
| Artikel: | The long-term behaviour of viaducts subjected to heavy traffic and situated in an aggressive environment: the viaduct on the Polcevera in Genoa |
| Autor: | Morandi, R. |

The Long-Term Behaviour of Viaducts Subjected to Heavy Traffic and Situated in an aggressive Environment. The Viaduct on the Polcevera in Genoa.

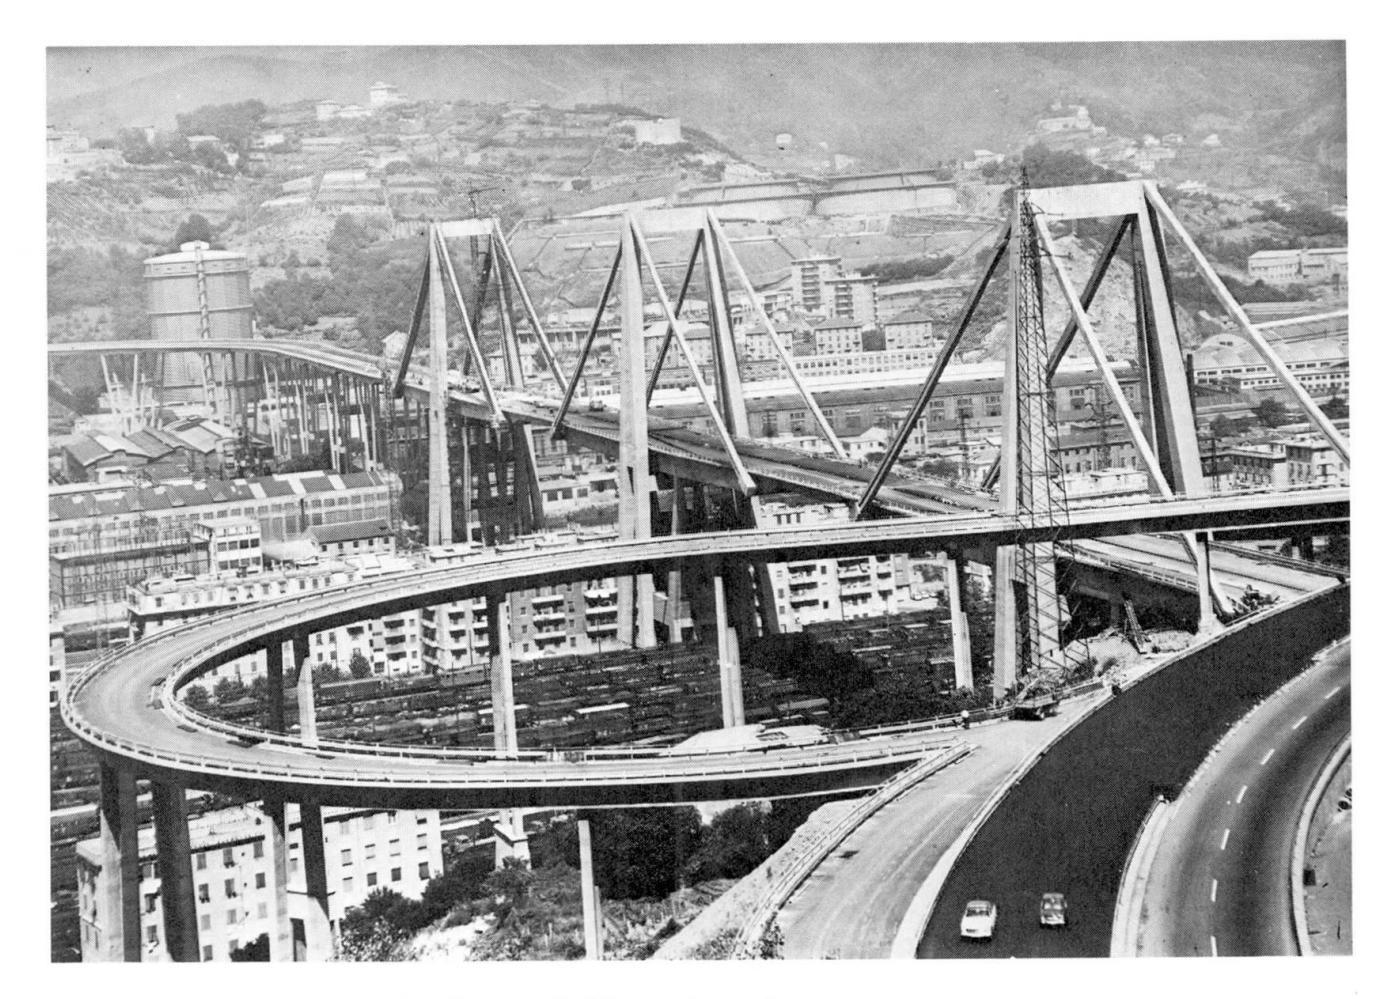
Figure 3 - General view of the structure.

Some slight cracks of a very 'small size (much below 0.2 mm) have been noticed in the secondary connecting cross elements which obviously had not been prestressed - and which were surely due to the vibration caused by the traffic.

Furthermore, in these last years the external surfaces of the structures and especially those exposed towards the sea and therefore more directly attached by the acid fumes of the chimneys, start showing an aggression phenomenon of a chemical origin.

This is obviously due to the production of soluble salts resulting from the combination of the acids of the fumes with the free lime of the concrete : the well-known loss of superficial chemical resistance of the concrete itself.

I thinck that sooner or later, may be in a few years, it will be necessary to resort to a treatment consisting of the removal of all traces of rust on the exposure of the reinforcements, to fill the patches, with epoxidic type resins and finally to cover everything up with elastomers of a very high chemical resistance.
