Zeitschrift:	IABSE reports = Rapports AIPC = IVBH Berichte
Band:	41 (1983)
Artikel:	Accidents involving bridges
Autor:	Frandsen, Aksel G.
DOI:	https://doi.org/10.5169/seals-31652

Accidents Involving Bridges Accidents impliquant des ponts Brückenunfälle

Aksel G. FRANDSEN Consulting Engineer Cowiconsult Copenhagen, Denmark

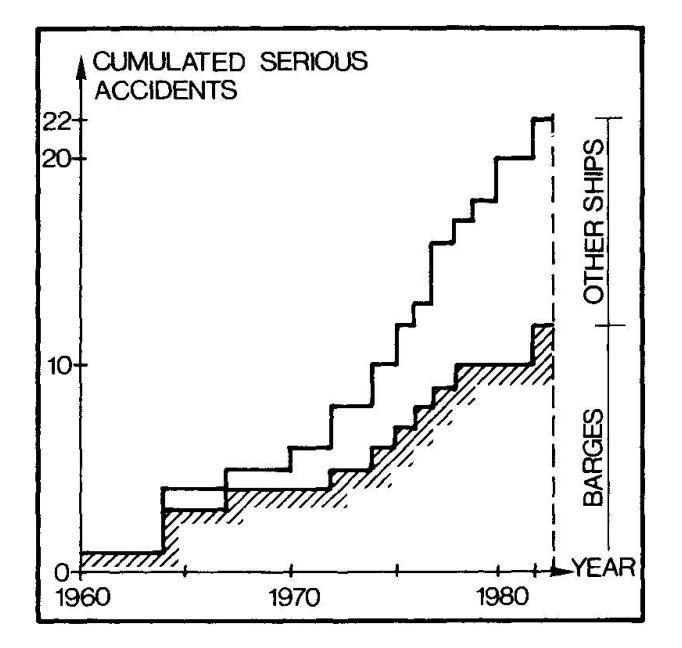
Fig. 1 shows the cumulated number of serious ship collisions since 1960. It can be seen, that the annual rate of such collisions has increased from 0.5 to 1.5 during the last two decades. It can also be seen from this figure, that collisions involving barges constitute about 55% of all the cases. This corresponds well with the above mentioned distribution of the accidents on rivers and channels, as one group, compared to the group of all the other navigable waters.

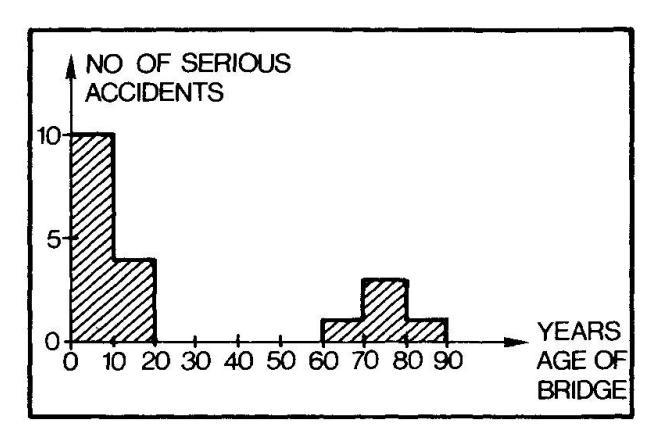
Fig. 2 No of serious accidents in relation to age of bridge.

In most of the cases it has been possible to establish how old the bridges are/were. Fig. 2 shows the number of serious accidents set in relation to the age of the bridge at the time of the accident. It is interesting to note, that most of the bridges were seriously hit while they were quite young - under 10 years of age, that no bridge between 20 and 60 years of age was hit, and that some very old bridges - between 60 and 90 years - were also hit. This pattern is known from many other areas, and is probably quite natural.
