Zeitschrift:	IABSE reports = Rapports AIPC = IVBH Berichte				
Band:	42 (1983)				
Dubrile	Theme A. Coop staries of recent chip collicies assidents				
RUDIK:	I neme A: Case stories of recent ship collision accidents

Case Stories of Recent Ship Collision Accidents Rapports d'accidents de collisions de bateaux Fälle von neueren Schiffskollisionen

Ship Collisions with Danish Lighthouses Collisions de navires avec des phares danois Schiffskollisionen mit dänischen Leuchttürmen

Newport Bridge Collision Collision au pont de Newport Newport Brückenzusammenstoß

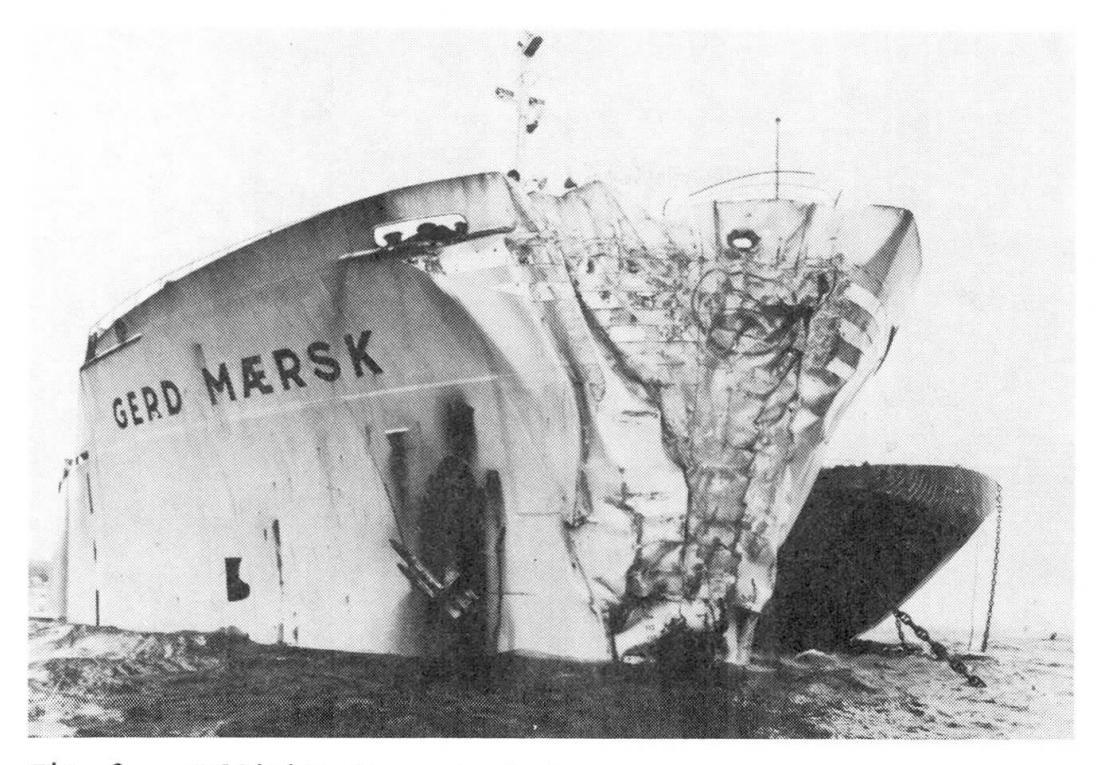
Fig. 2. Collision damage to tanker.

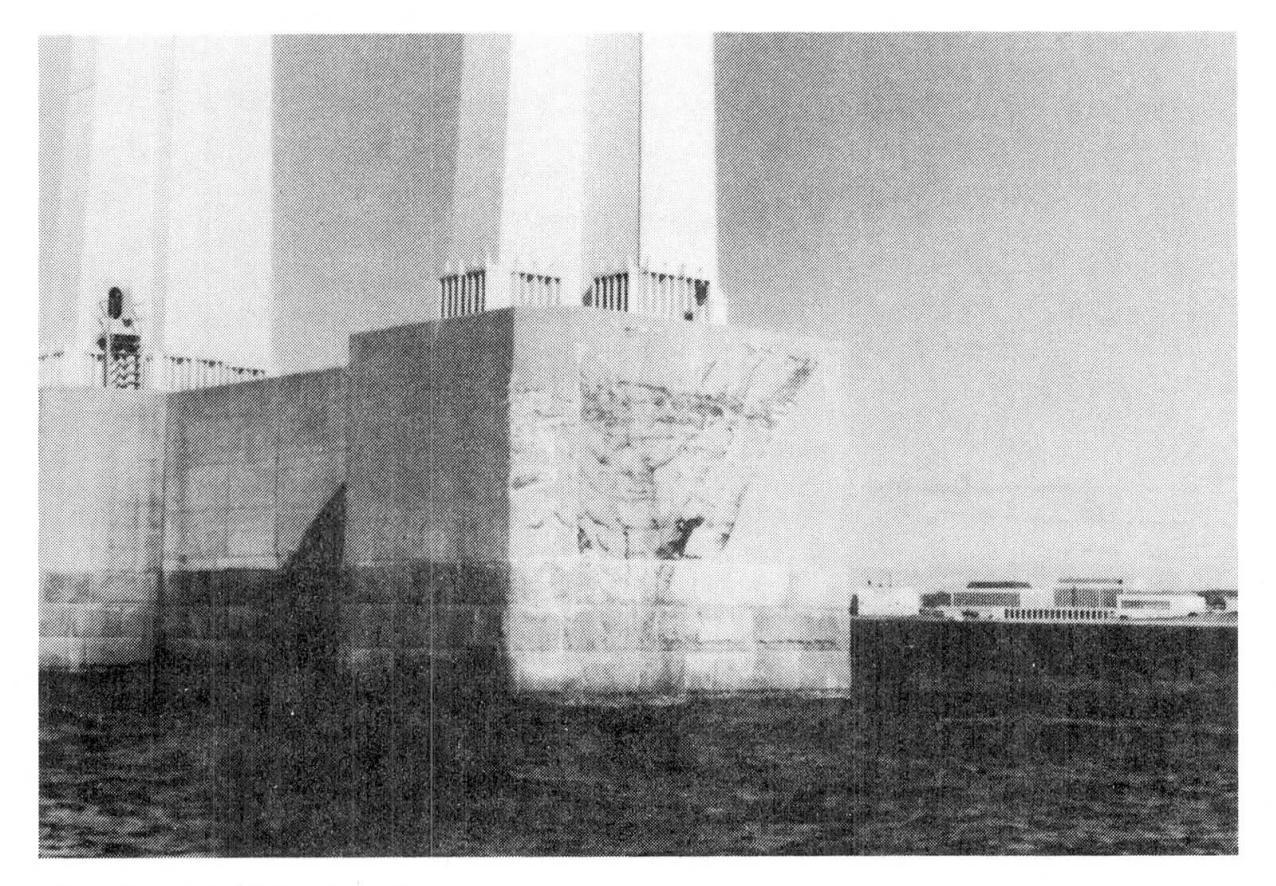
Damage to the bridge was negligible. The pier suffered no displacement or rotation, and there was no misalignment of the roadway deck joints or any other superstructure elements. The side of the pier suffered extensive surface scrapes, gouges, and spalls of the concrete (Fig. 3) to a depth of 2 to 5 cm over an area roughly 7 m wide by 20 m high, approximately equally above and below the water line (Fig. 4).

Fig. 3. Bridge pier damage.

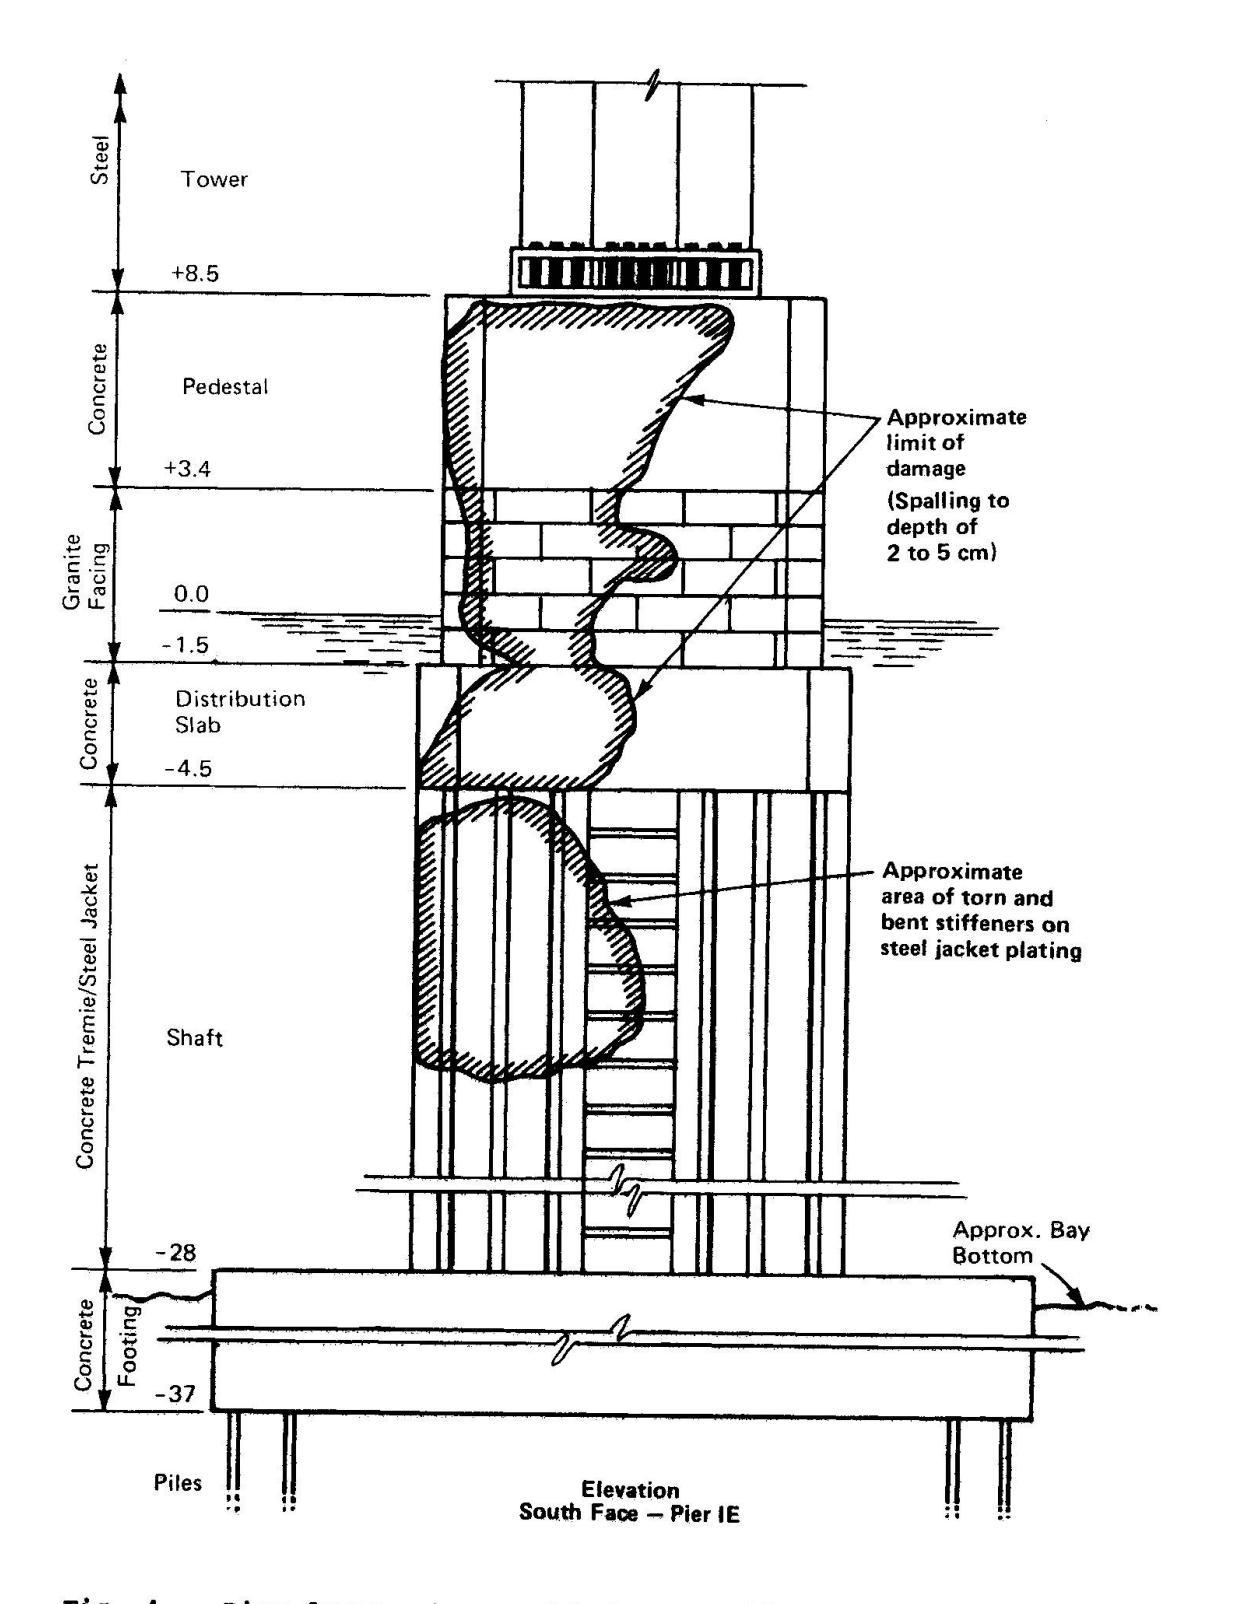
There were a number of superficial tears in steel plating of the underwater caisson structure, but no damage to the concrete behind the plating. A spectacular blotch of gray paint decorated the side of the pier for several days before falling off.

Fig. 4. Pier damage above and below waterline.

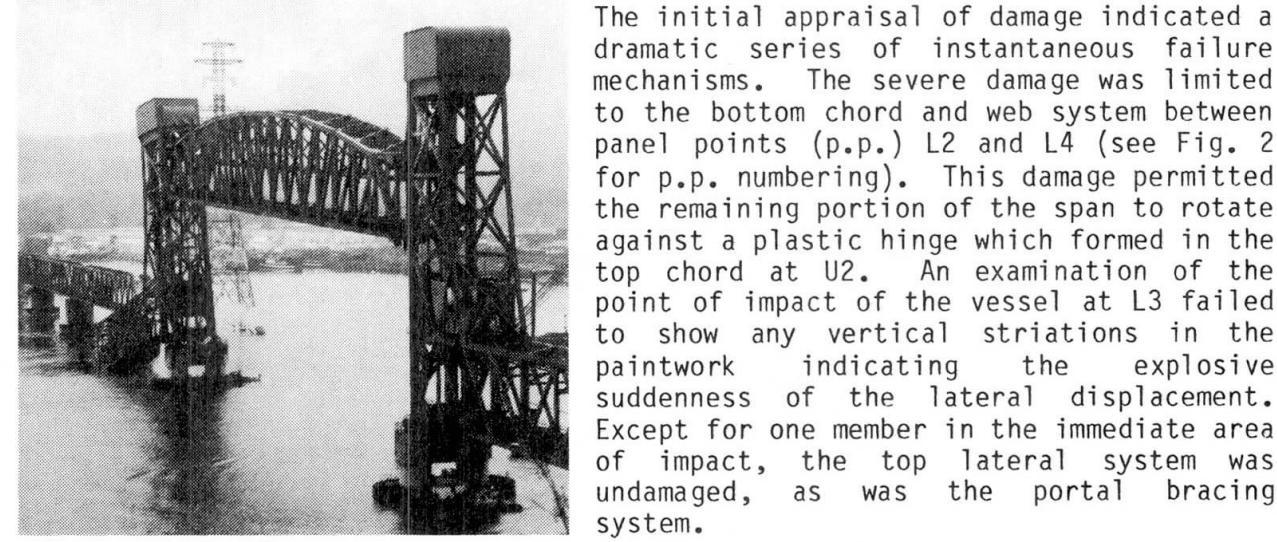
Figure 1

dramatic series of instantaneous failure The severe damage was limited mechanisms. to the bottom chord and web system between panel points (p.p.) L2 and L4 (see Fig. 2 for p.p. numbering). This damage permitted the remaining portion of the span to rotate against a plastic hinge which formed in the top chord at U2. An examination of the point of impact of the vessel at L3 failed to show any vertical striations in the paintwork indicating explosive the suddenness of the lateral displacement. Except for one member in the immediate area of impact, the top lateral system was undamaged, as was the portal bracing system.

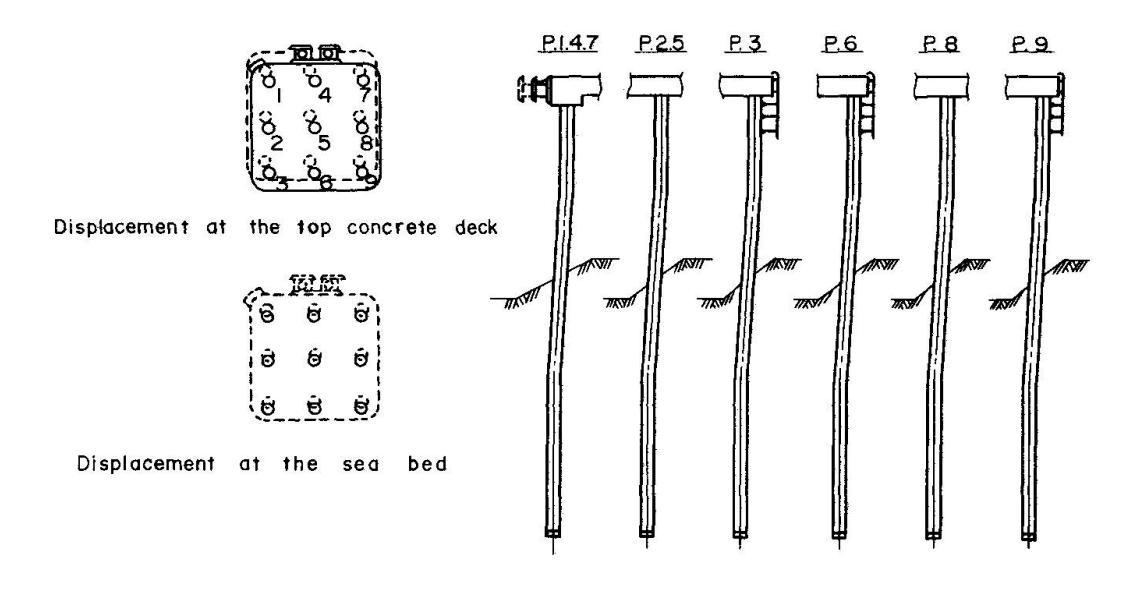
The results of our inspection carried out immediately after the accidents are briefly as follows: (See Fig.5)

Fig.5 Deformation of Dolphin B-3

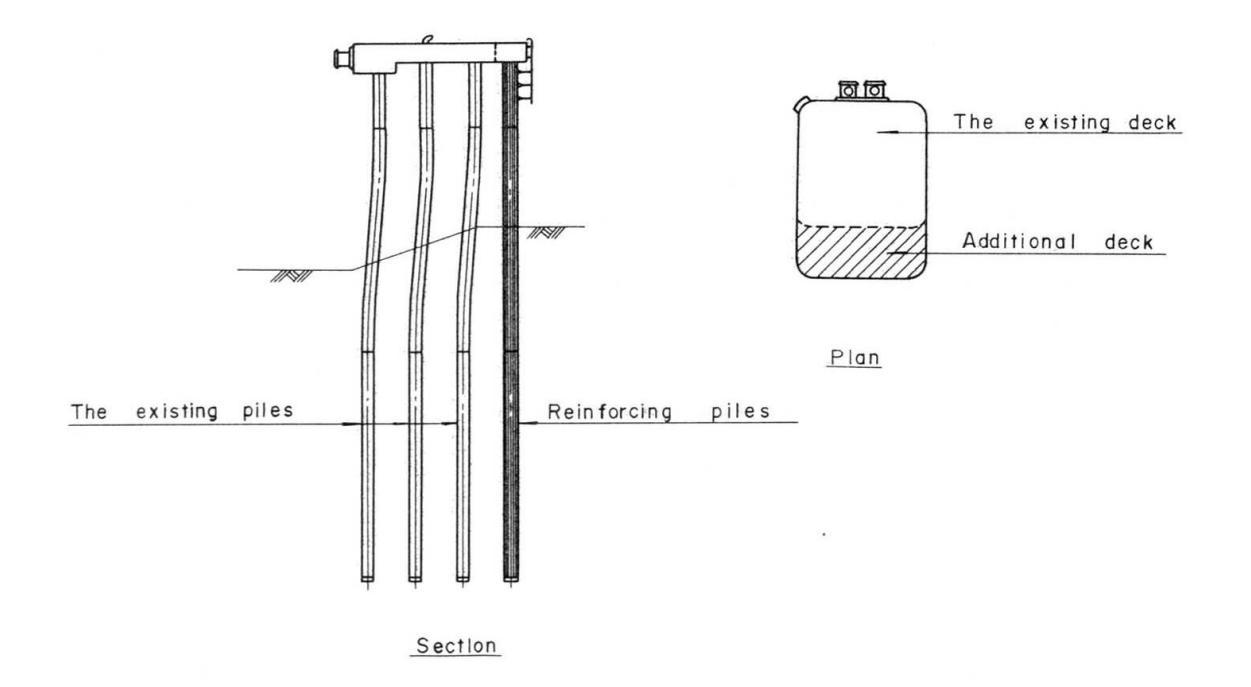
Fig.7 Restoration of Dolphin B-3

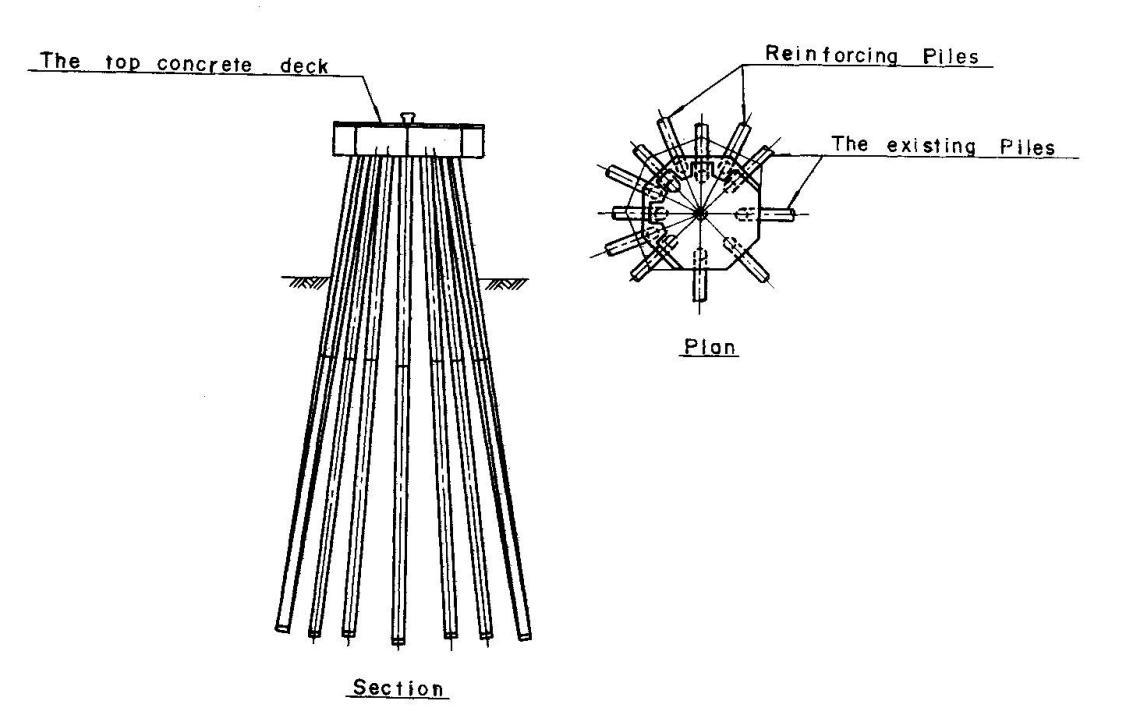
Fig.8 Restoration of Dolphin M-1
