Recovery and Repair of the Second Narrows Railway Bridge

The paper describes the damage caused by a ship collision with the Canadian National Railway Lift Span in Vancouver, British Columbia. The theoretical and practical consideration of the stabilisation and recovery schemes are discussed and the equipment and procedures used in the twenty weeks it took to restore the train service are described in detail.

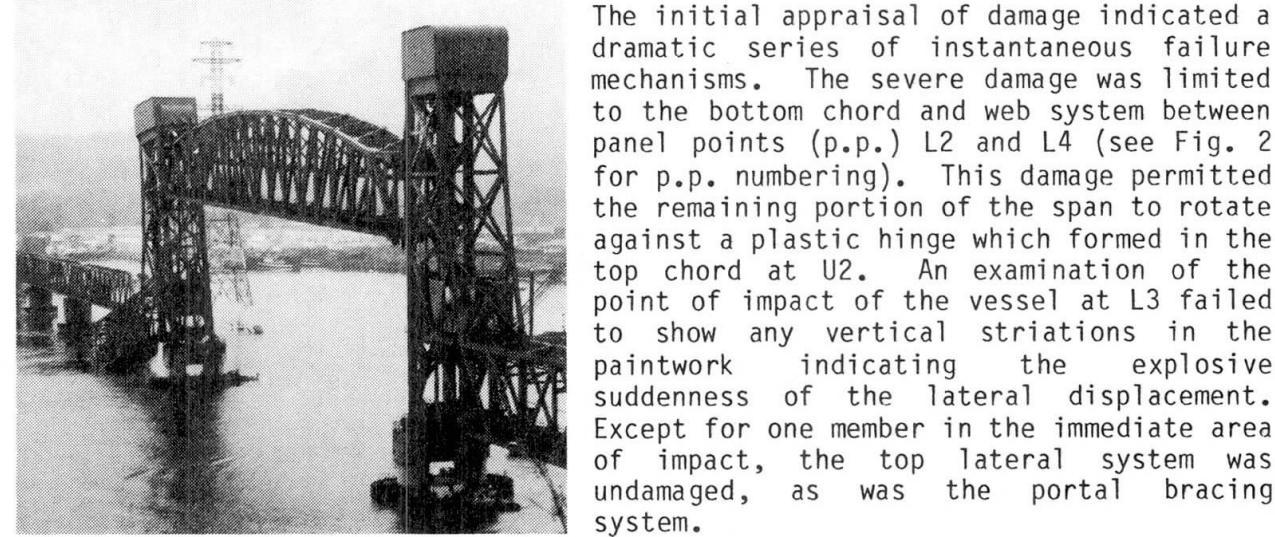
Figure 1

Although the ship was moving dead slow the impact knocked the north end of the span clear of the pier and displaced it laterally the width of the bridge (Fig. 1) by pivoting around the central wind post of the main pier.

The wind post prevented complete displacement of the span as the 12-64 mm anchor bolts in the pier members were sheared. The span was skewed approximately 9° to the axis of the bridge and the north end dropped to a gravel bar at the foot of the pier.

The tower lost substantial support as the bearings were displaced to the extent that they were partially projecting over the N.E. and S.W. edges of the main pier. In this precarious state of equilibrium the lift span, which had been torn from the vertical tower guides (Fig. 3) was left hanging, hammock-like, from the lift ropes.

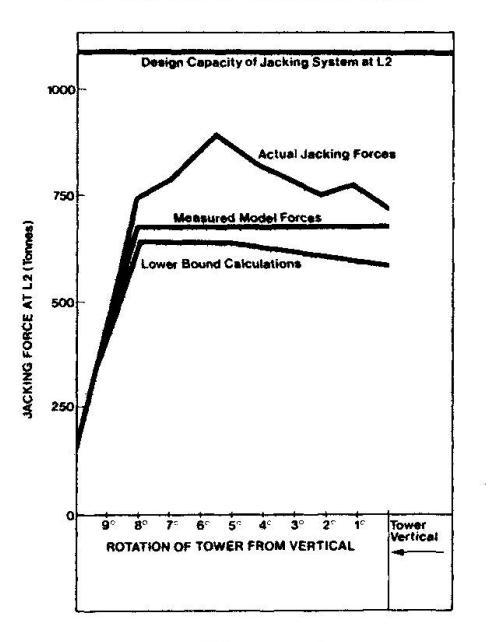
Figure 4 shows the accuracy that the various analyses achieved by plotting the jacking forces at L2 as the tower rotated to the vertical. The lower bound calculations were derived from measured forces and theoretical analysis and, as can be seen, are very close to the forces predicted by model analysis.

The actual values had a disturbing peak in them which was caused by a jammed shear lock. Without this occurence it is believed that the measured values would have paralleled the model values closely. Even with the jamming, the maximum jacking forces did not come close to the upper capacity provided in the recovery scheme.

The design capacity had been conservatively estimated by considering the tower weight and ignoring the restraining forces from the inclined cables.

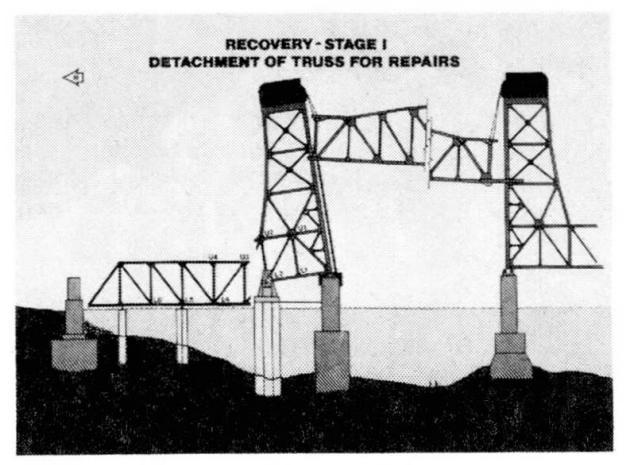
Figure 8

During the driving of the 500 mm dia. pipe piles the tides produced currents of up to 8.4 km/h which engendered destructive vortex shedding in the piling and produced several modes of vibration.

7 Figures 6 show the final and configuration of the L2 bent. The table beside Figure 7 lists the variety of

oscillations observed in the bent during construction. The amplitudes in most cases are visual estimates and therefore, are not too accurate. The measurement that is guaranteed, however, is the Stage 1 plus or minus 900 mm value. In this case the piles were driven at 1800 mm centres and during oscillations actually made contact with each other. Tidal flow and frequency were Vibrations only occurred for about 1 to 2 hours during accurately measured. every other tide during a two week period. It was unfortunate that the construction schedule did not fully coincide with the tidal cycle. Attempts to damp out the oscillations with ropes attached to the piers were unsuccessful. It was fortuitous that the oscillations almost always occurred after the dayshift was complete (7 p.m. to 9 p.m.) or before it started (3 a.m. to 5 a.m.) and work could always continue on bent completion during daylight hours with no oscillations. The Stage II oscillations came as a considerable surprise since group oscillation was considered to be unlikely. The east pile group survived the first set of oscillations, but top bracing of the west group was partially destroyed and was subsequently re-installed.

Temporary 500 mm dia. tube struts were installed from the bents to the piers which eliminated the violent crossflow vibrations but replaced them with plus or minus 76 mm in-line vibrations.

The jacking bent was completed as designed with 600 mm dia. pipe bracing and no serious vibrations were detected thereafter.

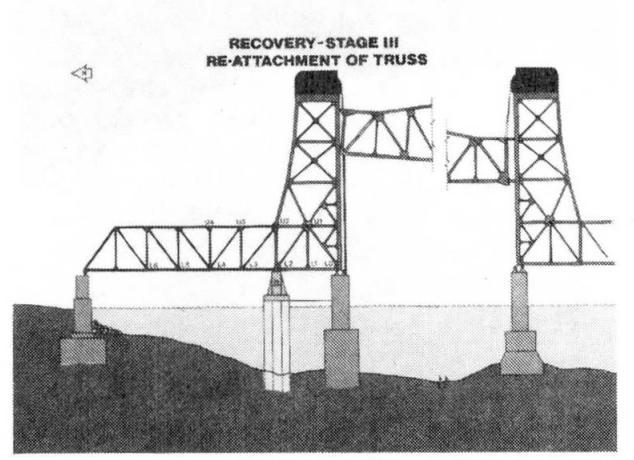
Figure 10 e node point was 150 mm to the

As the tower was jacked to the vertical the effect of the rack in the span, which was now contained by the vertical bracing, caused the jacks to be more heavily loaded on the east side than those on the west. At one time this disparity in loads increased uncomfortably close to the design loading of the easterly pile group.

This required the provision of falsework under the back legs of the tower of sufficient capacity to carry the heaviest vertical reaction and provide a base large enough to carry a jacking frame, and a transversing system which would be required to re-align the tower after plumbing (Fig. 10). Support for this falsework, which was designed for 1091t, was provided by two groups of 12 - 500 mm dia. pipe piles supporting a transverse girder system of adequate size to

The locus of the tower top during jacking was south east while the lift span was supported N-S. Therefore, during the jacking of the tower it was necessary to traverse the lift span to the east as the weight of the lift span was transferred to the bent.
