# Strengthening and/or Repairing of Existing Structures

Leon A. GRILL Civil Eng. Rankine & Hill Assoc. Sydney, Australia

Three cases of reinforced concrete structures presenting unusual problems to the engineer are presented:

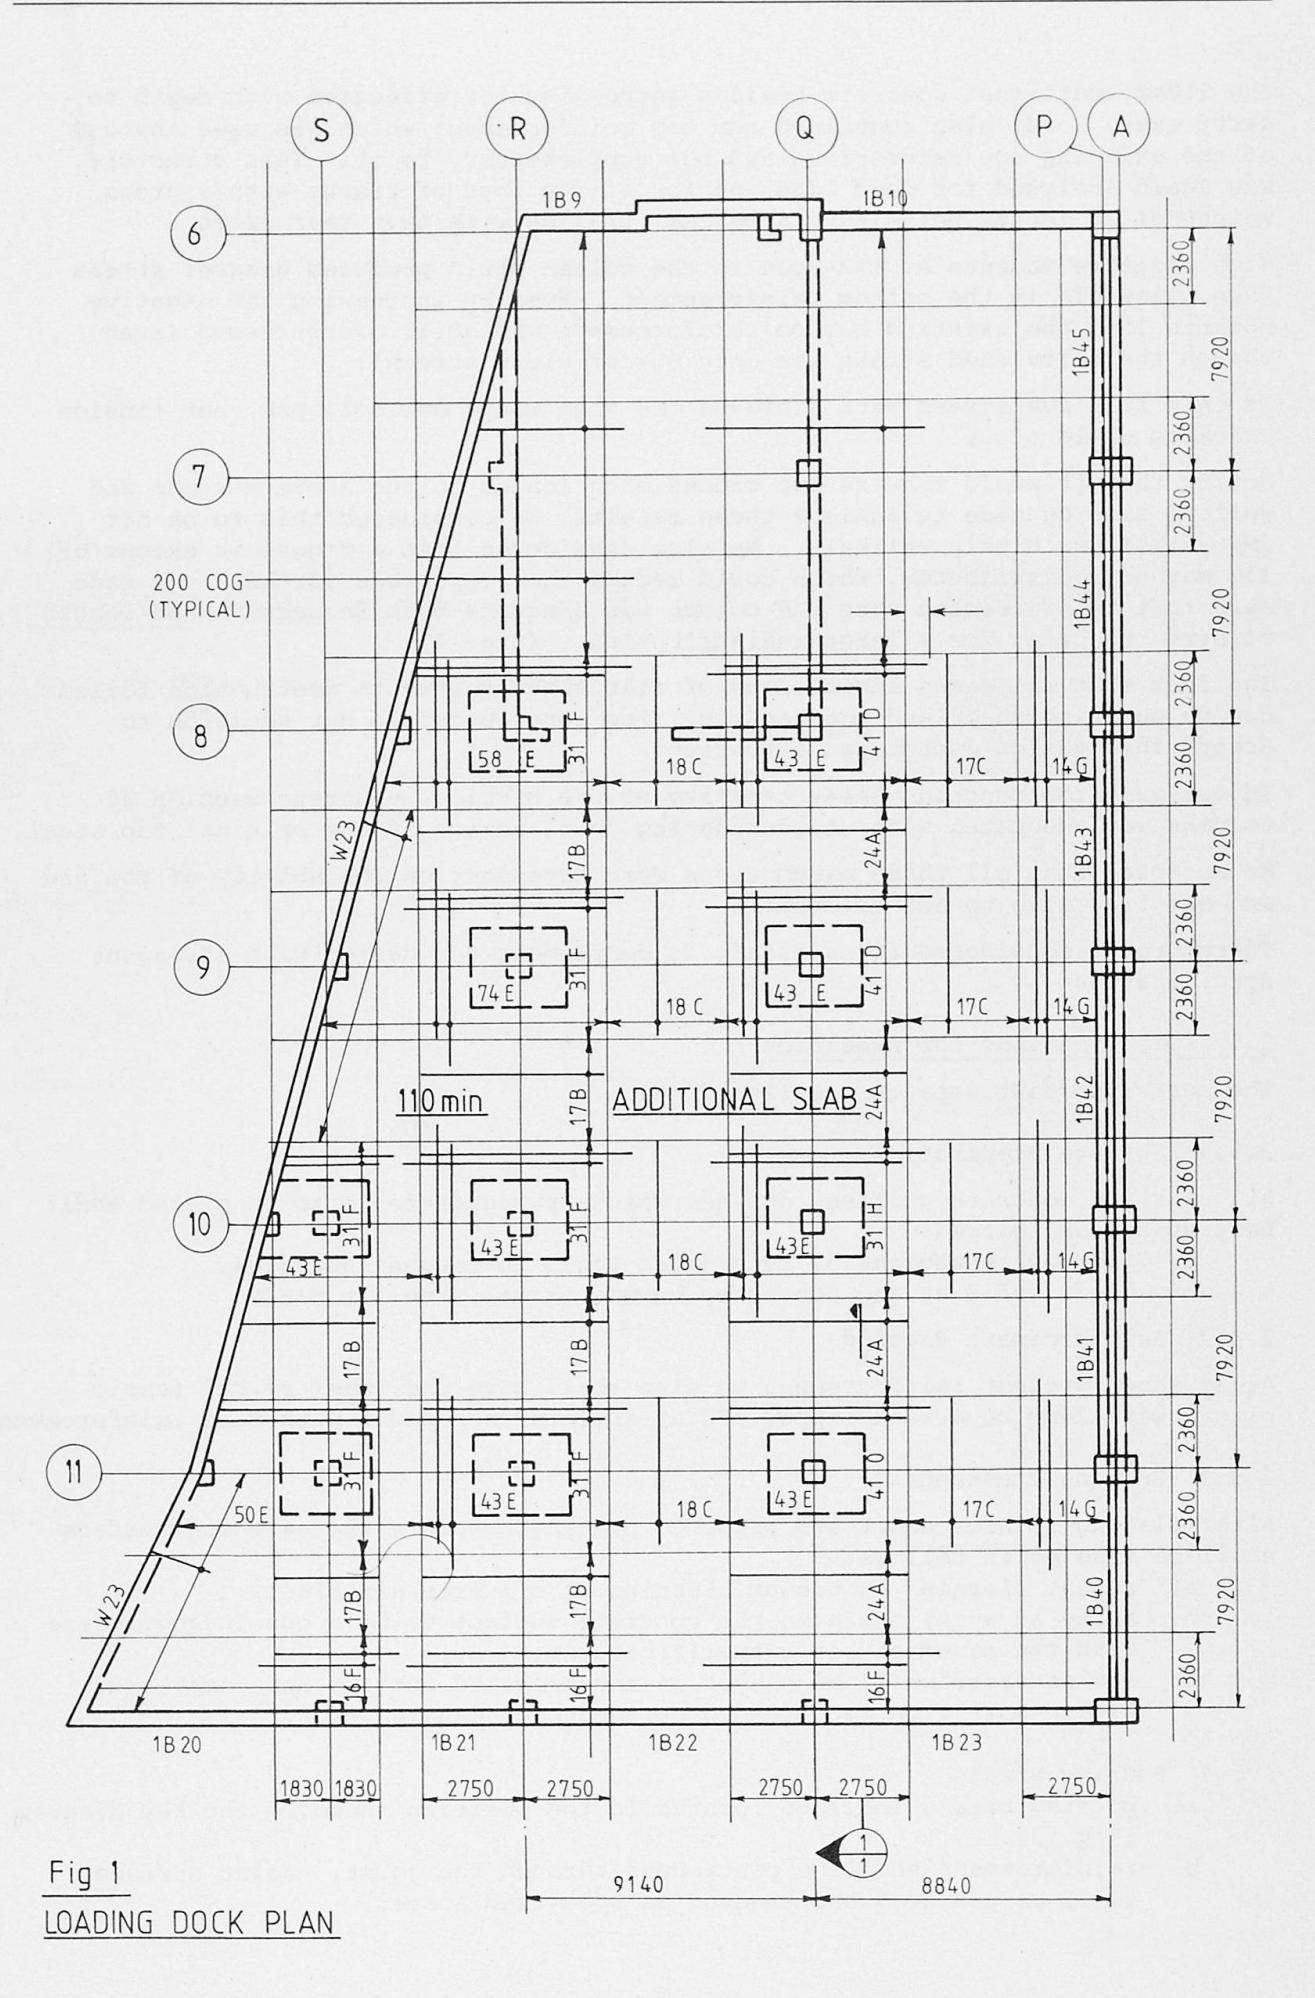
To increase the capacity of the slab it was proposed to add 110mm of reinforced concrete on top of the existing slab, keyed to the existing slab by scabbling the contact surface and using a wet to dry epoxy. Special attention was given to this detail to insure a sufficient bond to resist the horizontal sliding shear (Fig. 2).
