## Rehabilitation and Maintenance Design for Durability

Carolyn L. SEARLS Senior Engineer Wiss, Janney, Elstner Assoc. Inc. Emeryville, CA, USA

Barbara ZOOK Historical Architect National Park Service Santa Fe, NM, USA

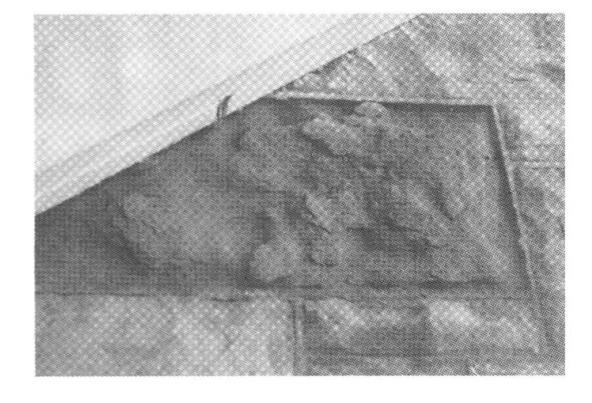
Use of a modern, high strength "durable" material for repointing mortar joints often results in lessened durability for the building as a whole. In general, repointing should be done with a "soft" mortar, lower in strength than the adjacent masonry so that stresses from expansion, moisture migration or settlement can be accommodated within the joints rather than the stones. Use of a hard portland cement mortar can result in accelerated deterioration of the stone, while the mortar joints remain intact, as shown in Fig. 1.

Fig. 1 Stone deterioration at repointed joint

Periodic maintenance of mortar joints will greatly increase the durability of the building by reducing water infiltration into the stone.

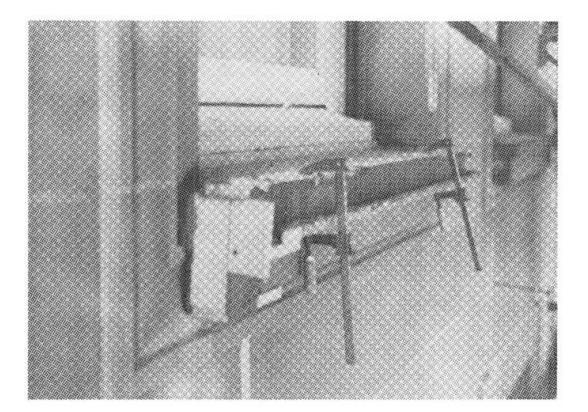
Mortar material is used to rebuild deteriorated sections of stone. The mortar is placed by hand or cast into forms to reproduce original details, as shown in Fig. 2. The durability of the patch improves when the patching material is similar to the stone in strength, porosity, and thermal expansion characteristics. The surface preparation, application method, reinforcement, and curing

# Fig. 2 Stone window sill rebuilt with mortar

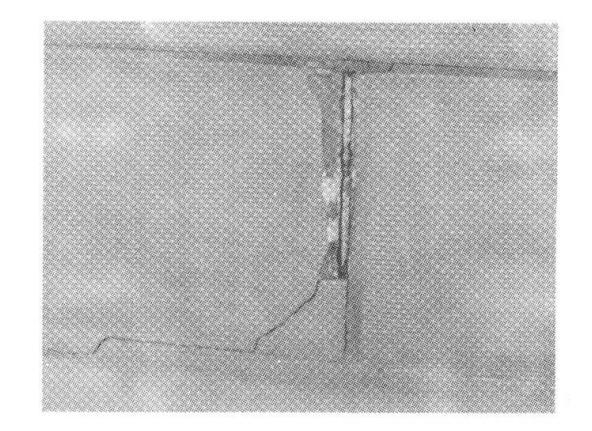
also control the success of the patch. Failure of the repair shown in Fig. 3 occurred because the patch was placed across a mortar joint with no provision for movement of the stones on either side of the joint.

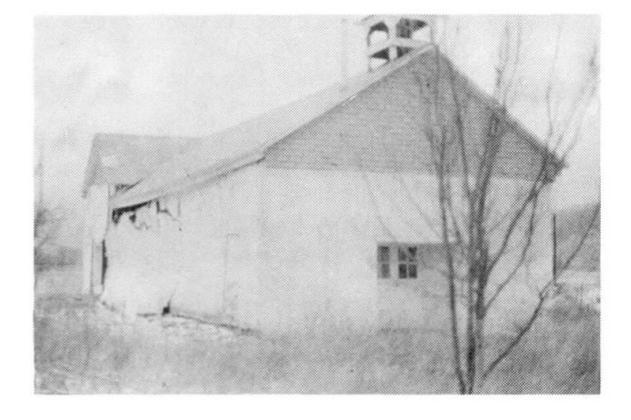
Basal erosion caused by the presence of moisture and freeze thaw action, requires immediate repair because it reduces the load bearing capacity of the wall. The west wall of the San Jose Church in Upper Rociada, New Mexico, shown in Fig. 4, slumped recently after the removal of interior wood furring and removal of adjacent exterior grade. The base of the wall had a moisture content of 17 to 24 percent and the imposition of additional loads on the moist mudbrick base caused the wall failure. Basal erosion is repaired by removing loose material and adding new mudbrick, using

Fig. 4 Wall failure resulting from high moisture content

matching mud mortar. Specifying a good particle size distribution, a nonexpansive clay, and using correct manufacturing procedures for the replacement mudbrick will increase the durability of the repair. [5]

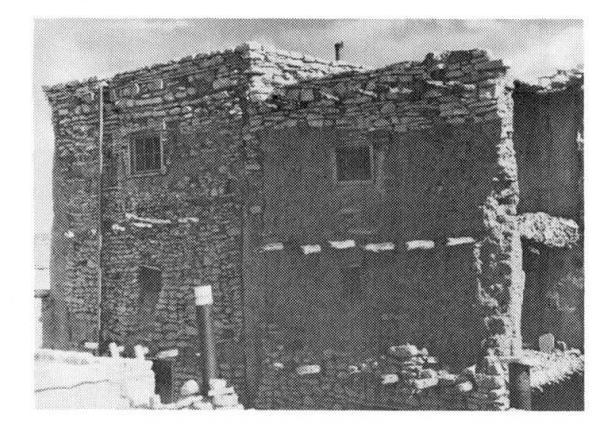
The Pueble of Acoma in central New Mexico consists of three-story contiguous southfacing mudbrick structures on a high sandstone mesa built by Indians in the eighteenth century. Moisture deterioration has not been a problem in these structures but construction with unkeyed corners and narrow widths of three-story high mudbrick walls caused collapse of a section of an Acoma structure, as shown in Fig. 5. The collapsed wall was rebuilt with additional thickness of adobe and with keyed in corners.

Fig. 5 Mudbrick wall collapse
