| Zeitschrift: | IABSE reports = Rapports AIPC = IVBH Berichte |

KEYNOTE LECTURES

Prise en compte de la durabilité du projet à l'exécution Berücksichtigung der Dauerhaftigkeit vom Entwurf bis zur Ausführung

Prolongation de la durée de vie du pont de Williamsburg Verlängerung der Lebensdauer der Williamsburg-Brücke

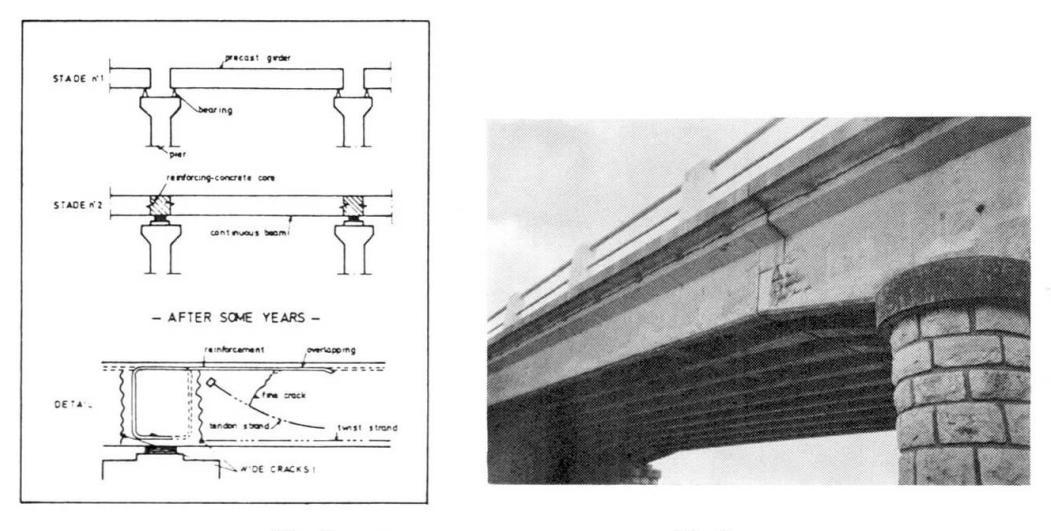
Fig.8

First example: we refer to reinforced concrete bridges composed of prefabricated contiguous beams linked by spacers poured in situ. The current state of decks, about forty years old, in relation to the very satisfactory state of bearings shows what can be achieved without top slab and waterproofing layer - Figure 8.

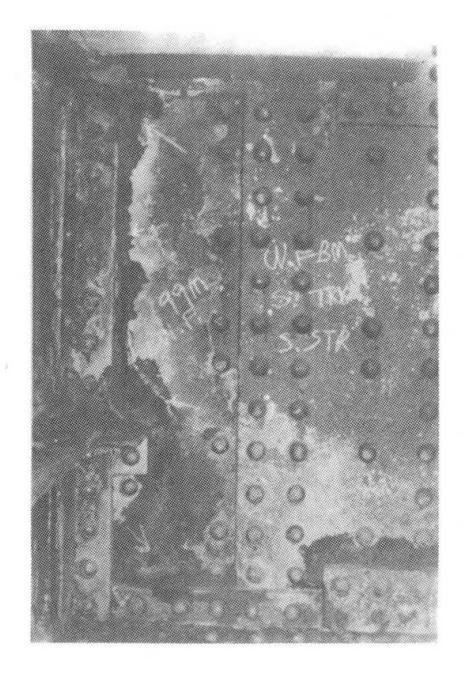
The first major areas of deterioration were found on the Brooklyn Bound outer roadway cantilever floorbeams on March 28, 1988. The webs of the floorbeams adjacent to the stiffening truss (at location of maximum moment and maximum shear) were severely deteriorated (many with through holes) in an "L-shaped" pattern vertically along the truss chord and horizontally along the floorbeam bottom flange angle. Upon being notified of this condition, the NYSDOT and NYCDOT decided to close the roadway to traffic. Considering the condition of the Brooklyn bound roadway, the cantilever floorbeams on the Manhattan bound roadway were then immediately inspected and similar conditions were found. This roadway was subsequently closed to traffic. In total, 46 out of 116 floorbeams required emergency repair.

The severity of the deterioration resulted from the fact that the roadway has no drainage system and water continually flows off the roadway onto the structural steel below. Modern design calls for a drainage collection system but frequently the discharge is not carried below structural members resulting in unnecessary corrosive conditions.

Fig. 3 Web Deterioration

PP99 was found to have its web completely deteriorated between the flange angles at the point of near maximum shear adjacent to the exterior stringer. Upon being notified of this condition the Transit Authority immediately suspended service across the Williamsburg Bridge.

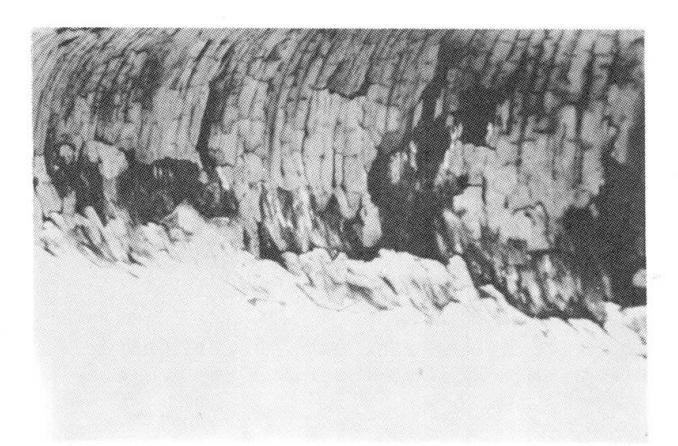
Our visual inspection of the wrapping found that the paint had peeled from the wrapping throughout most of its length but especially at the bottom of the cable. The wrapping had corroded at many locations and there were damaged

Fig. 4 Cable Paint Condition

sections of the wrapping that permitted water to penetrate to the cable. The locations of the worst situations plus a statistical approach led to the decision to pick five locations at which to unwrap cables and perform the sampling programs.

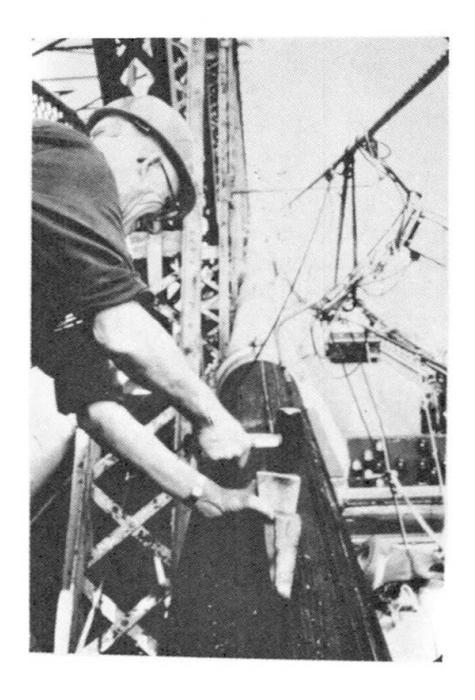
Fig. 5 Wedging the Cable

The procedure was to open a groove in the cable using wooden wedges and hydraulic jacks, visually inspect and take macro lens photographs, extract, coil and tag the sample for shipment to the laboratory. As the wire was cut the retraction of the wire was measured. The groove opening was then cleaned using a soft wire wheel brush or a cup wire brush. Samples of the corrosion and existing lubricant were then collected and sent to the laboratory for analysis. After cleaning photographs of the wire were taken at five foot intervals. One coat of protective oil (Vitalife 400) was then applied in the groove opening. After this procedure was completed at the eight groove openings, additional protective oil was applied liberally into the cable at that work location. The cable was then wrapped with Herculite and the inspection proceeded to the next work location.

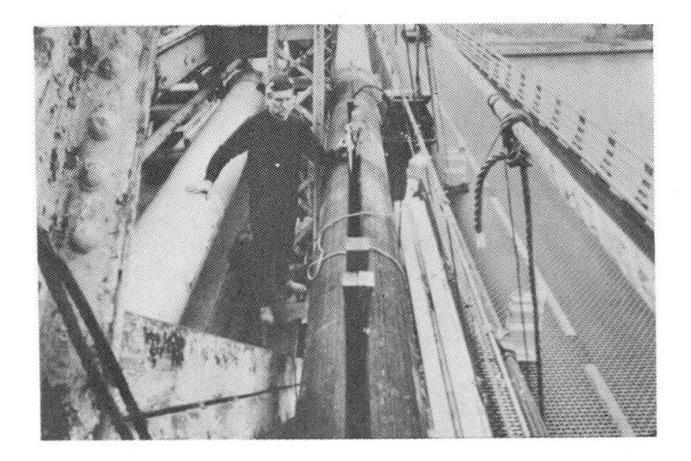
Fig. 6 Hydraulic Jack

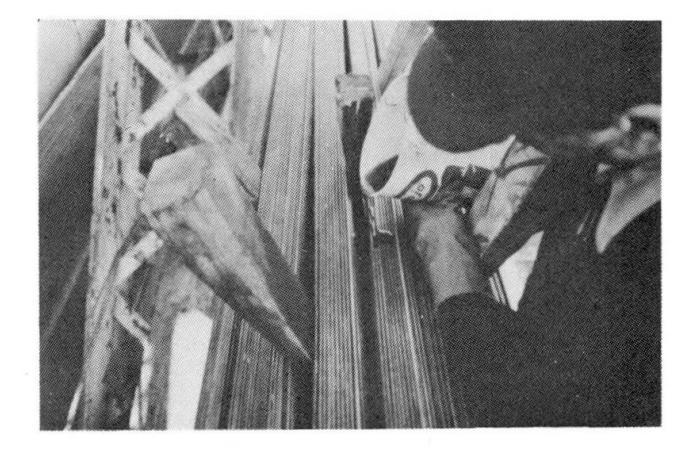
Fig. 7 Applying Protective Oil

With the results of this in-depth investigation at hand, the decision to proceed with the rehabilitation rather than replacement of the structure could be made. An opportunity now exists to rehabilitate the structure eliminating those causes of serious corrosion and establishing a rehabilitation design and maintenance program developed to optimize the life-cycle costs of a durable structure.
