Zeitschrift:	IABSE reports = Rapports AIPC = IVBH Berichte
Band:	57/1/57/2 (1989)
Artikel:	Causes of damages and rehabilitation of the Pancevo Bridge
Autor:	Pakvor, Aleksandar / Djurdjevi, Mihajlo
DOI:	https://doi.org/10.5169/seals-44282

Causes of Damages and Rehabilitation of the Pancevo Bridge

Aleksandar PAKVOR Professor, Dr. Sc.

Mihajlo DJURDJEVIĆ Research Assist., Mr. Sc. University of Belgrade Belgrade, Yugoslavia

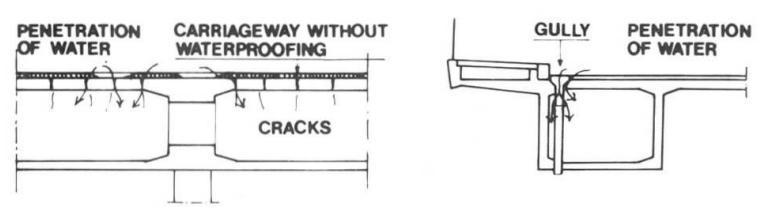
Fig. 3 - The penetration of water to the inside of the box

majority of structures. The cracks were mainly perpendicular to the main girders direction and distributed in the zones around the medium supports and about the middle of the span, Fig. 3. A detailed inspection of the structures has been made including the "survey" of cracks, both from the outside

One of important design and execution failures is that waterproofing has not been planned. That has caused penetration of water and salt used for rubbing the bridge deck during the winter time. The penetration was to the inside of the box, through the bridge deck, and especially through cracks appearing in the upper zone, above the medium supports, Fig. 3. Incorrect and damaged gullies were another way of water penetration to the inside of the main girder box. Their designed position in the middle of the span is very inconvenient as that is the place where the tendons are concentrated in the lower zone and the lower chord through which the drainage tubes penetrate, Fig. 6.

In order to improve the traffic conditions on the bridges and in order to acquire protection and to increase durability of the structures, the following has been done beside the already mentioned works: waterproofing, replacement of the pavement and of guilles and expansion joints, repair or replacement of the bearings and of other damaged elements.

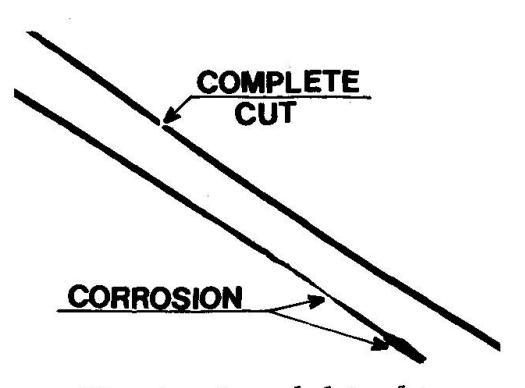
Fig. 4 - Corroded tendon

It has been found out that prestressing tendons were corroded on some of the places, from slight corrosion to complete cut, Fig. 4. Cement grout for injecting tendons was not of the required quality and on some of the places it did not exist, at all, Fig. 5. By measuring the existing force in the tendons, it was established that on a number of wires the designed prestressing force was not achieved. The results of measuring their own free oscillations and damping pointed to the decrease of general rigidity of the main girders.

For improving the state of stress and in order to achieve the required prestressing force, supplementary prestressing has been performed using new tendons of the IMS system. The tendons 4015.2 mm in polyethylene tubes are placed in the inside of the main girder boxes, Fig. 10. On the places on which the tendons

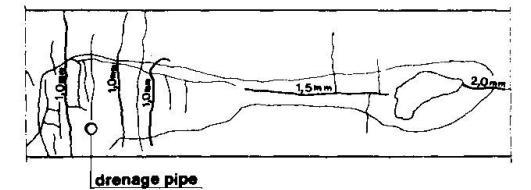
Fig. 6-Damaged lower chord

Large damage and concrete deterioration zones have been tested and checked by ultrasonic, Fig. 6. The quality of the built in concrete and of the prestressing wires was examined, too.

Long presence of water in the inside of the box has also contributed to the corrosion of tendons as no openings on the lower chord for drainage of possibly penetrated water have been designed. No wire net was placed at the openings for entering the inside of the main girders and for aeration so the inside of the box made a good "home" for birds. In time, a thick layer (10 cm and more) of birds'excrement, eggs and similar impurities was formed which had extensively increased aggressivity of the environment, Fig. 6.

On one of the structures on which greater deterioration of the concrete, due to permanent wetting, and action of frost and salt took place, the whole damaged zone of the lower plate was replaced – several square metres, Fig. 6.

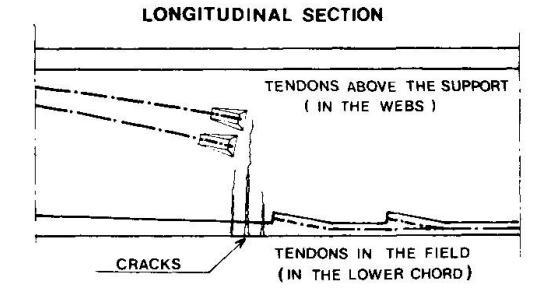
Fig. 8 - Irregular end of tendons

A certain number of crackes has appeared in the zones around 1/4 of the span due to incorrect anchoring of the tendons in the lower chord and webs as no care was taken of the necessary overlapping of the tendons at the places of anchorage, Fig. 8.
