Zeitschrift:	IABSE reports = Rapports AIPC = IVBH Berichte
Band:	57/1/57/2 (1989)
Artikel:	Repair of fatigue-cracked plate girders in highway bridges
Autor:	Nishimura, Akira / Horikawa, Kohsuke / Takayama, Hiromi
DOI:	https://doi.org/10.5169/seals-44284

Réparation de poutres métalliques de ponts ayant des fissures de fatigue Reparatur von Blechträgern mit Ermüdungsrissen in Brücken

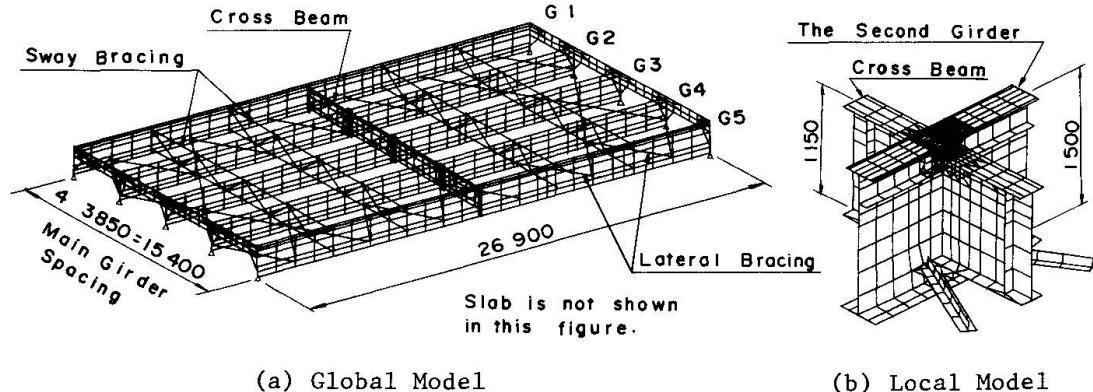
Fig. 1 Types of Fatigue Crack

Plate girder bridges have been of predominant use in the construction of urban highway system in Japan. These are comprised of main girders, cross beams and sway and lateral bracings. And reinforced concrete deck is placed on the top of girders. Recent investigation reveals that small fatigue cracks are apt to be found at welding around connection plate at the intersection between the main girder and the cross beam, or the bracing. Some propagate through web of the girder.

(3) Most cracks are classified into Type 1 shown in Fig. 1. Type 2 cracks follows.

From the experiment, it was concluded that the rotational difference between the slab and the cross beam or the bracing is the main cause of the defects. Other inducements are to be welding defects caused by an excessive root-gap, or a notch of weld bead around a scallop.

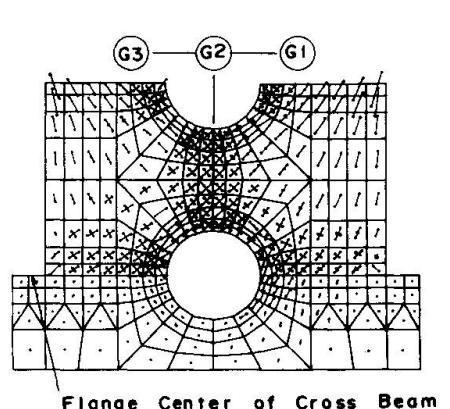
Relation between σg and $\Delta \theta$ Fig

close correlation between the equivalent stress at the connection plate and the rotational difference between the slab and the cross beam as shown in Fig. 4.

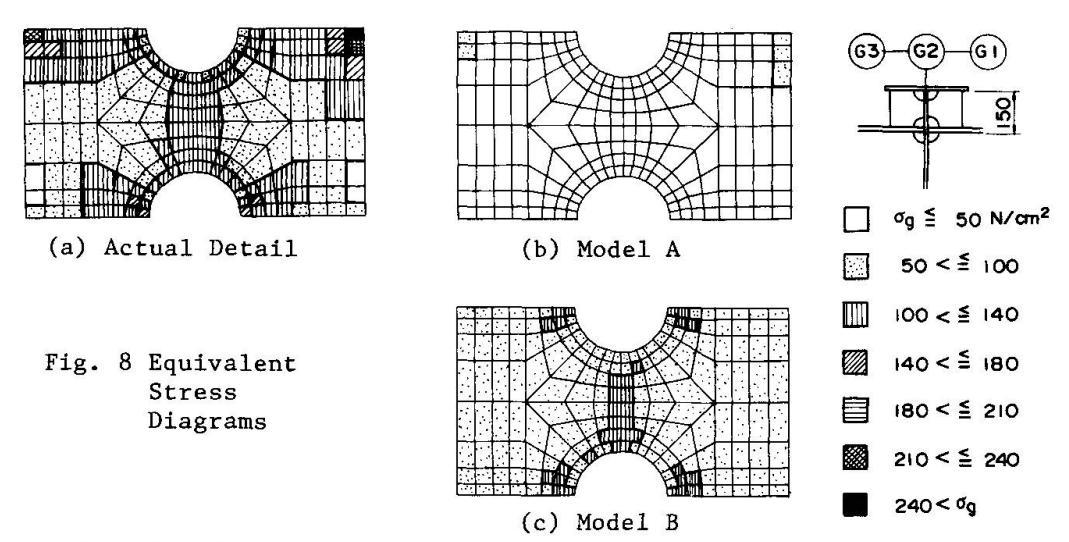
Fig. 7 Prototypes

Two prototypes shown in Fig. 7 are proposed as repairing prototypes. For Model A, Fig. 7(a), the thickness of the connection plate was tripled. For Model B, Fig. 7(b), a rib plate was attached along the edge of the connection plate. Analysis was performed in accordance with the method shown in 3.1. The results are shown in Fig. 8. Model A lessens stress to one third. Model B improves the stress distribution at the free edge of the connection plate, but stress distribution around the scallop remains almost the same.

From these results, Model A was expected as an effective repairing detail and its availability was confirmed by fatigue testing on the tested two-girder type specimen by replacing cracked connection plate with tripled thickness one.

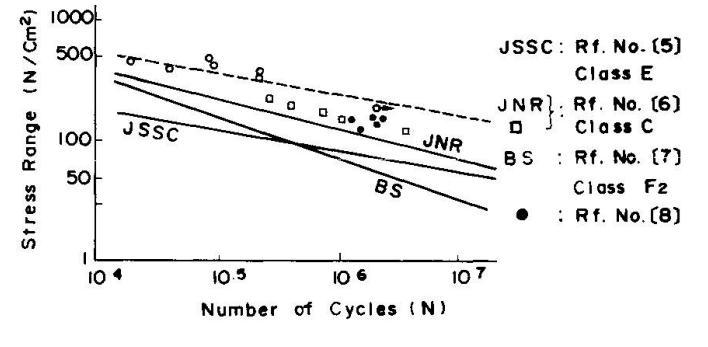
The similar fatigue test as 3.3 was also performed for the structure designed by applying new specification. No cracks were detected. A series of the fatigue test was summarized as S-N relation in Fig. 10. The

doted line shows the S-N line given by the least square method. The slope is, k = 1 / m = 0.185,

m = 5.4,

therefore the stress amplitude for 2,000,000 cycles is about 200 N/cm². Assuming that the bridges showed the defects are estimated to have experienced stress amplitude of 80 N/cm² for the past 14 years, we may conclude that bridges designed by new specification can sustain more than $(80/25)^{5.4}$ × 14 years.
