Zeitschrift:	IABSE reports = Rapports AIPC = IVBH Berichte
Band:	57/1/57/2 (1989)
Artikel:	Aluminium curtain wall panel failure; assessment and repair
Autor:	Cuoco, Daniel A. / Velivasakis, Emmanuel E.
DOI:	https://doi.org/10.5169/seals-44285

# Aluminum Curtain Wall Panel Failure, Assessment and Repair

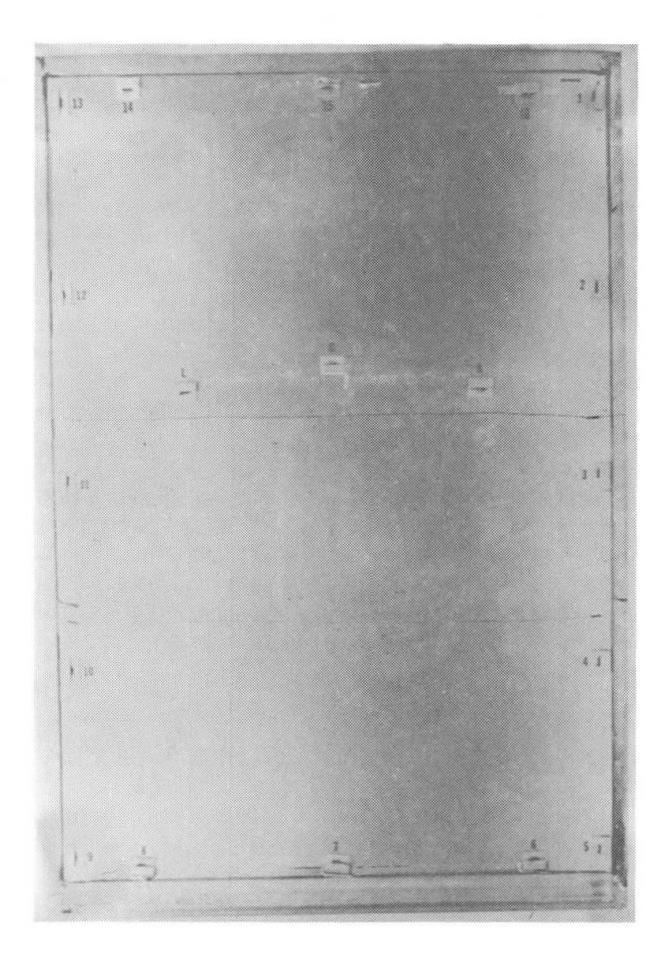
FIG. 1 Typical wall panel assembly

The typical wall panel assembly consists of a 1.42m x 2.13m x 4.76mm aluminum flat plate with 19 aluminum clips welded to the inside surface of the plate (Fig. 1). These clips attach the plate to the perimeter mullion system and an intermediate horizontal stiffener at the approximate mid-height of the panel. In addition, the top edge of the plate fits into a continuous groove formed into the upper horizontal mullion. Since the building has approximately 9,000 wall panels, there are almost 200,000 clips utilized on the building.

A metallurgical evaluation of the separated panel and its remaining clips was conducted. It was concluded that the fatigue-sensitive nature of the clip-topanel weld detail, combined with poor welding, resulted in fatigue cracking of panel clip weldments which caused the panel to separate from the building.

Clips that were found to be missing or broken during the field inspection and survey were repaired by fastening either the existing clip or a new replacement clip to the panel using stainless steel screws.

In addition, stainless steel screws were installed along the bottom edge of all panels by drilling and tapping into the panels from the inside of the building. This, along with the existing continuous groove support at the top of the panel, provided basic stability for the panel independent of the clips, and was performed as an advance safety measure while the investigation was proceeding.

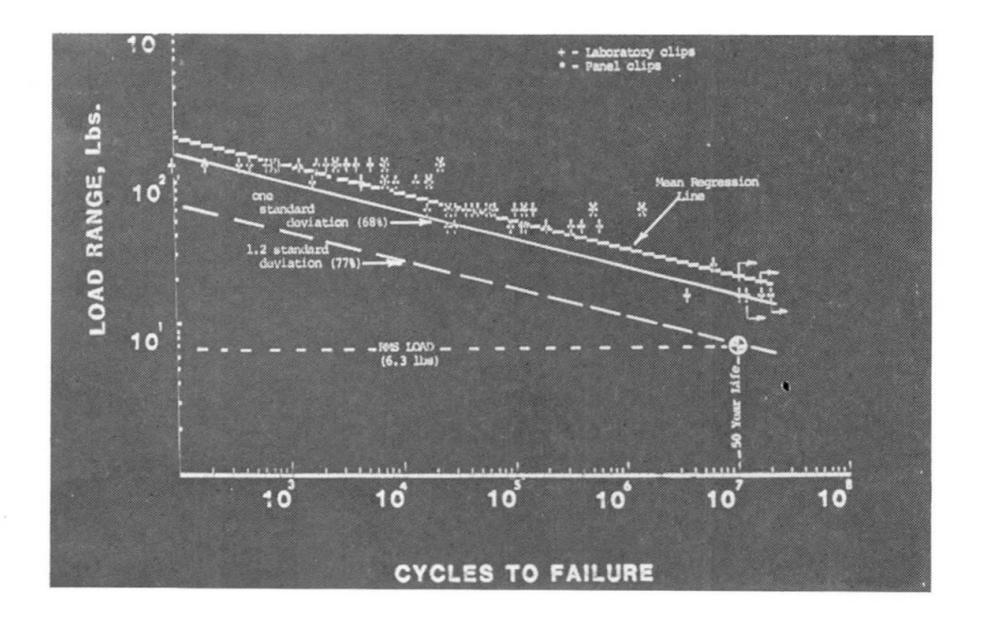
FIG. 2 Load vs. cycles to failure

In order to determine the expected fatigue life of existing panel clips, constant-amplitude cyclic testing of numerous panel clips was performed. These panel clips consisted of existing clips removed from the building, and also new clips fabricated with "imperfect" weldments simulating the existing weldments in the building. The test results were plotted to obtain a "load vs. cycles-to-failure" curve for the clips (Fig. 2).

Based upon the cyclic wind loading spectrum that was derived, a root-meansquare (rms) wind loading of 10.4 kg/m<sup>2</sup> at 10 million cycles, corresponding to a 50-year life, was computed. This translates to an rms load of 2.9 kg at 10 million cycles on the most highly loaded clip. Fig. 2 indicates that there is a 77% confidence level that a maximum-loaded clip weld will survive 50 years.
