# Repair of the Bascule Pier of the Oddesund Bridge

Hans TYCHSEN Civil Engineer Danish State Railways Copenhagen, Denmark

Poul CHRISTENSEN Civil Engineer Rambøll & Hannemann Aalborg, Denmark

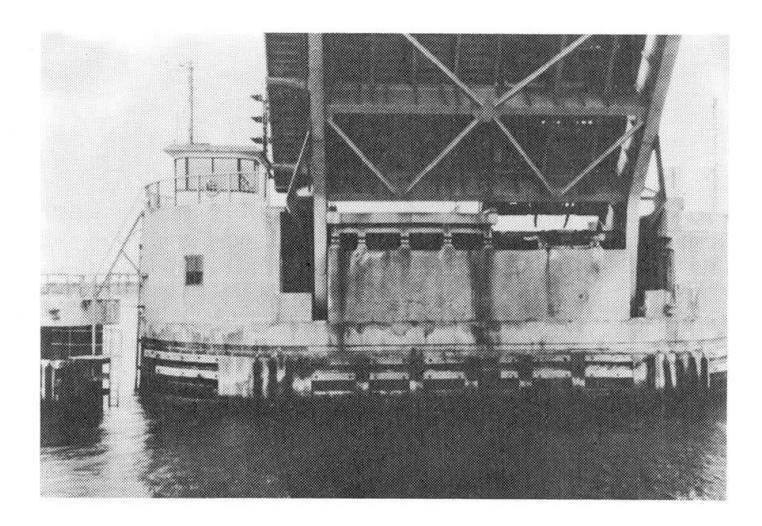
Fig. 2

Already shortly after the Oddesund bridge had been finished in 1937, settlements and cracks as well as deformations were found in the bascule pier (Fig. 2). Since then the bascule pier has been subjected to continued examinations, repairs and reinforcements. Likewise, it was the main object in connection with the work of the Danish Alkali-Silica Committee in the 1950's and the 1960's.

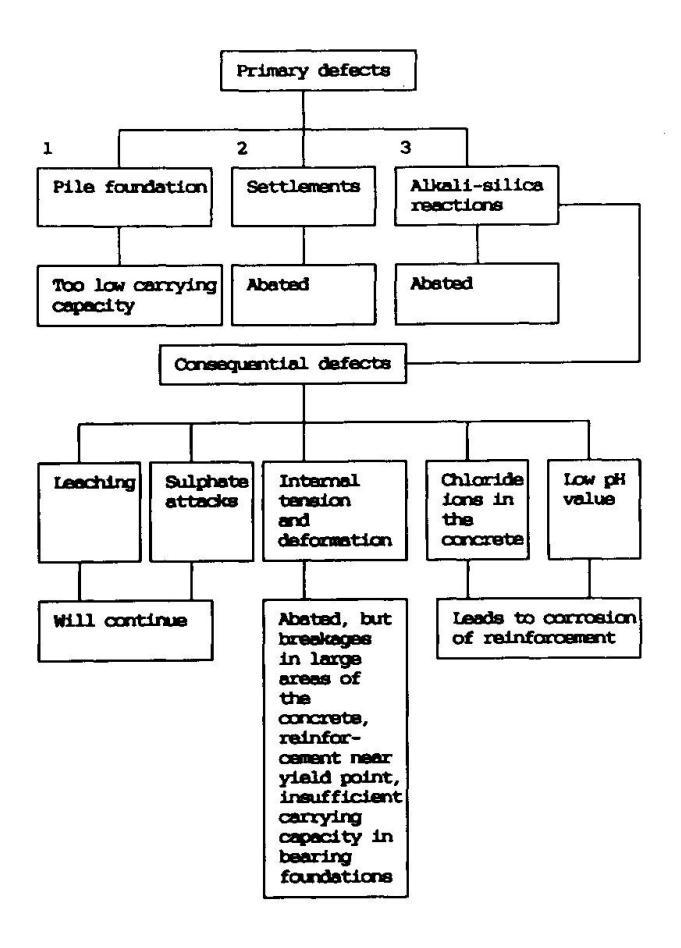
Registration of the condition of the pier was carried out as well as evaluation of its carrying capacity and structure, and the history of the defects was clarified. The history of the defects appears from the outline below.

The defects can be divided into three "primary defects":

- 1. The carrying capacity of the pile foundation is too low, especially with regard to the ability to absorb impacts from ships and the load of ice.
- 2. The pier has settled towards the channel and towards the west owing to different foundation conditions and different pile point levels, but the settlements have now abated, and the consequential damage has been repaired.
- 3. The concrete of the bascule pier structure is heavily affected by alkali-silica reactions resulting in expansion and differential expansions. As a consequence of this the concrete has become severely cracked, and changes in the original geometrical form of the bascule pier have occurred.
