# Vibration Fatigue of Steel Bridges of the Bullet Train System

Fatigue cracks caused by out-of-plane vibration were observed in steel bridges of the Tokaido Shinkansen. Crack growth behaviour, measured cyclic stresses, evaluation of fatigue damage, and retrofitting methods are described.

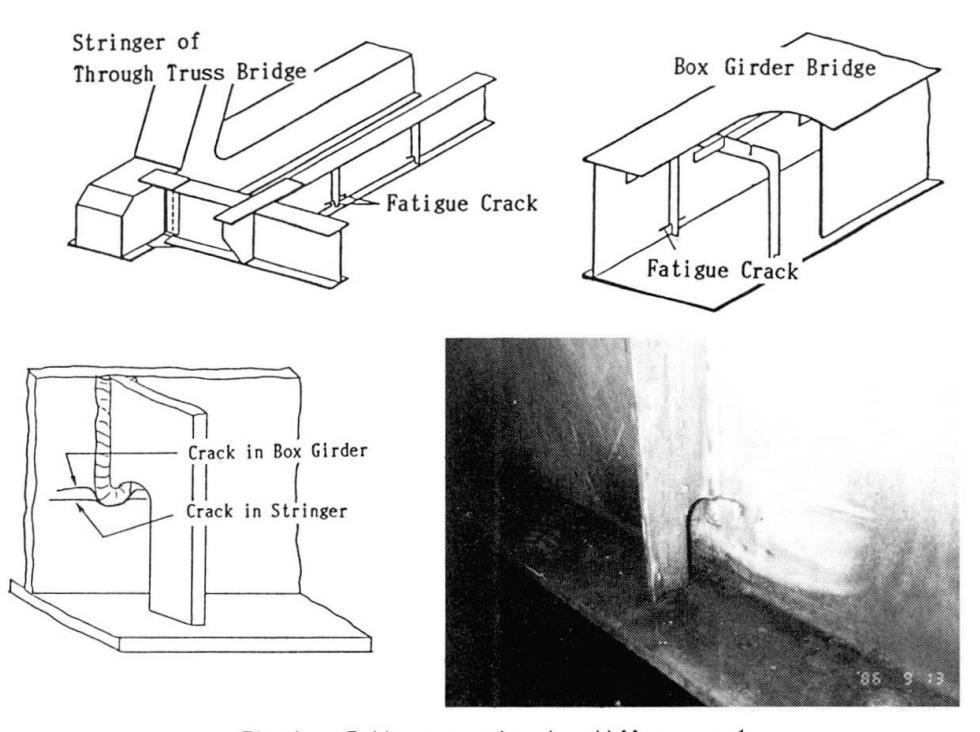
Fig.4 Fatigue crack at stiffener end

Fig. 4 shows cracked girder web. This type of fatigue cracks occurred at the lower end of the stiffener on girder webs of box girder bridges and stringer webs of through truss bridges. Characteristically, no crack has occurred at the end of the stiffener to which floor beams or sway bracings are connected. These fatigue cracks began to be observed in 1978. To date, cracks have been observed in about 10,000 details of about 200 box girder bridges and in about 100 details of five through type truss bridges. Countermeasures were taken against all parts of through type truss bridges which were considered to undergo cracking.

As a countermeasure against these fatigue cracks, it is most effective to stop local horizontal vibrations of lower flange which cause fatique cracks. In some truss bridge stringers, fatique cracks were removed by applying of arc air gouging and rewelded and then an additional plates were installed by highstrength bolts (Fig. 10). In some cases a sway bracing was also Another possible measure is to increase the fatigue added. strength of the detail. As it is costly to add plates to a slight fatigue crack, it was necessary to consider an economic method for raising fatigue strength. It is advisable to improve the fatigue strength of the toe of a fillet weld and prevent occurrence of additional crack in a part where occurrence of a fatigue crack is not confirmed as a preventive measure. Application of TIG (Tungsten Inert Gas) arc remelting has considered as an effective and economic method for repairing a fatigue crack at the toe of a fillet weld and improving fatigue strength.
