Zeitschrift:	IABSE reports = Rapports AIPC = IVBH Berichte				
Band:	67 (1993)				
Artikel:	Safe capacity of suspension bridge cables				
Autor:	Sluszka, Peter / Kendall, Martin				
DOI:	https://doi.org/10.5169/seals-51399

Safe Capacity of Suspension Bridge Cables Sécurité de la capacité portante des câbles de ponts suspendus Sichere Traglast von Hängebrückenseilen

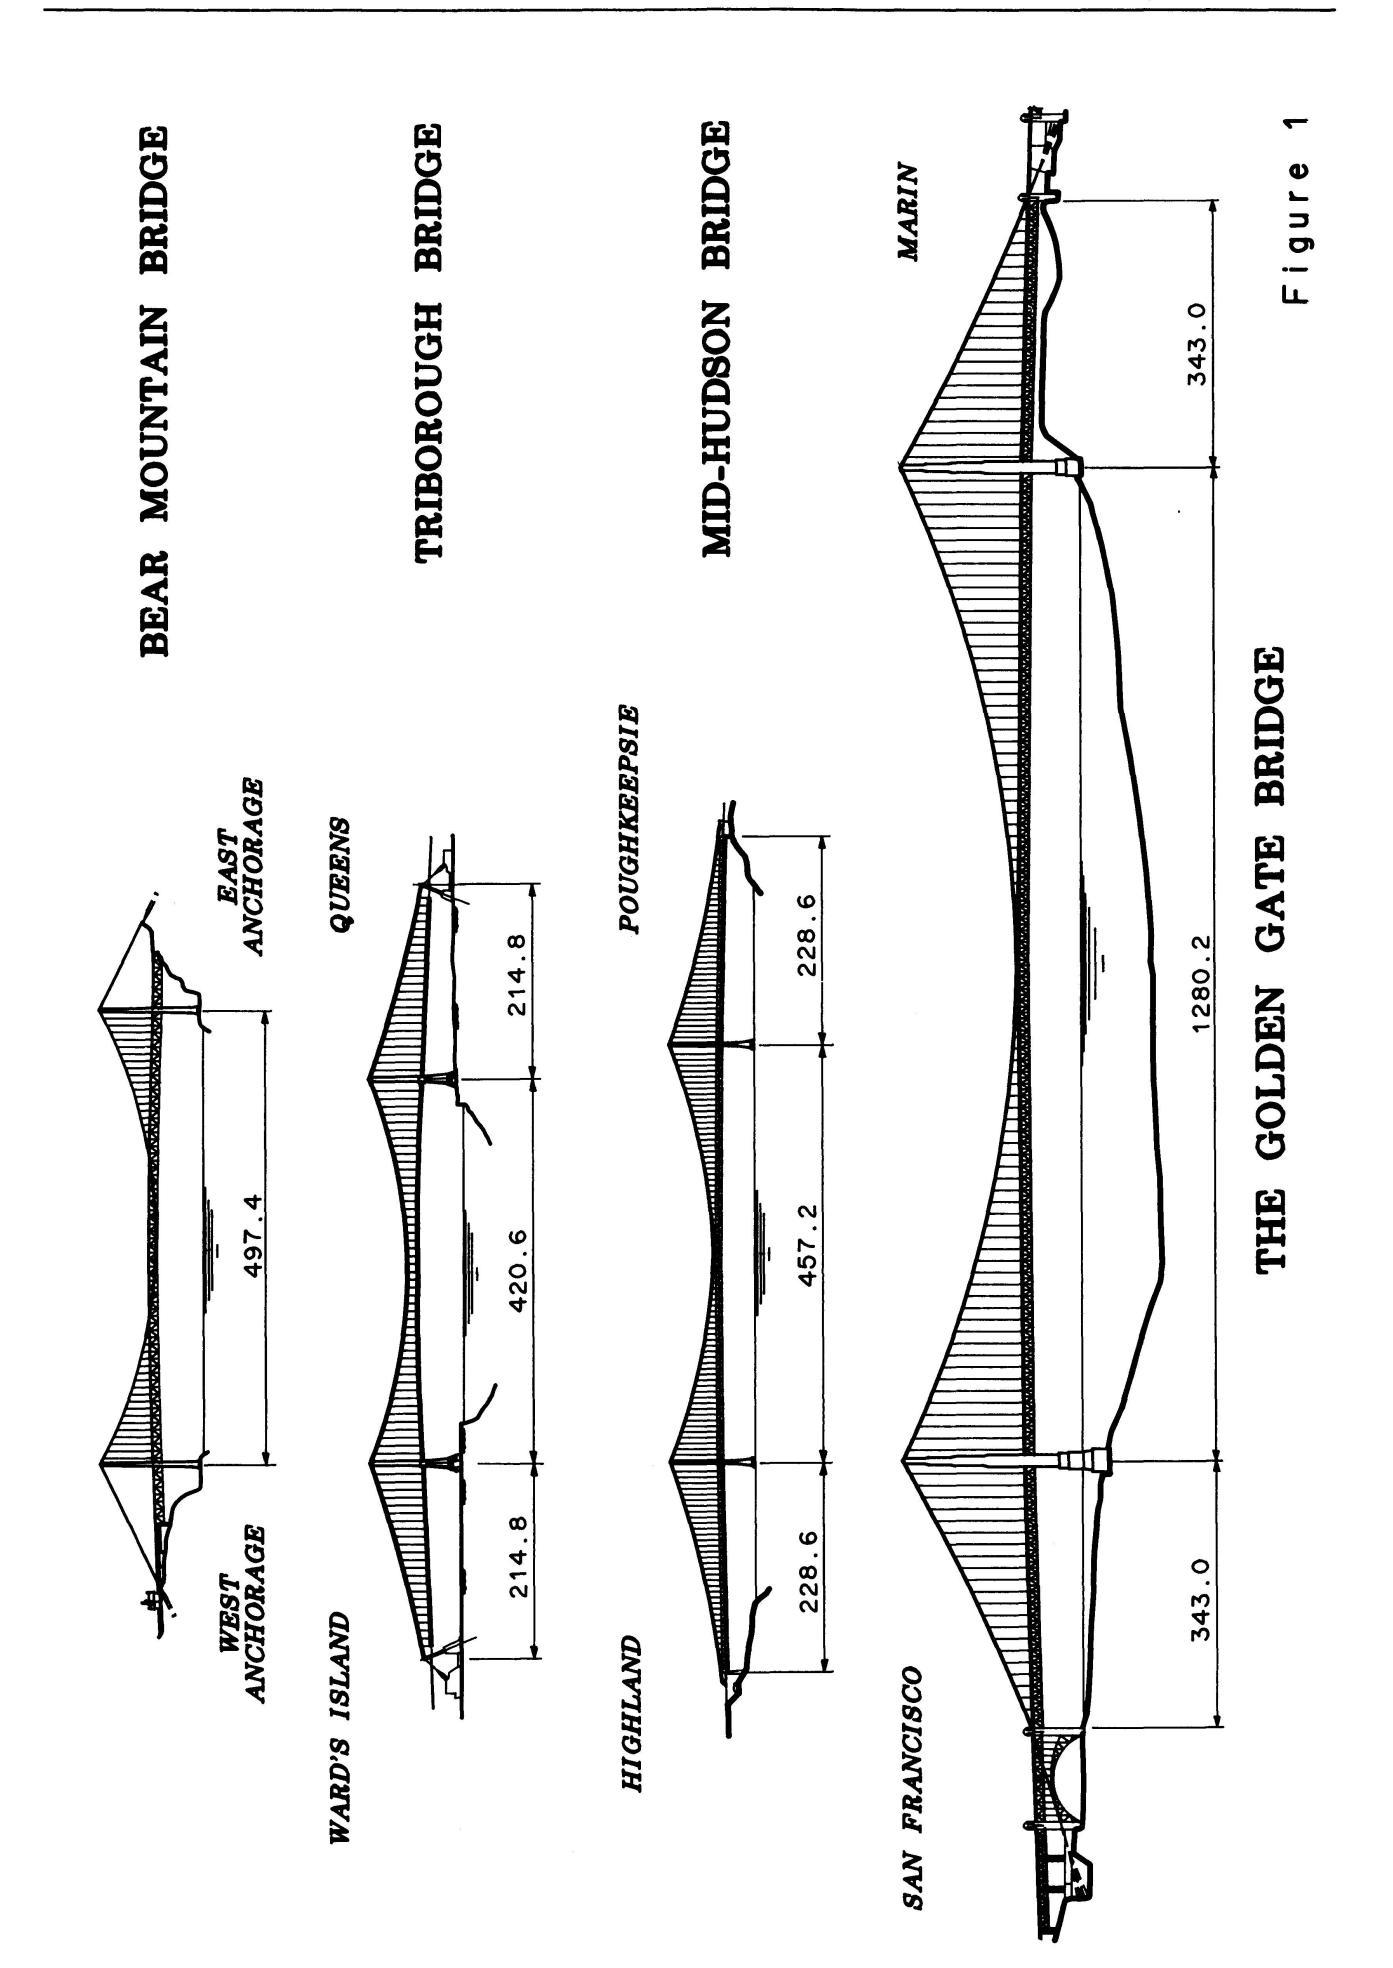
1.6 The size of the spans and cables, with the exception of the Golden Gate Bridge are all roughly comparable. The make-up, size of cable, and spans are listed in Table 1 and the bridges are illustrated in Figure 1.
