Zeitschrift:	IABSE reports = Rapports AIPC = IVBH Berichte
Band:	70 (1993)
Artikel:	Structural assessment of St. Mark's Basilica, Venice
Autor:	Rossi, Pier Paolo / Ventrucci, Franco / Vio, Ettore
DOI:	https://doi.org/10.5169/seals-53298

Evaluation structurale de la Basilique de St. Marc, Venise Tragfähigkeitsbeurteilung der Basilika von San Marco, Venedig

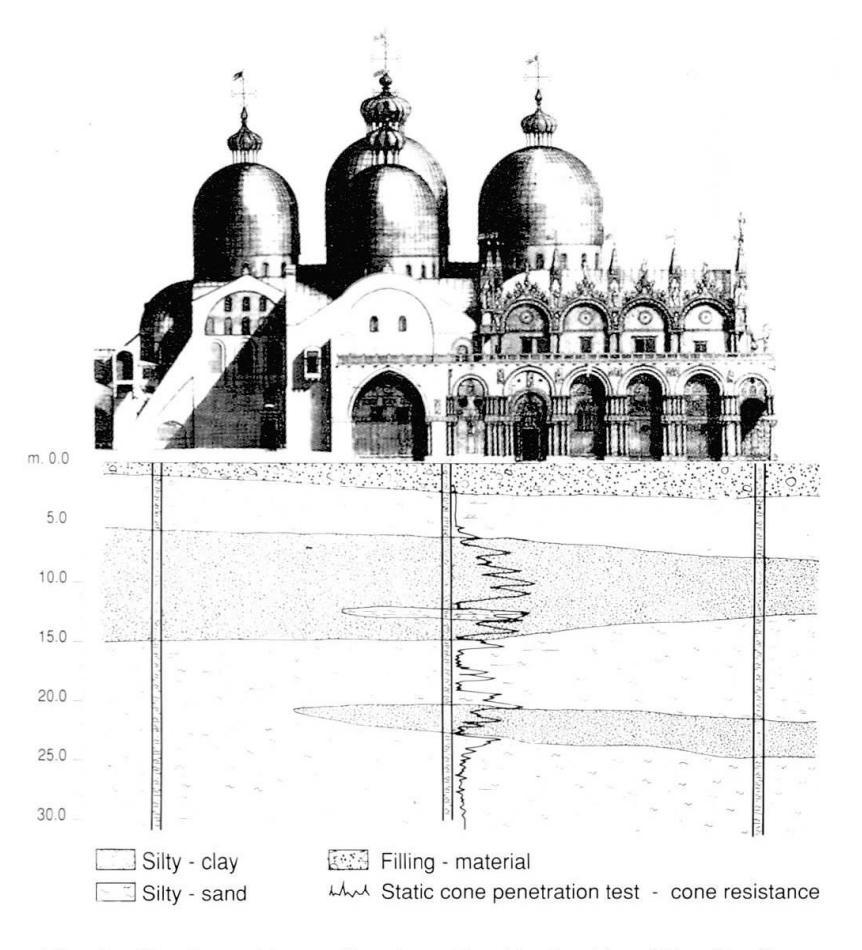
Fig. 2 - Stratigraphic profile along the North side of the Basilica. The results of static cone penetration tests are presented

silty-sand layer with higher mechanical characteristics is also present with a thickness varying between 5 and 10 m. Under the sand layer, silty-clay material was found. The presence of local lenses of sand inside the silty-clay material was observed as usual in lagoon-side environments. Three boreholes were equipped with electric piezometers and three with long base settlement-gauges connected to an automatic reading unit. This monitoring system will allow the settlement of the perimeter of the Cathedral to be controlled as a function of time and water-table variations.

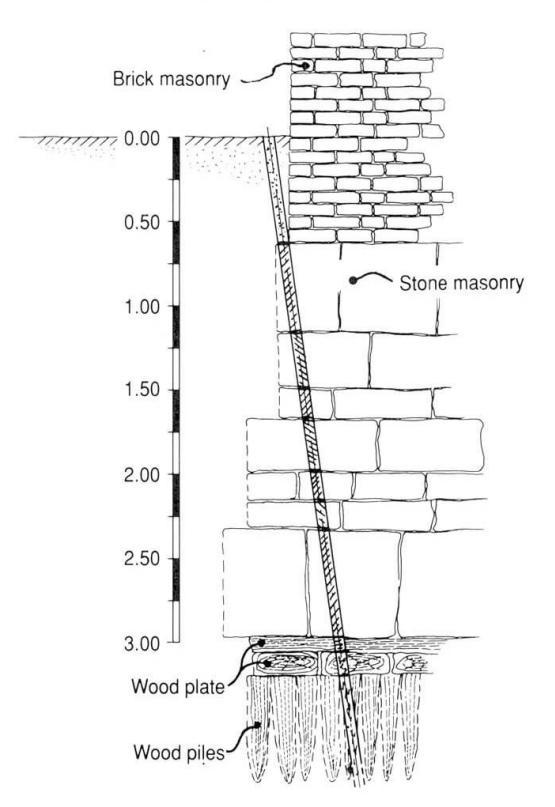
An in-depth investigation was also carried out to analyze the geometric and structural characteristics of the foundation masonry of the perimeter walls and of the pillars. Several small boreholes (diameter 62 mm) were cored by using a light diamond saw and the lateral surface of the boreholes was surveyed by means of a colour video camera. Fig. 3 shows the drilling equipment installed at the base of a pillar for coring the foundation masonry. More than 50 subvertical boreholes were drilled to investigate the structural characteristics of the foundation masonries. In order to obtain qualitative information concerning the mechanical characteristics of the masonry structures, a sonic-log survey was carried out as well as cross-hole measurements by using two parallel boreholes. As a result of the coring and video camera survey, the typical structural scheme of the foundation masonry was determined (Fig. 4). At a depth of about 70-90 cm from floor level, a stone basement made with large blocks of sandstone is present with a thickness of about 2 m. Underneath this stone basement there is a wood plate (10 cm thick) which is about 3.0 m below the floor. This wood plate rests on short wooden piles which are very poorly preserved.

Fig. 4 - Structural scheme of the foundation masonry

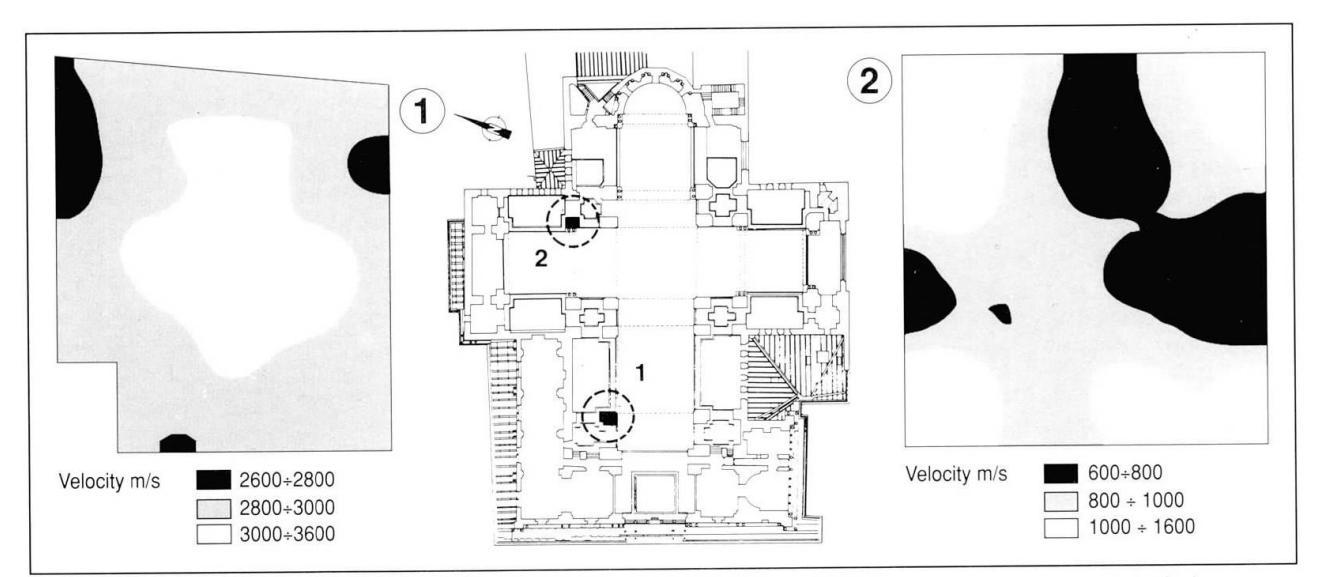
Fig. 5 - Results of tomographic survey in two pillars with different mechanical characteristics

shows the results for pillars 1 and 2. It can be clearly observed that pillar 1, which was consolidated by grouting about 30 years ago, clearly shows high velocity values, especially in the internal zone which was involved in the grouting operation. On the contrary, the velocity values obtained for pillar 2 show that the mechanical characteristics of this pillar are very poor (in fact no consolidation work was performed on this pillar in the past).

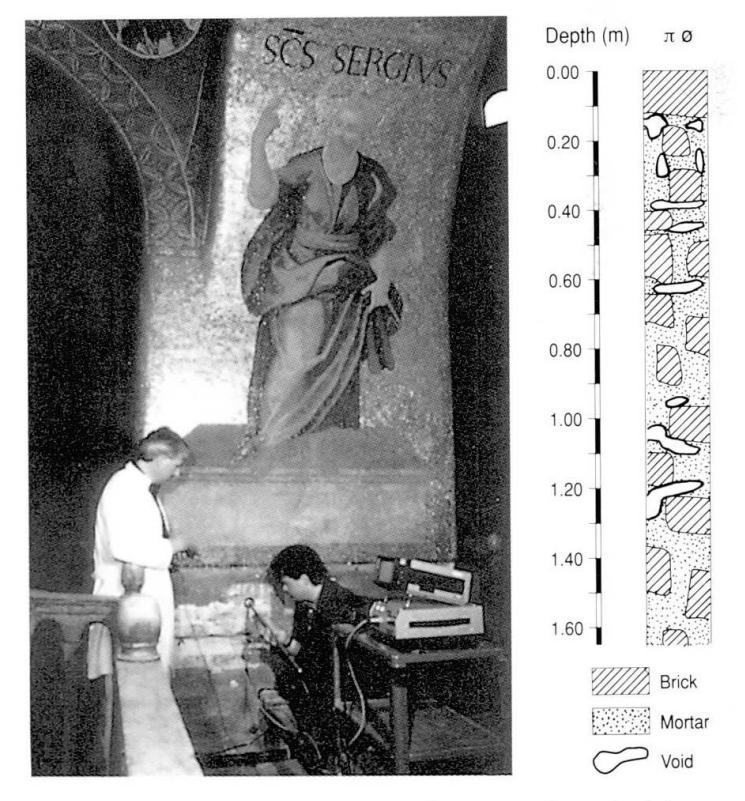
In every pillar, horizontal and vertical boreholes (more than 60) were drilled by using light drilling equipment. Then a video camera survey was performed with a detailed description of the surface of the boreholes. Fig. 6 shows the equipment used for the video camera survey and the results of the inspection into the horizontal borehole of the pillar 2 indicated in fig. 5. A large number of voids can be observed inside the masonry, which confirms the results obtained by sonic tomography. By drilling subvertical boreholes (about 4 m long) starting from the level of the women's gallery, it was possible to investigate the lower part of the pillars lined with marble plates. Several boreholes were also carried out along the perimeter walls of the Basilica.

Fig. 6 - Video-camera survey equipment and result of the inspection into the horizontal borehole drilled in the pillar n. 2

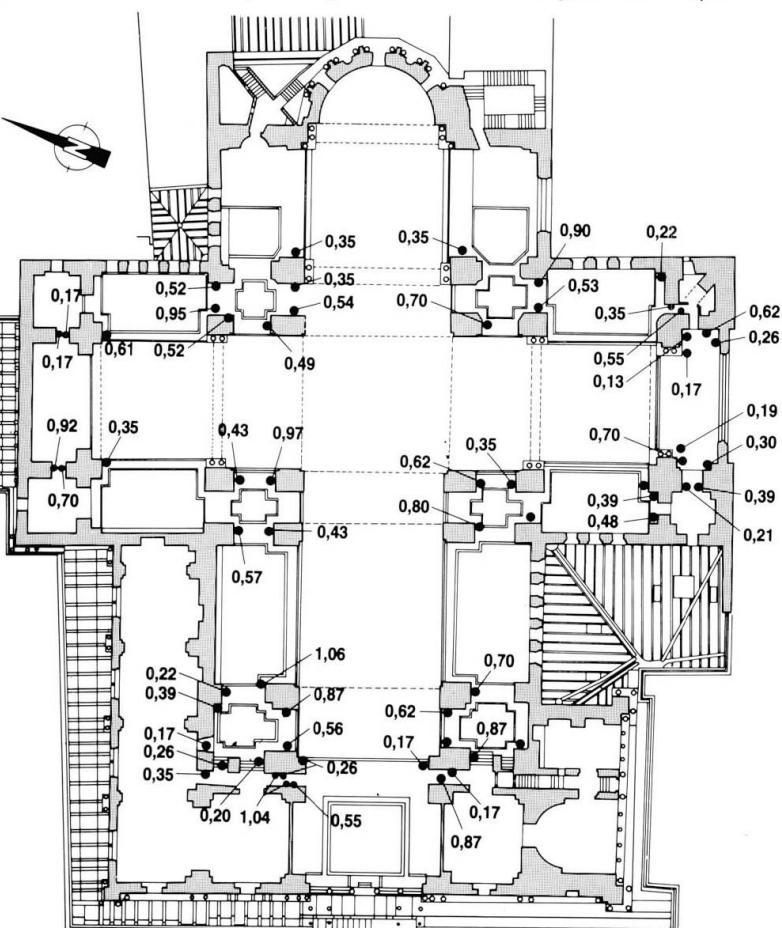
The stress values measured on the pillars are shown in fig. 8. A certain heterogeneity of the state of stress in the pillars can be observed, which is related not only to the position and size of the pillars but also to the type and extent of the consolidation works which some pillars have undergone in the past. High stress values (up to 1.1 MPa) were measured in some pillars. Furthermore, in the above-mentioned pillar 2 (the south-east pillar of the St. John's Dome), a state of stress of 0.95 MPa was measured. This value was considered very high in relation to the results obtained by sonic tomography, coring and video camera survey.

Fig. 8 - General lay-out of the flat-jack testing point with the indication of the measured states of stress

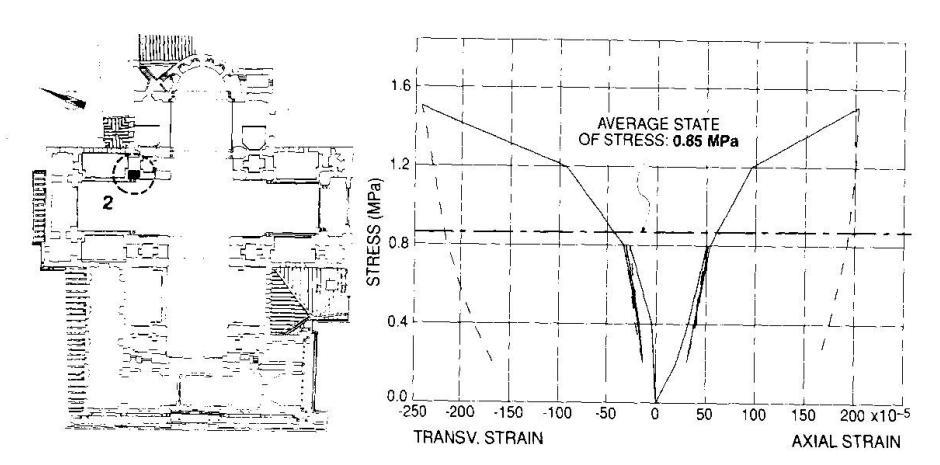
crack pattern survey was carried out which showed the presence of several vertical small cracks, especially near the corners. Sonic tomography was performed at three sections of the pillar at different heights from the floor and the results obtained confirmed the low velocity values presented in fig. 5. In several points of the pillar, the state of stress was measured by flat-jack test and an average value of 0.85 MPa was found. Then, in two points, the deformability characteristics were determined by two parallel flat-jacks. The typical stress-strain curve of the masonry is shown in fig. 9, where axial and transversal strain values are presented as functions of axial stress. The average value of the measured state of stress is also indicated. It can be observed that the masonry presents a linear behaviour up to a stress level of about 0.8 MPa with a value of Young's modulus of about 2.000 MPa. For higher stress levels, up to 1.2 MPa, Young's modulus decrea-

ses to a value of about 900 MPa and for the stress range between 1.2 and 1.5 MPa the modulus is lower than 300 MPa. It can be observed that the average state of stress measured in the pillar exceeds the limit between elastic and plastic behaviour. This supplementary investigation clearly confirmed that the static conditions of the pillar are not satisfactory and for this reason it was decided to carry out urgent consolidation works which are now in the design phase.

Fig. 9 - Stress-strain diagrams obtained by flat-jack tests on the pillar n. 2 with the indication of the measured state of stress

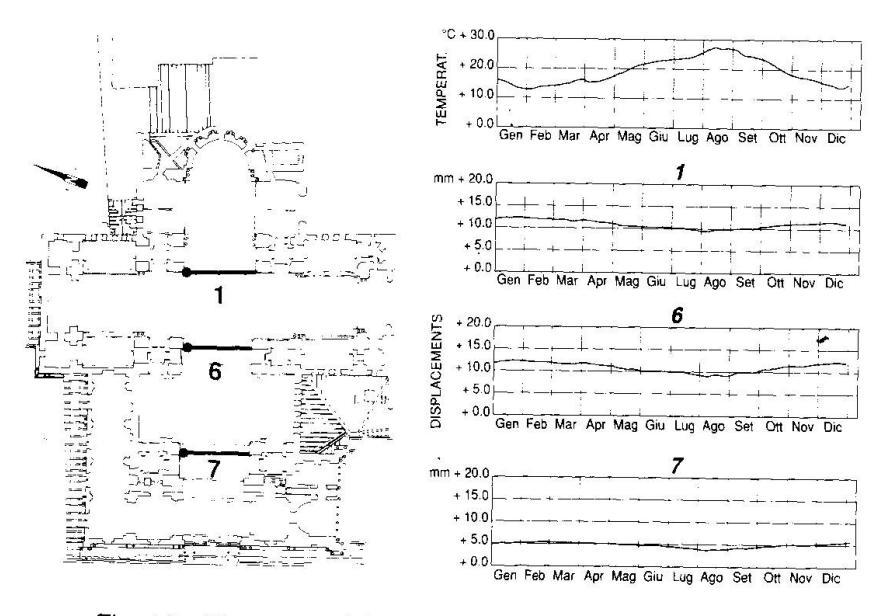
Fig. 10 - Diagrams of the relative horizontal displacements of some pillars during the first year of observation

seen that the deformation diagrams follow temperature changes and no permanent deformation is noticed at the end of the first yearly cycle.
