Repairs to English Monuments: Some Case Studies

Ian HUME Chief Engineer English Heritage London, England

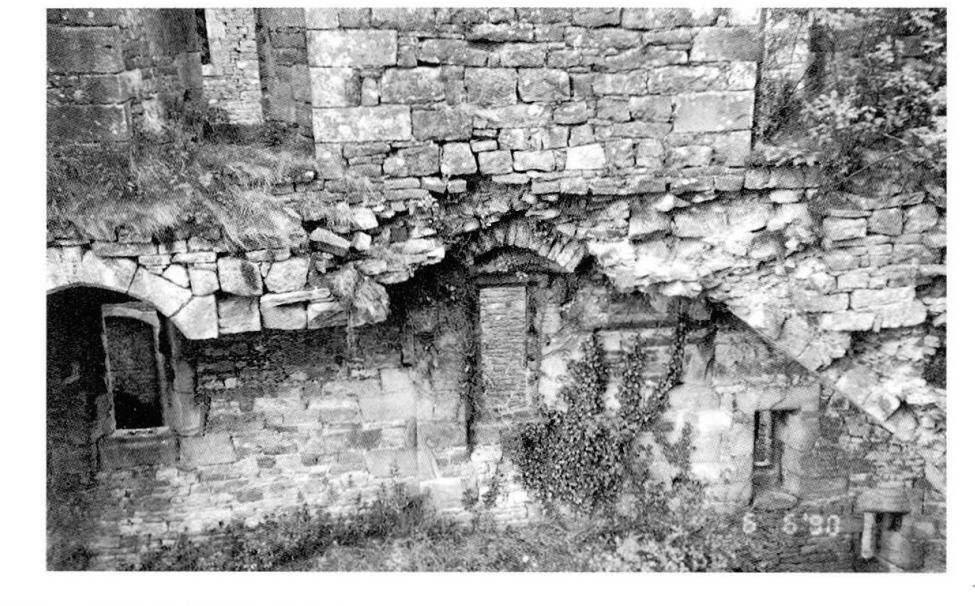
Figure 1. Castle Bolton.

4.1.3 The major problems with Castle Bolton were due to the ingress of dampness into the masonry and the subsequent growth of weeds, plants and trees. In some cases some quite substantial trees were growing in the masonry in inaccessible positions.

Major overhangs of masonry now supported by stainless steel posts.

- Additional supporting works. The additional supporting works thought necessary at Castle Bolton, apart from numbers of small stainless steel dowels to fix loose masonry back locally, consists of some vertical square tube supports in stainless steel. These have been installed to support major overhangs of potentially unstable masonry and are intended as a clear statement of 20th century minimal intervention.

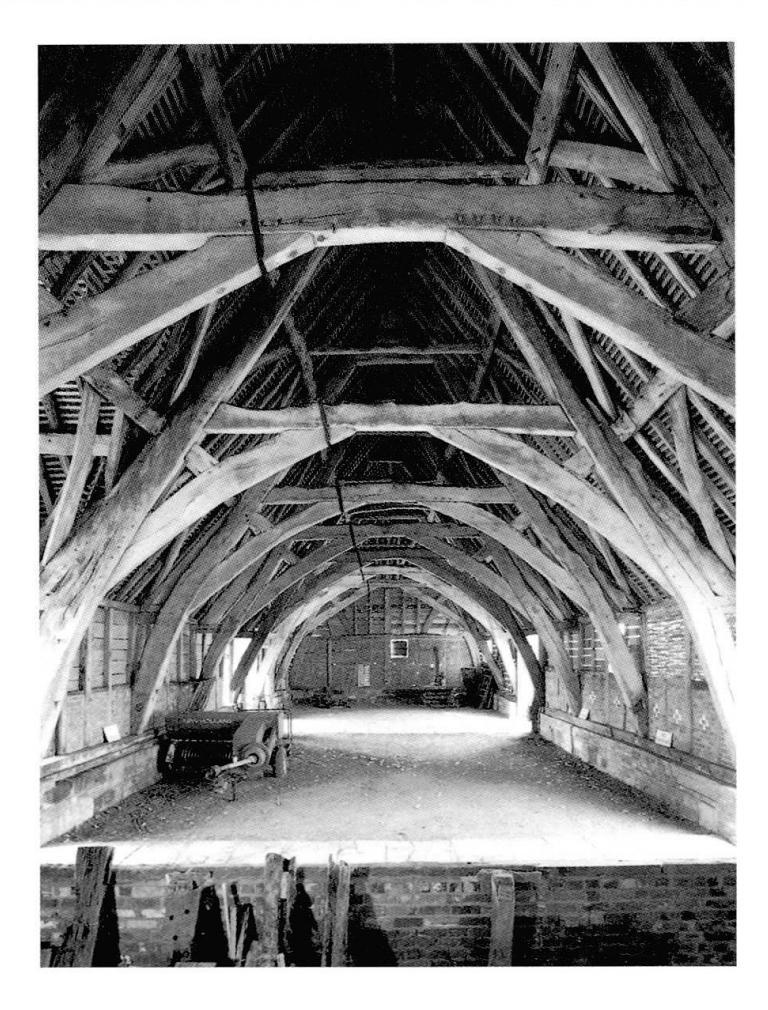
Figure 2. Leigh Court Barn.

5.1.2 The feet of the crucks sit on masonry walls approximately 1m above ground level. The ground conditions are often fairly wet. The thrusts from the feet of the crucks had pushed out these masonry walls to varying degrees and the barn had taken on a distinct lean lengthways. These quite considerable movements had caused some damage to bracing members in the timber frame.

5.1.3 It was decided in this instance to partially dismantle the barn in order that the main cruck arch-braces could be pulled vertical, it being felt that the lean which had taken place was causing undue stress on the timber framework.

new foundations were installed. The foundations consisted of large concrete pads supporting steel columns, which in turn were connected to the bottom of the cruck arches. The concrete foundations being below ground were of course completely buried and the steel supporting posts have been totally surrounded in the original masonry, which was replaced in its original locations. The original timber work was replaced almost 100% with very few members being renewed. Some minor repairs were made to severely decayed members. In order to be certain of the structural adequacy of some of the more decayed rafters simple load tests were carried out to prove that these were strong enough for their purpose.

5.1.5 The whole barn was re-assembled with no signs of modern intervention whatever and few new timbers being used.

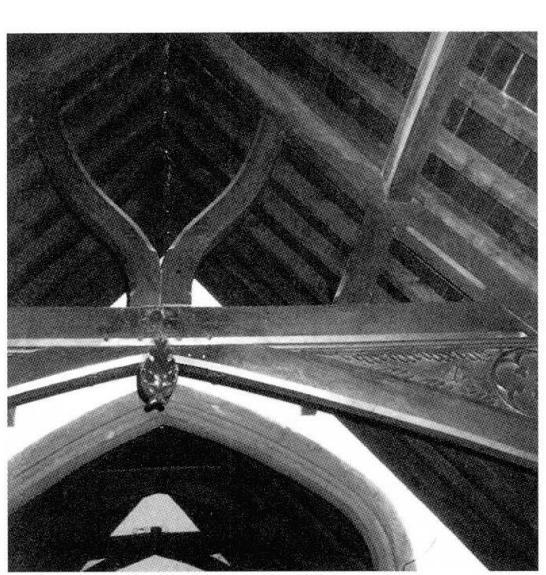
Figure 3.

6.1.2 It was noticed in early 1990 that one roof truss had broken Further investigations showed that a second roof truss was also damaged and that the nave was beginning to lean to the north. A scheme of accurate structural monitoring was immediately installed and when this monitoring proved continuing movement, shoring was installed to the north wall to restrain any further leaning. Investigation of the construction of the building showed that it is, structurally, an exceedingly complex and much altered building. Its complicated construction and important history restricted the possible repair methods available.

Greensted Church. The roof truss joints had pulled apart and the principal rafter had broken at the purlin.

6.1.3 Although the roof covering was in good condition it was decided to strip this to expose the rafters to insert steel T-bars into the upper surface of the principal rafters and to introduce steel bracing to the upper faces of the secondary rafters.

6.1.4 The intention of this was to repair the fractures in the principal rafters rather than to replace them and to strengthen unbroken principal rafters. The bracing created a strong diaphragm on each slope of the nave roof such that sideways forces were transmitted to the substantial brick built chancel arch and the west gable of the nave. When the building was re-roofed all of the bracing work was hidden and the only visible signs of the repair works are some small steel brackets forming end plates to the principal rafter repairs hidden under the overhanging eaves of the nave.

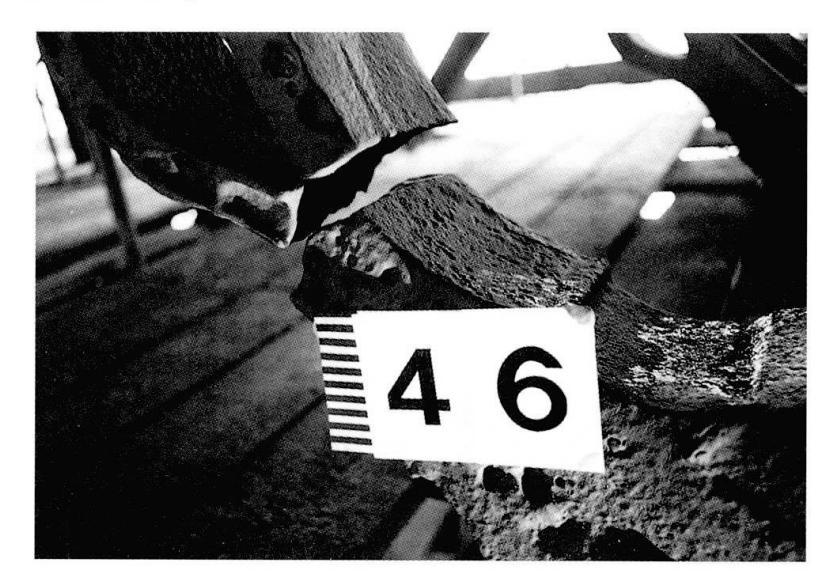
Figure 4.

9.1.1 The Iron Bridge in Shropshire, as will be well known, is the world's first cast iron bridge, being built in 1779 and opened for traffic in 1781. It spans the river Severn at Coalbrookdale with a span of some 32m. In 1981 a scaffold was erected to enable access to be gained to all parts of the bridge. Subsequent survey work showed that there were 83 cracks to various members of the bridge structure. It was decided after considerable thought and a certain amount of computer analysis of the structure, that no action need be taken to repair any of these fractures and therefore work was restricted to thoroughly repainting the bridge and some cosmetic repairs to items such as railings.

Ironbridge. A typical fractured member.

9.1.2 The reasons for taking no action were:

- Some years previously a reinforced concrete strut had been put across the bed of the river to restrict movement of the bridge abutments.

- The arch crown connecting detail which connects the main arches together was a rigidly fixed detail and this had in no instance cracked or become deformed and this clearly showed that no major movements had taken place.

- There was concern that repairing any fracture could, if new movements occurred, create a further fracture rather than allowing the bridge to move on an old fracture point.

- No work was done on the understanding that regular inspections of the bridge were possible and that any further movement would be detected quickly.
