Repair and Strengthening of a Medieval Brickwork Bell Tower

A. BUSETTO Consulting Eng. Pordenone, Italy S. MACCHI Consulting Eng. Milano, Italy

C. MODENA Univ. Padova, Italy

The described case study is the evaluation, repair and strengthening of the bell tower of the Cathedral of Pordenone, in Friuli, the Italy's region stricken by a strong earthquake in 1976. The structure, built during the last years of the 13th century, is 72 m high (Figure 1) and dominates with its imposing mass the historical center of the town.

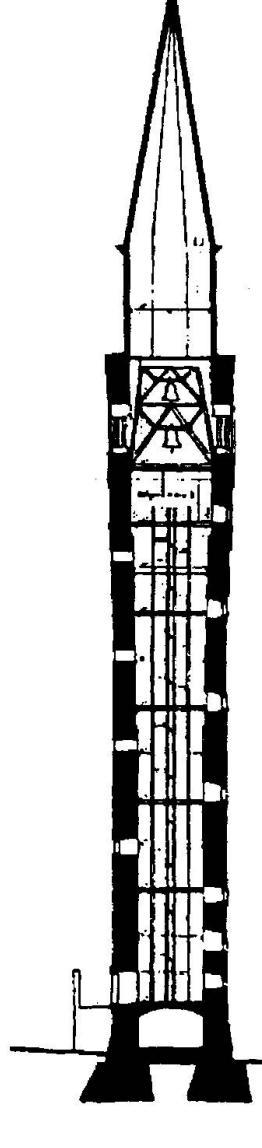
Figure 1

Some major concerns about its actual safety level were however justified by the not negligible inclination (about 1%) and by evident traces of past heavy damages, often caused by lightnings, which were repaired between the end of the last century and the beginning of the present one.

In particular, pictures exist of the damages at the northern corner of the tower, which was near to collapse at the beginning of this century, and the inner part of such corner still presented damages and cracks in 1990.

The previous interventions appeared to be in general very efficient. Such are in particular the strong iron ties applied at five different levels and the reconstruction of the masonry in the outer part of the northern corner.

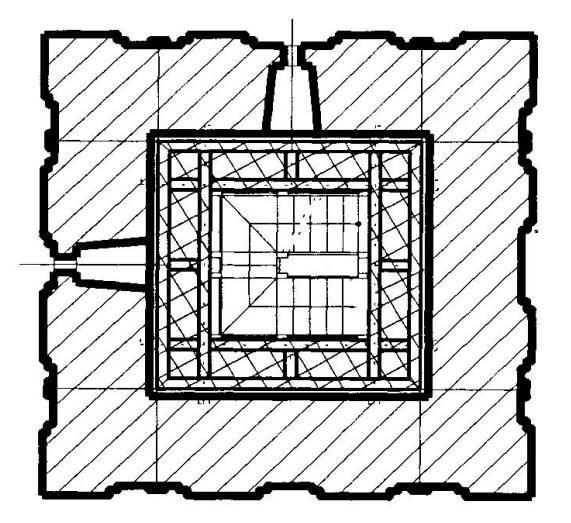
Figure 2 a: section of the tower at the level of one of the diaphragms.

Then, the inactive ties have been substituted and some new ties have been added. Finally, the confinement of the inner parts of the masonry walls have been substantially improved where an external confinement is already provided by the existing iron ties by means of five steel diaphragms in the positions indicated in Figure 1. They are included in the system of the internal stairs as shown in Figure 2 a. Their principal characteristics are shown in Figure 2 b.

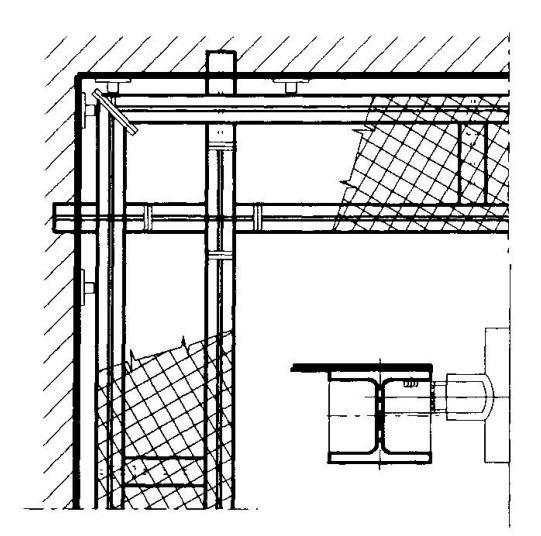
Figure 2 b: details of the steel diaphragms and of the devices used to put them in contact with the masonry walls.

The installation of the diaphragms inside the tower has been made possible by the use of several bolted joints. This construction technique allows the maintenance and, in case, the removal or substitution to be easily executed.

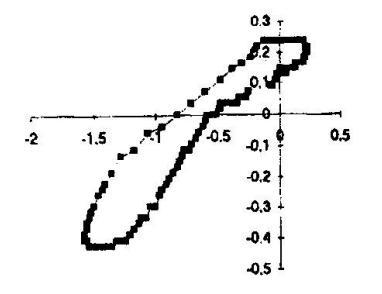
In Figure 3 the daily variation of the tower inclination is shown, which is typically measured through the displacements of the pendulum, in sunny days.

A monitoring system was finally installed to realise an automatic control of: tower inclination, cracks movements, temperature in the walls thickness, water table level and dynamic excitations.
