Zeitschrift:	IABSE reports = Rapports AIPC = IVBH Berichte
Band:	73/1/73/2 (1995)
Artikel:	Reinforced concrete framed building strengthened by prestressing
Autor:	Najdanovic, Dusan / Alendar, Vanja
DOI:	https://doi.org/10.5169/seals-55296

# **Reinforced Concrete Framed Building Strengthened by Prestressing**

Administration building within an industrial complex in Arandjelovac, Yugoslavia, was constructed in 1978. During construction, and very soon after the building was furnished, appearance of cracks and appreciable deformations of the structure was noted. The condition of the building got worst in course of time, caused fear and uncertainty, until the owner has decided to call for help.

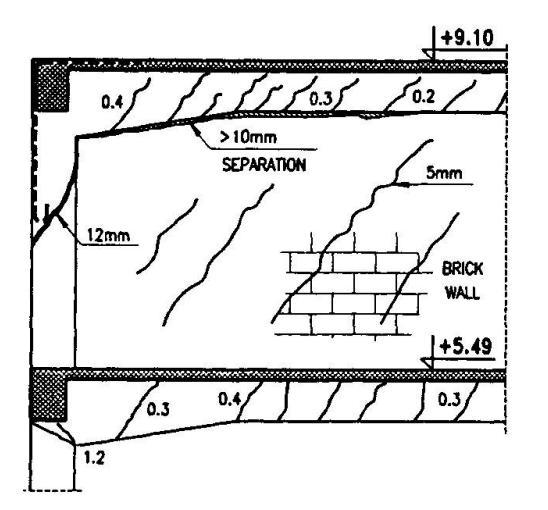
Fig. 2 Characteristic detail 'A' of damages

The most outstanding cracks, up to 0.5 mm wide, appeared in the structure beams. In the span cracks spread in vertical direction along the entire depth of the beam, up to the roof slab. Towards the ends of the beams, the cracks gradually incline up to an angle of approximately 60 degrees regarding the horizontal plane, Fig. 2.

Appearance of inclined cracks at the top of the short columns in the top story, up to 12 mm wide, indicates failure of the column, Fig. 2. Due to increased deflections of frame beams, up to 60 mm in case of roof beam (span-deflection ratio 255), the functionality of the structure was violated, specially at the top story: appearance of doors and windows distortion and jamming, discomfort while walking, separation of partition brick walls from frame beams and columns, in some places more than 1 cm which violated their lateral stability as well as functionality of the installations. Excessive deflections of the roof beams caused loss of the draining layer slope and therefore retaining of water on the roof.

Subsequent structural analysis showed that, due to omission in load estimation and pattern, safety coefficients regarding the ultimate limit state in the large part of the structure are considerably smaller than required, and that the cross-sections are underreinforced. For example, original structural analysis was carried out with assumption of uniformly distributed load. which underestimated "concentrated" effect of load from partition brick walls 120 mm thick, which are perpendicular to transverse frames in the corridor zone, Fig. 1. During service of the building, permissible tensile stresses in reinforcement in a large number of beam and column sections were exceeded, and notable cracks and deformations appeared.

The intensity of columns loading was additionally underestimated, since the stiffness of the beam haunches was not taken into account. As it is common in design of buildings, control of shear strength of columns was not carried out. In case of the third floor 'shallow frame' columns, that was an unacceptable oversight. Inspection of performed column reinforcement details showed that the tensioned reinforcement at the column-roof beam joint was not anchored deep enough into the column, which created conditions of "pulling out" the beam from the column, Fig. 2. At the same time, the lateral reinforcement of the columns is not sufficient to resist developed large shear forces, therefore, failure of column, decrease of rigidity of this story and increase of deformations of roof frame beam occurred.

Before tensioning of the tendons, injecting of cracks and local strengthening of beam and column ultimate shear capacity was carried out by well experienced method of glueing steel sheets onto lateral sides, by glue on the basis of low viscosity epoxy raisins with addition of filler [1]. Firm contact and glue spreading was achieved by bolts, Fig. 5.
