Survey on Fatigue Damage in Steel Railway Bridges in Thailand

Thongpan THAVEE Director The State Railway of Thailand Bangkok, Thailand

The results of the survey of fatigue damage of steel bridges of the State Railway of Thailand are presented. An investigation of the characteristic and the cause of cracks occurring in the welds of stringer necks of through girder bridges was conducted.

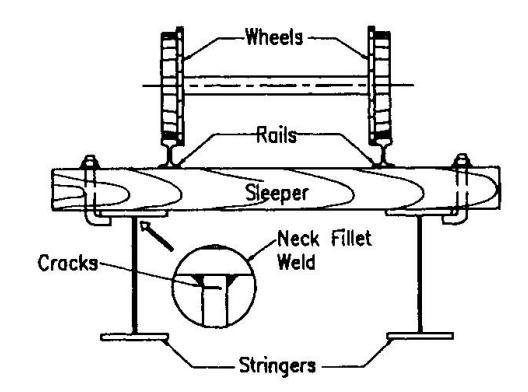
Fig.1 Wheels, track and stringer

The arrangement of stringers and the track and positions where fatigue cracks have occurred are shown in Fig.1. (the same figure used in bibliography 1)

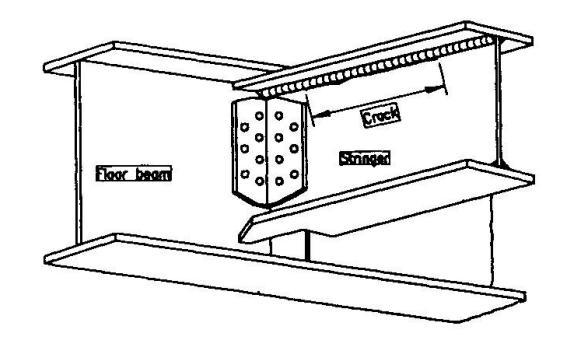
Fig.2 Crack occurring just under the sleeper

Fig.2 shows a crack developing about 700 mm horizontally along the toe on the weld between upper flange and web of stringer (we called "the neck's weld) just under the sleeper. It had, however, not reached the beam's end of the stringer.

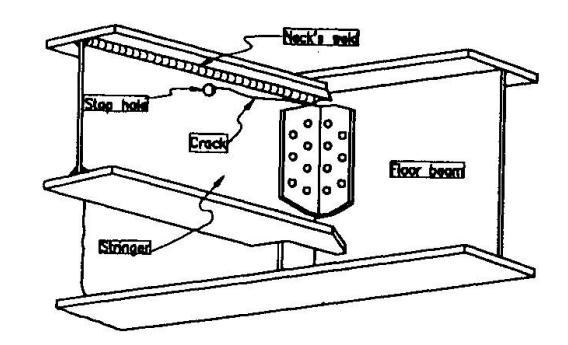
Fig.3 Crack occurring in the beam end

Fig.3 shows a crack occurring in the beam end of a stringer advancing horizontally on the web along the bead toe. At this position, a stop hole is provided at the end of the crack, and found effective to some extent.
