Case Study of a Damaged Reinforced Concrete Bridge

Arlindo GONÇALVES Civil Engineer Lab. Nac. de Engenharia Civil Lisbon, Portugal

This paper presents the results of an inspection carried out in one bridge built 50 years ago, aiming at identifying the origins of general concrete cracking. The results of the observations and tests made it possible to conclude that the cracking was due to alkalisilica reactions. Subsequently, the corrosion of the reinforcing steel caused larger cracks and concrete spalling.

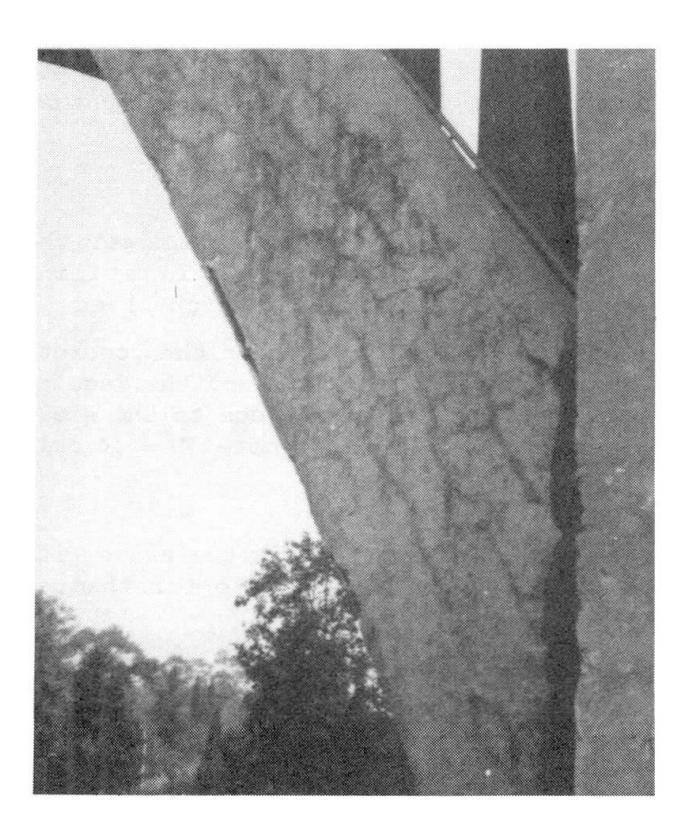
The areas of greater deterioration were located in the central arch, below which the road traffic is more intense, in places more exposed to rain and sunshine. Figs. 2 and 3 show typical examples of cracking observed in concrete.

Fig. 2 Central Arch, southern view. Map cracking

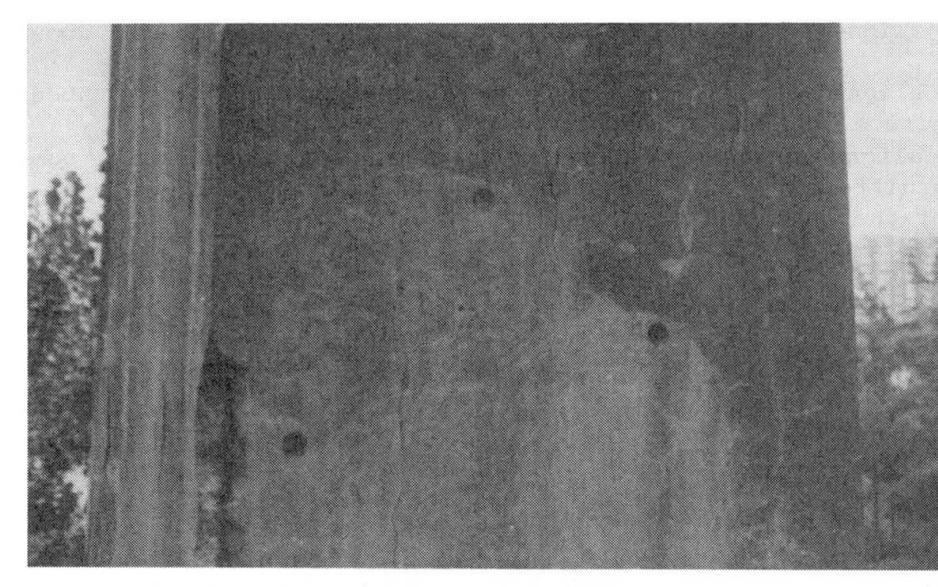
Fig. 3 Column of the Central Arch, facing the south. Cracking aligned with the main reinforcing bars

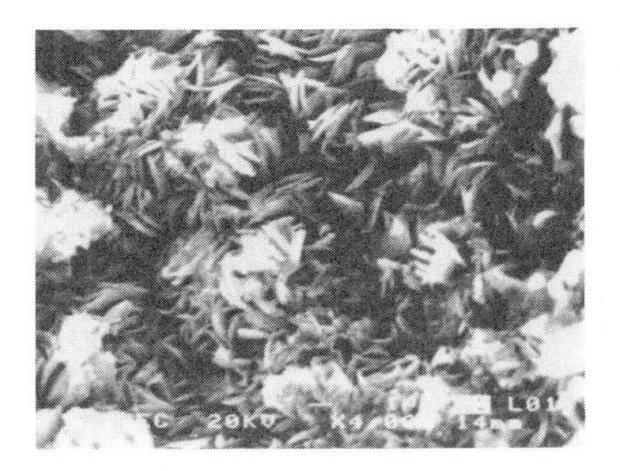
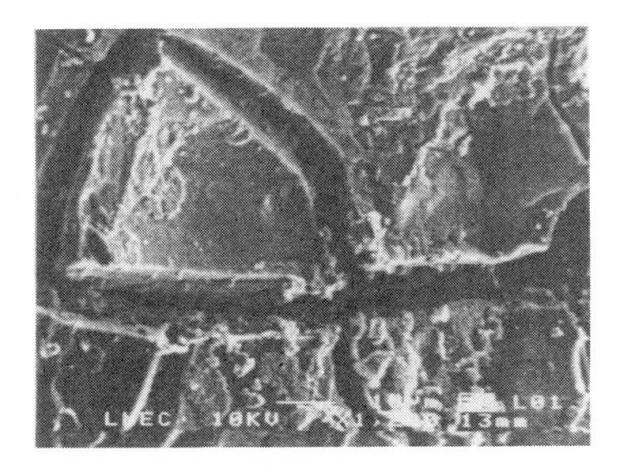
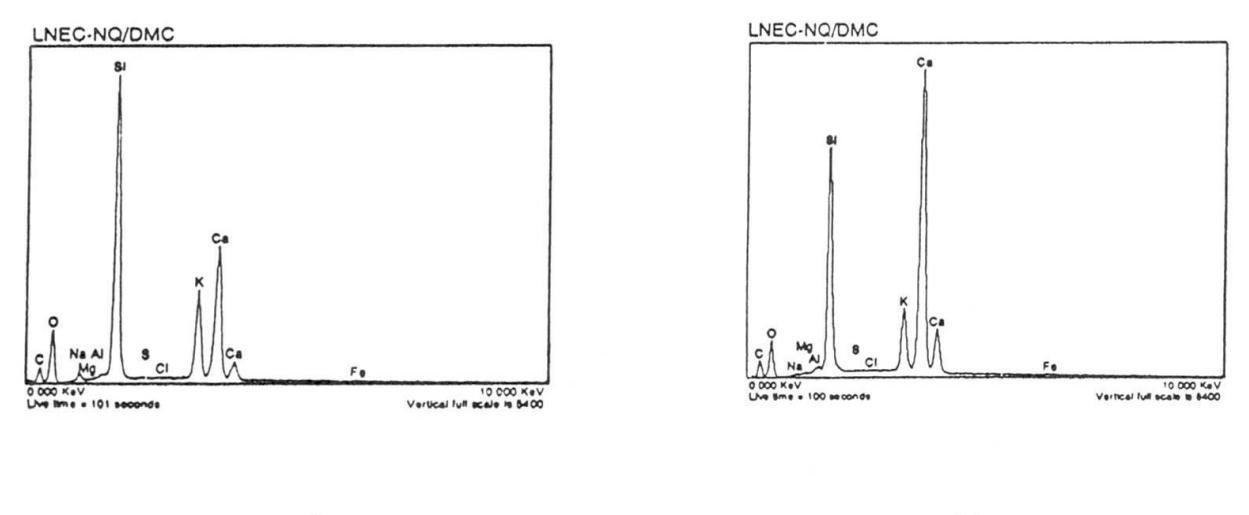
Observations were also carried out on other samples taken from more cracked areas of the Central Arch. These observations showed in limestone/paste interfaces the presence of typical compounds of alkali-silica reaction (Fig. 4), such as hydrated calcium and potassium silicates (crystalline and amorphous), as well as ettringite, either in the characteristic form of acicular crystalls, or in a massive form. Other authors [6] have observed similar morphologies in the presence of alkalisilica reactions.

The X-ray microanalysis of the alkali-silica reaction products showed that the crystalline products are less rich in calcium (Ca) than the amorphous ones. The occurrence of ettringite in cracks, pores and slightly disperse in the paste was also observed.

Fig. 4 Products of alkali-silica reaction (calcium and potassium silicates) in a limestone/paste interface.

a) Crystalline products and corresponding X-ray spectrum;

b) Cracked gel and corresponding X-ray spectrum.
