Zeitschrift:	IABSE reports = Rapports AIPC = IVBH Berichte
Band:	73/1/73/2 (1995)
Artikel:	Structural rehabilitation of a reinforced concrete and a prestressed concrete bridge
Autor:	Croci, G. / Santoro, V.M. / Macri, F.
DOI:	https://doi.org/10.5169/seals-55162

Structural Rehabilitation of a Reinforced Concrete and a Prestressed Concrete Bridge

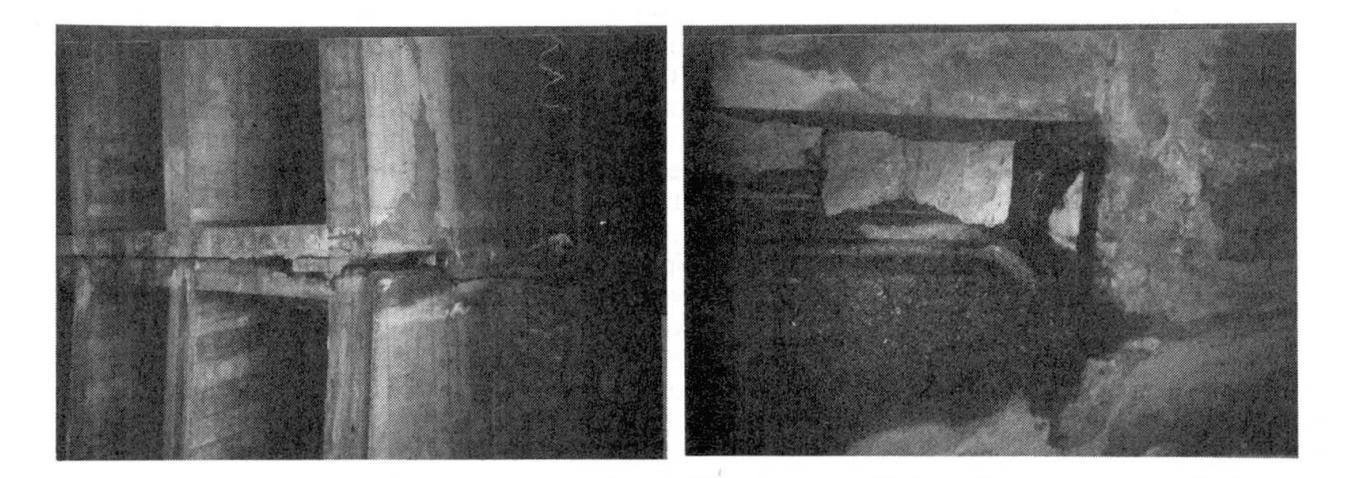
On account of the severe environmental conditions (marine salts in the rain water, wide temperature ranges, heavy traffic) and poor maintenance, the degradation has affected mainly structural elements such as the Gerber joints, in which the steel bars are completely uncovered and deeply corroded

photo 4 - Fiumara di Gallico Viaduct Gerber joint (lower view)

photo 5 - Fiumara di Gallico Gerber joint (detail)

(photo n. 4-5). The seat of the supported beams - which is further restricted by degradation - is so reduced as to cast doubt on the stability of the beams. Weathering has also removed the concrete bar covering in many areas of the decks, particularly on the west side, towards the coast. A detailed program of in situ tests (pull-out tests, carbonation tests, microdrilling and sampling of concrete, endoscopic tests, etc.) on the structure was carried out to evaluate the actual state of alteration of the material, their strength and the efficiency of the supports apparatus.

The principal objective of the intervention was to improve the seismic behaviour of the structure by creating a continuous kinematic chain between the various spans so as to transfer the horizontal actions to special purpose-built structures. In consideration of the state of the Gerber joints, it was decided to demolish these parts of the structure (figure 6) and rebuild them along more siutable geometric lines in order to ensure an adequate seat to the support, insert the bearing devices and accomplish the continuity of the structure by consolidating the upper slabs. The new structure was realized in Rheoplastic high-strength concrete connected to the remaining parts through connecting bars (figures n. 7-8). The supports on the piers were removed, after lifting the decks alternately, and replaced by mobile

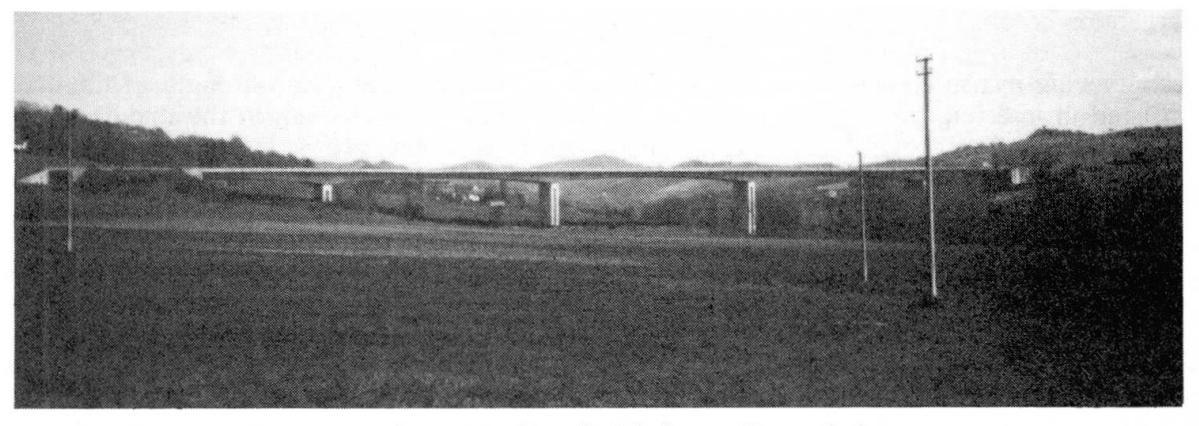
photo 10 - Reggia Viaduct - General view

The Reggia viaduct crosses the catch drain of the same name on the E45 Highway 30 km north of Perugia. It was built in the late seventies using the successive segment cantilever method on piers with a maximum height of 15 meters (photo 10). The cantilevers were then connected, so that the end result is a continuous 5-spans beam on 6 supports. The three central spans are 90 meters long and the lateral spans 45 meters. The supports on the central piers are of the fixed hinge type and those on
