Zeitschrift:	IABSE reports = Rapports AIPC = IVBH Berichte
Band:	999 (1997)
Artikel:	Damage of SRC building structures by 1995 Hyogo earthquake
Autor:	Sakai, Junichi / Minami, Koichi / Matsui, Chiaki
DOI:	https://doi.org/10.5169/seals-1035

# Damage of SRC Building Structures by 1995 Hyogo Earthquake

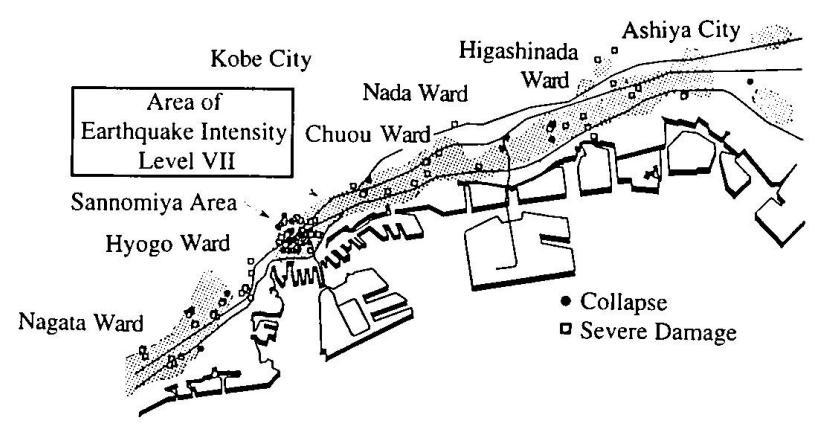
Fig. 1 Distribution of SRC buildings subjected collapse or severe damage.

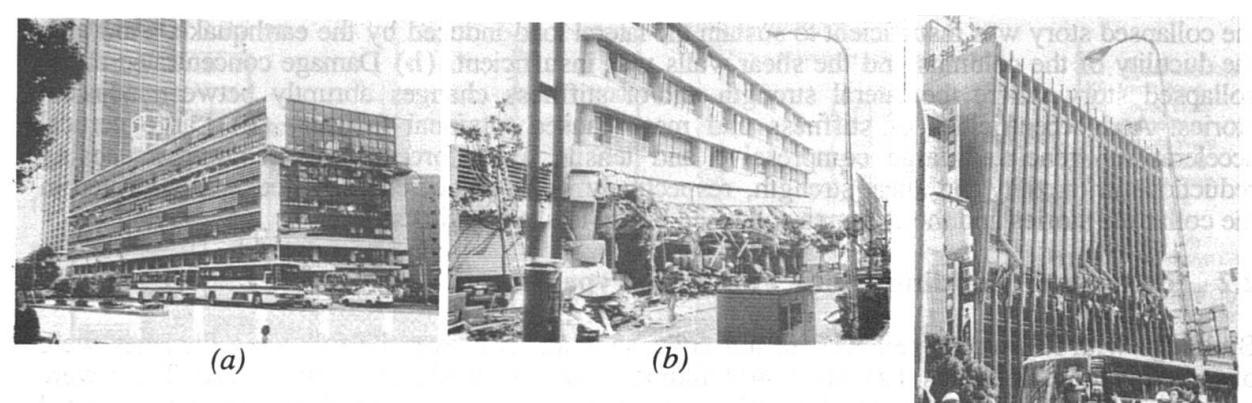
Photo. 1 Collapsed Building with Story Failure at an Upper Floor Level

Thirty-one of SRC buildings collapsed by the story failure. All of them were constructed before 1972 and composed of the open web type SRC. Twenty-seven buildings collapsed by the story failure at an upper floor level (see Photo. 1) and four buildings collapsed at the first story. At the failure story, SRC columns collapsed brittly in shear (see Photo. 2) and concrete in RC shear walls crushed to out of plane. Collapse by the story failure at an upper floor level was characterized of the damage caused by this earthquake. Several factors potentially responsible for these failures can be considered as follows: (a) The design earthquake force distribution over the height used in the old design codes is different from the one used now, and the proportion of design story shear force is smaller at the mid-stories in the old codes. Then the ultimate strength of

the collapsed story was insufficient to sustain the lateral load induced by the earthquake. And also the ductility of the columns and the shear walls was insufficient. (b) Damage concentrated at the collapsed story where the lateral strength and/or stiffness changes abruptly between adjacent stories. And eccentricities of stiffness and mass caused torsional failure. (c) Large vertical accelerations generated large compressive and tensile axial forces in the columns, causing reductions in ductility and shear strength, respectively. (d) Joint of encased steel was located in the collapsed stories and the columns collapsed brittly in shear at this story.

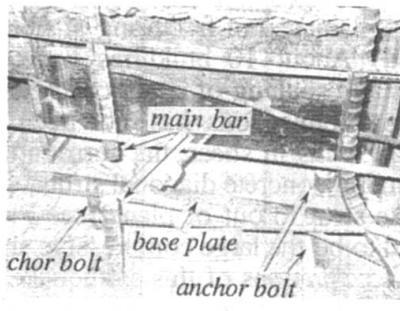
Photo. 3 Fracturing of Anchor Bolt at Column Base (after chipping concrete)

Buildings with full web type SRC did not collapse at all. However the following damages were observed in these buildings: (a) About 40 buildings were damaged at the column base. There were many buildings in which the steel base plate was anchored at the ground floor level using a detail known as "non-embedment type steel base". Severe damage was observed in buildings that used this base plate detail. Concrete crushed at the column base and anchor bolts were pulled out (see Photo. 3). (b) About 10 buildings were damaged of fracturing of encased steel flange plate (see Photo. 4). (c) About 10 buildings were damaged of fracturing of steel splice plate at the joints of columns or beams (see Photo. 5). (d) About 10 buildings were damaged at beam-column connections where diagonal shear cracks and spalling of cover concrete were observed (see Photo. 6), but severe damage at beam-column connections has not been reported. (e) About 40 buildings were damaged of the shear RC walls in shear; the surrounding SRC frame was strong enough to carry the forces delivered from the concrete diagonal struts, so sliding failure of the wall took place with crushing of the concrete strut to out of plane (see Photo. 7). Reasons for the damage from (a) to (d) were considered to be the large compressive and tensile axial forces in the columns generated by the large vertical accelerations of this earthquake and the existence of multistory shear walls. A large number of columns or beams with flexural cracks, shear cracks, and shear bond cracks were observed, but severe damage has not been reported.

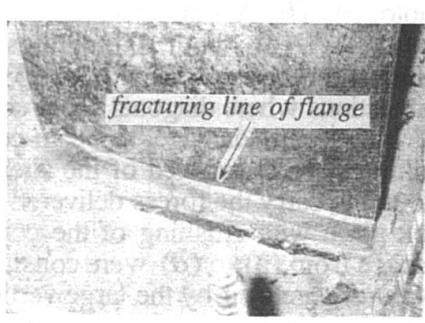
Photo. 4 Fracturing of Column Steel Flange Plate (after chipping concrete)

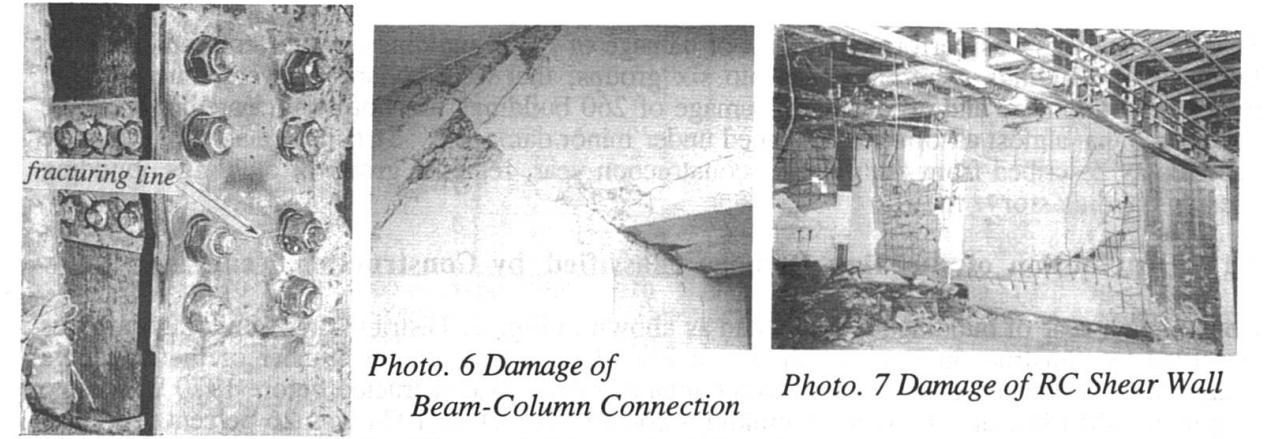
Photo. 5 Fracturing of Splice Plate at Column Joint (after chipping concrete)

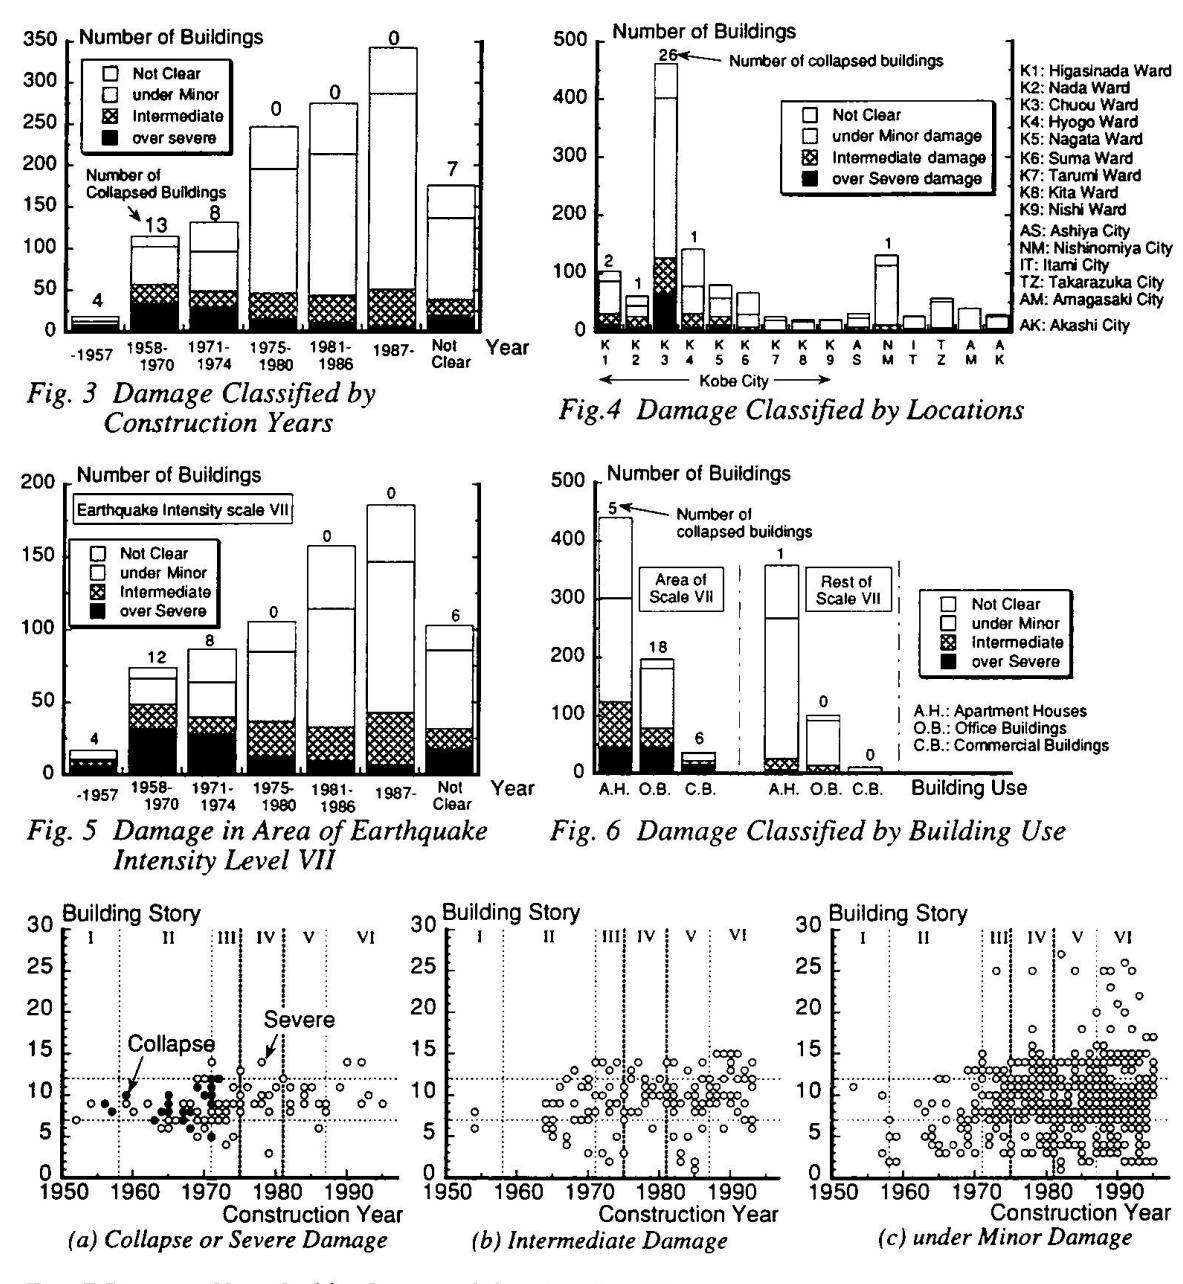
Fig. 7 Damage Classified by Story and Construction Year

Figure 7 shows the distribution of damage classified by building story and construction years. From these figures, it was clear that almost all of the buildings collapsed or sustained severe damage had over seven to twelve stories, and the buildings under six stories tended to be able to avoid severe damage, regardless of construction years of buildings. The buildings over fifteen stories did not sustain severer damage.
