## Elastic Composite Construction between Timber and Wood-Based Materials

**Hans HARTL**  
Civil Eng.  
Holzbau Gmbtt  
Vienna, Austria

Due to higher demands reconstruction of timber floors often request elastic composite construction between timber and wood-based materials. To commence construction, building or renovating it is necessary to uncover the existing timber beams. Afterwards sheathing panels (chip boards) are fixed to the beams with special connectors. A method of calculation and construction as well as the building process itself will be shown. This will be demonstrated with the example 'Salzburger Decke' ('Salzburg-type floor') in the ancient building 'Höllbräu' in the city of Salzburg.

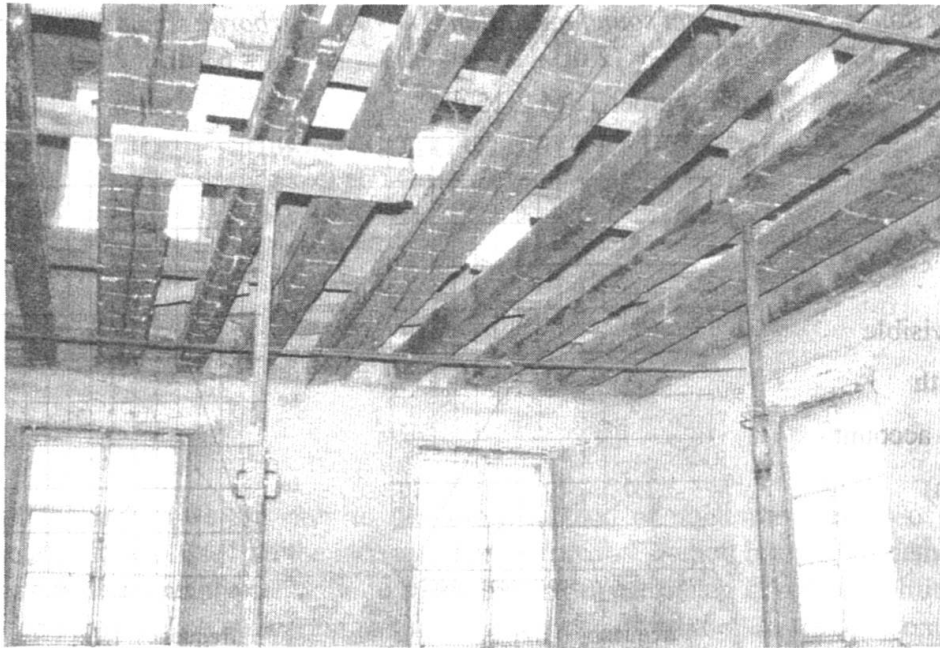
Fig 5 'Salzburger Decke' - 'Salzburg-type floor' after uncovering the existing timber beams

The architectural aura of the city 'Salzburg' is mainly determined by its old buildings. In the middle of the city the ancient building 'Höllbräu' is located and is one of the oldest buildings. Its history traces back to the year 1377. After renovation it is now a high-class hotel. To increase the load bearing capacity and to reduce the deflections of the 'Salzburg-type floor' one possibility is to create the floor structure given in Figure 6. After the timber beams have been exposed, sheathing panels (flat chip boards) are connected to the beams with special nails. This floor structure represents an elastic composite construction between timber and wood-based materials.

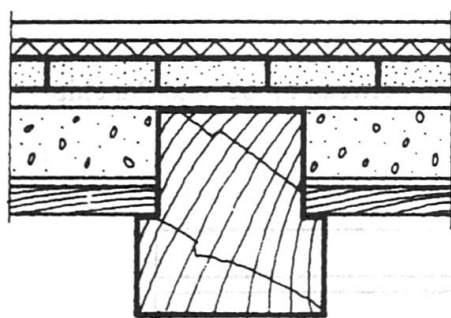
Flat chip board V 100, 25 mm (700 kg/m<sup>3</sup>)  
 Noise reduction mineral fibre  
 insulation elastic material 30/25  
 Concrete paving slabs 300x300x40, non-reinforced  
 Flat chip board V 20, 30 mm (700 kg/m<sup>3</sup>)  
 Loose filling 60 mm  
 Plaster board 25 mm  
 Wooden boards 40 mm (existence)

Fig 6 'Salzburger Decke' - 'Salzburg-type floor' after renovation

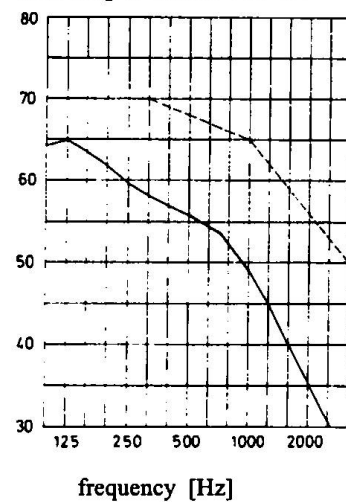
$$\text{TSM} = +12 \text{ dB}$$

with carpet  $\text{TSM} \geq 15 \text{ dB}$

Fig 7 Impact sound insulation

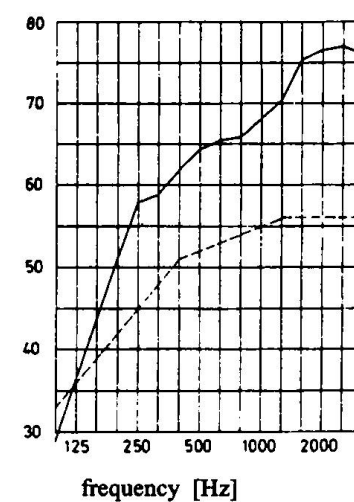
$$R_w = 63 \text{ dB}$$

Fig 8 Airborne sound insulation
