Collapse and Rehabilitation of Composite Trussed Structures

A failure case of a 2.400 m^2 area of an industrial roofing structure is presented. The investigation leading to the cause of the disaster, the numerical and experimental study using reduced models the rehabilitation procedures for the remaining part of the structure are described. Conclusions are also drawn concerning the application of external tension reinforcements to restore the original load capacity of the structure.

Major Repairs to Frank Lloyd Wright's Largest House: Wingspread, Racine, WI, USA

Frank Lloyd Wright's design for Wingspread was a brilliant conception but contained several inherent structural deficiencies. These did not manifest themselves significantly for the first 56 years of the house's life, but in 1994 large displacements occurred due to heavy snows. Repairs were made using a carbon fiber-epoxy thin shell laminated directly to the timber roof to form a composite structure. This shell was built up *in situ* from 13 layers of quad-axial carbon fiber.

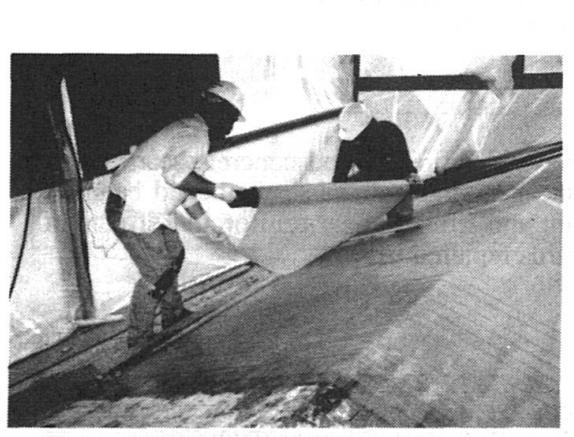
Fig. 1 Installation of Carbon Fiber Fabric É

Temporary shoring was installed and the roof tiles were removed (they were not original in any case, having been replaced in 1993). The permanent repair for the great Hall sought to achieve several objectives. First it should never be visible in the completed work. Second it should minimize disturbances to the existing interior finishes. And third it should be as economical as possible while still conforming to the rules of historic preservation. After extensive computer modeling using Finite Element Analysis, it was decided to create a shell structure out of the lower roof by coating the bare wood sheathing with 13 layers (12 mm total thickness) of quad-axial carbon fiber fabric set in a 50%-50% matrix of epoxy resin which was bonded to the wood. Prior to the first layer of carbon fiber installation the wood was thoroughly cleaned and large diameter screws were installed through the sheathing into the rafters at 15 cm on centers in oversized holes flooded with epoxy. Thus the carbon fiber was bonded to the wood sheathing which was in turn acting compositely with the rafters. Each layer of carbon was offset approximately 7-8 cm from the layer below to provide a scarf joint at every lap of fabric. Vacuum bagging was not practical for this on site installation so air bubbles were forced out using toothed rollers. The entire operation was conducted inside an environmentally controlled temporary timber framed structure built over the top of the roof. Upon completion, the composite membrane was post cured at 60° C for 24 hours.

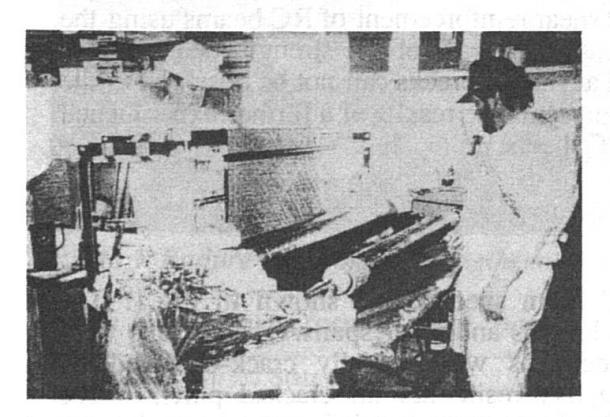
Fig. 2 Impregnating Fabric with Epoxy
