Zeitschrift:	IABSE reports = Rapports AIPC = IVBH Berichte
Band:	999 (1997)
Rubrik:	Diagnosis, maintenance, retrofitting, repair

Collapse and Rehabilitation of Composite Trussed Structures

Major Repairs to Frank Lloyd Wright's Largest House: Wingspread, Racine, WI, USA

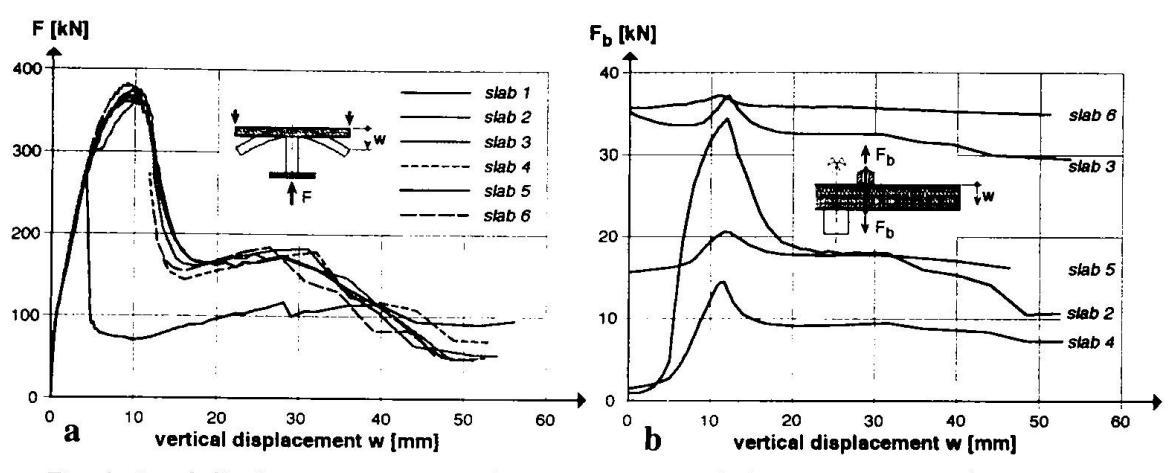
The test results are presented with the load-displacement curve (Fig. 1a) and the mean force in the bolts versus the vertical displacement of the slab (Fig. 1b). It follows that the punching load is increased from 280 kN up to 380 kN or 37% due to the strengthening. The vertical displacement at maximum load is significantly increased by the strengthening as it has more than doubled. It is observed that slab 1 is characterized by a punching cone inclined at an angle of approximately 30° . For all strengthened slabs, the punching cone is formed between the column diameter and the perimeter defined by the bolts. The inclination of the punching cone is approximately 70° (Fig. 2). This means that all the strengthened slabs exhibit a punching failure which is characterized by a punching crack that did not cross the strengthening bolts.

Fig. 1: Load-displacement curves and mean force in the bolts versus vertical displacement

Injection modifies the slab mode of resistance so that it resists globally resulting in reduction of the stress level in the bolts (compare slab 2 and 4 in Fig. 1b). The injection also improves the serviceability of the slab and provides a protection against corrosion of the bolts.

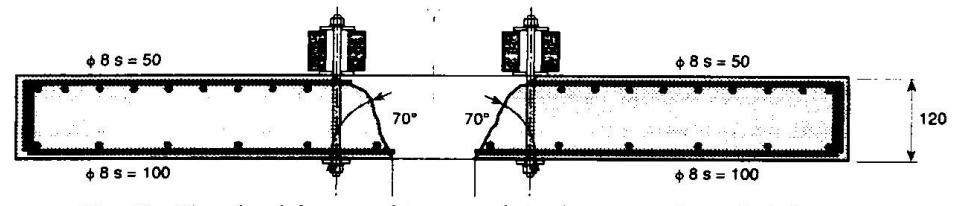
The punching load for the slab without strengthening bolts is predicted with the analytical model developed by Menétrey [2] which leads to $V_{pun}=250$ kN. The punching load of the strengthened slabs with a punching crack inclination of 70^{0} is influenced by the punching and the flexural strength (as proposed by Menétrey [3]) resulting in $V_{fail}=364$ kN.

Fig. 2 : Sketch of the punching crack in the strengthened slab
