Structural Rehabilitation of an Industrial Steel Building

Nicolae TARANU, Petru STRATEANU and Dorina ISOPESCU

Summary

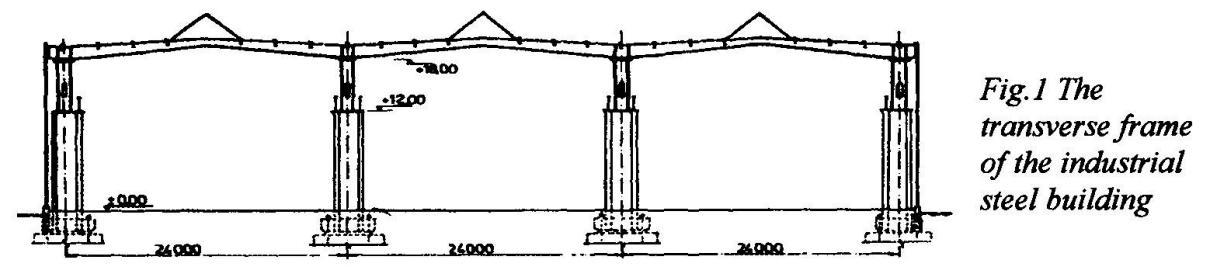
The framing system consists of ten main transverse steel frames, each of 3x24 m span (fig.1). The spacing between frames is 12 m. Seven overhead traveling cranes with handling loads of 125 kN to 500 kN are operating inside the building and transmit their load effects to the main structural system. Continuous tapered solid web welded sections have been selected for the main girders of the transverse frames. The main girders are supported on steel stepped built-up welded columns. The roof decking is made of prefabricated concrete elements which support thermal insulation and waterproofing. The roof decking is sustained by solid web welded purlins rigidly connected to the main transverse girders. The painting system applied on the steel members surfaces consisted of two main components: two layers of red-lead primer and two coats of chlor-rubber based paint.

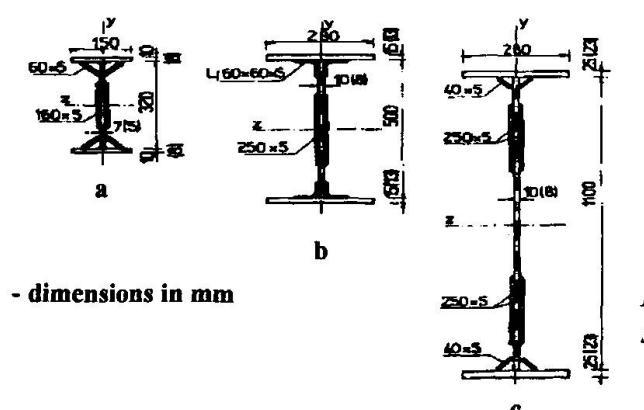
Fig.2 Strengthening solutions of bent elements: a-purlins; b&c-tapered frame girders

The verification procedures for ultimate limit states and for serviceability limit states have been applied according to the Romanian Standard STAS 10108/0, and to the Code P-100-92, for design of structures in seismic zones. To assess the corrosion effect on the loadbearing capacity of the structural steel members the initial geometric characteristics (A_0 =the noncorroded initial area and W_0 =the noncorroded initial section modulus) have been compared with the same properties after exploitation in corrosive atmosphere (A_c =the corroded cross-sectional area and W_c =the section modulus of the corroded structural members). The numerical values of the deterioration ratios have been calculated for all main structural members as follows: purlins, $W_c/W_0 = 0.785$; crane girders, $W_c/W_0 = 0.912$; columns, $W_o/W_0 = 0.789$ and $A_c/A_0 = 0.820$; frame girders, $W_c/W_0 = 0.823$ at midspan, and $W_c/W_0 = 0.901$ on columns.

To restore the initial loadbearing capacity of the steel members, the strengthening solutions presented in figs.2 and 3, have been proposed. The strengthening pieces illustrated by dashed areas have been attached to the weakened members after careful cleaning of the corroded elements. The dimensions given in the parenthesis correspond to the corroded areas. After consolidation the ratios between the strengthened sections characteristics (W_1 , A_1) and the initial ones (W_0 , A_0) have been calculated: purlins, $W_1/W_0 = 1.03$; columns, $W_1/W_0 = 1.04$ and $A_1/A_0 = 1.02$; frame girders, $W_1/W_0 = 1.08$ at midspan, and $W_1/W_0 = 1.02$ on columns.
