Ten Years' Maintenance of Seto Ohashi Bridges

On April 10th, 1998, the Seto Ohashi Bridge celebrated its tenth anniversary since its opening. During these ten years, some problems which were due to the initial defects were found. In this paper, the inspection of these bridges is introduced first then some of these problems are reported. These are, the corrosion of main cables of suspension bridges, the damages of cables of cable-stayed bridges due to vibrations, the accident of an inclination of one link type expansion joint, the noise problem of same joints, the noise problem of rolling leaf expansion joints and the noise problem of end links of the Shimotsui-Seto Bridge.

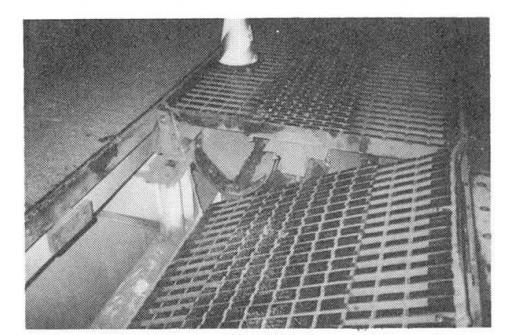
Fig.1 Accident of Link Expansion Joint

On May 3rd 1994, there was an accident that one of the link expansion joints of the Iwaguro-jima Bridge inclined and one car was damaged. This accident was due to the fact that the nuts of bolts of the universal joint which connected the expansion joint and the bridge deck loosened and fell. Consequently one end of the joint fell and the whole joint inclined. To prevent same accidents, expansion joint stoppers are installed and cotter pins are applied on all bolts which connect expansion joints and bridge decks. This improvement was finished in March 1995.

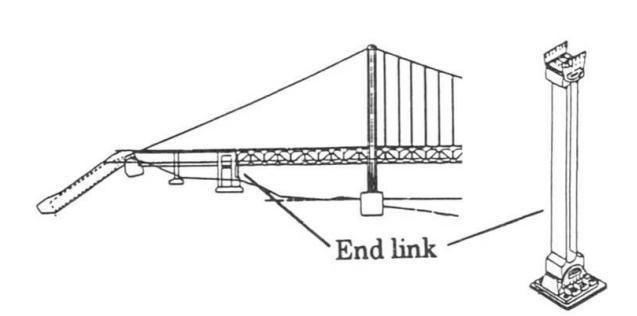
Three suspension bridges of the Seto Ohashi Bridge employ the rolling leaf expansion joints for the road way. These expansion joints also had noise problems after the opening of the Seto Ohashi Bridge. To suppress these noises, various countermeasures were adopted for these joints, until April 1989. The ends of stiffening truss girders of the three suspension bridges of the Seto Ohashi Bridge are supported upward by end links vertically from beneath the girder. The maximum reaction force of the end link of the Shimotsui-Seto Bridge is 2558 ton, which is about twice larger than other two suspension bridges because this bridge has extended side spans which are not suspended from the main cables. From June 1993, these end links began to make large noises when heavier freight trains passed through the bridge. In January to February 1994, the noise source was closely investigated using the acoustic emission method. It was found that the noise source was the center of the semispherical boss of the lower pivot structure of the end links. The pivot structure consists of a semispherical boss which is embedded on a concrete abutment and a concave semispherical cover which is placed at the end of the link beam and over the boss. It was inferred that the movement of a pivot was not large enough to diffuse solid lubricant embedded in the concave cover, consequently a stick slip phenomenon of metal surfaces occurred and noises were emitted. To prevent this stick slip phenomenon, a hole was bored on a concave cover to reach the center of a boss and liquid lubricant was pressured into the surfaces. This countermeasure worked well and the noise problem was solved. All of the end links of the Shimotsui-Seto Bridge was repaired by this method until 1997.

Fig.2 End link of the Shimotsui-Seto Bridge

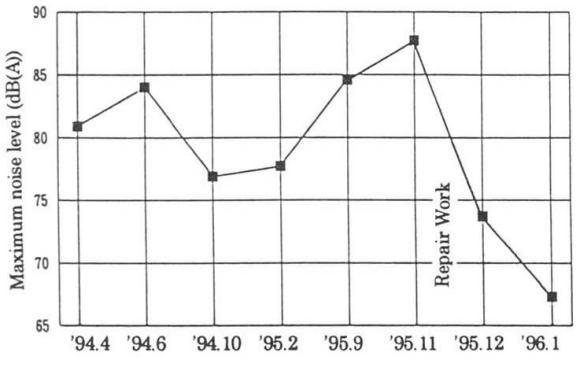
Fig.3 Noise reduction of end link
