Rehabilitation of the Luangwa Bridge

Peter REINHOLDT Department Head COWI AS Lyngby, Denmark

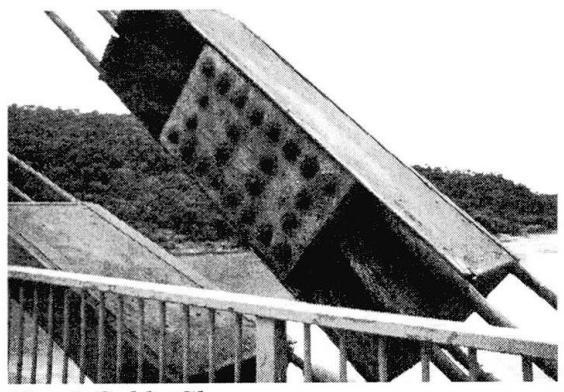
Fig. 1 Cable Clamps

- Shortening of stays by applying clamps to improve the vertical alignment of the bridge
- Mounting inside the bridge girder of horizontal compression steel tubes near the towers and horizontal tension cables near the middle of the bridge
- Replacement of failed friction grip bolts in the main steel boxes of the bridge girder.

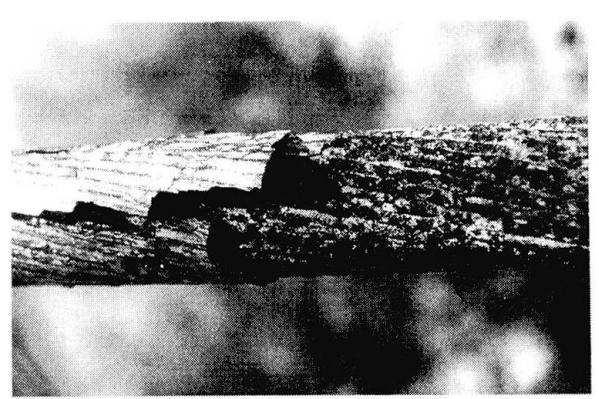
Severe pitting corrosion was found on the cable stays. The painting of the cable stays was cracked and there was virtually no adhesion to the cable surface any more.

Fig. 2 Severe pitting of cables

A rehabilitation of the bridge was carried out in 1997 to strengthen the bridge and enhance its load bearing capacity. The rehabilitation included replacement of all cables and strengthening of the bridge girder. Construction work had to be completed within a time slot between two rainy seasons, which represented a serious constraint on the project.
